BAT SURVEY AT -

11 HIPPIINGS WAY
CLITHEROE

DATE AND TIME OF VISIT
6TH Jan 2017 5.00pm- internal inspection
10th Jan 2017 - external inspection

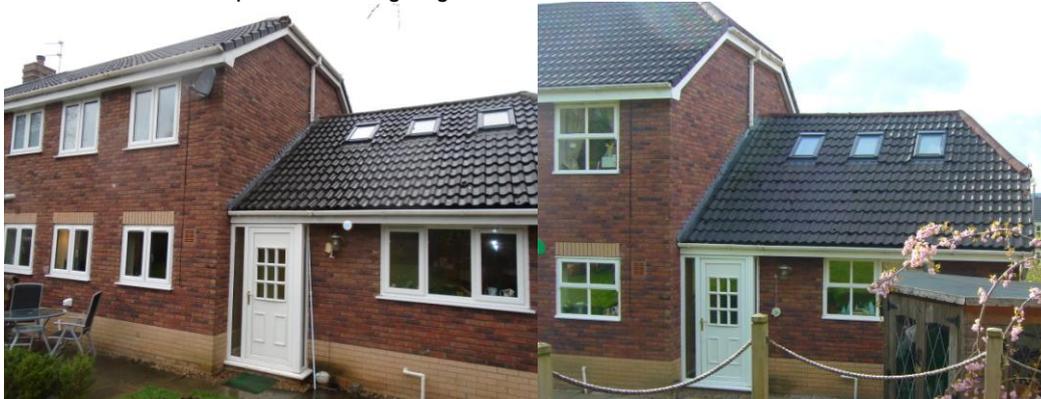
Part rear elevation

Detached house built around the 1990's. The main house is two storey with a single storey garage / utility room to the side. The roof space over the garage was converted at a later date to form a bedroom/ office.

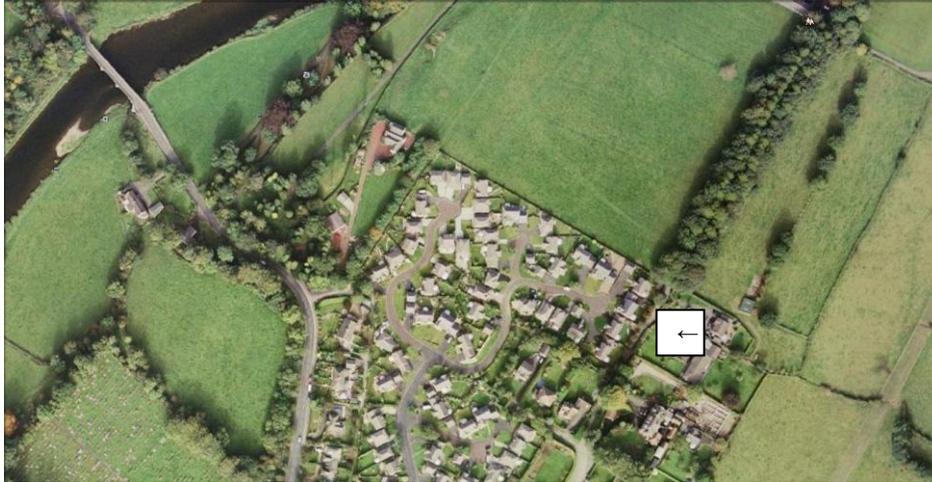
LOCATION SD: 742 426

The house is located on the edge of a large housing estate on the outskirts of Clitheroe, the properties are all of a similar age and type. The rear boundary of the garden is adjacent to the access road to Moorlands school and some large period properties located in large gardens.

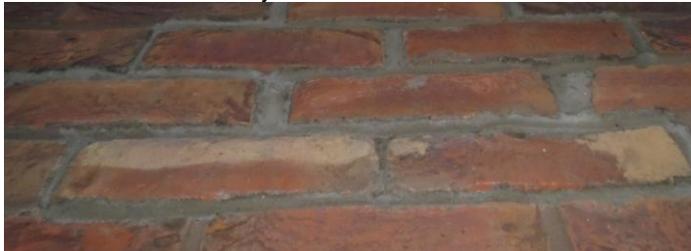
The walls are brick cavity construction.

The walls and pointing are in perfect condition with no access points.

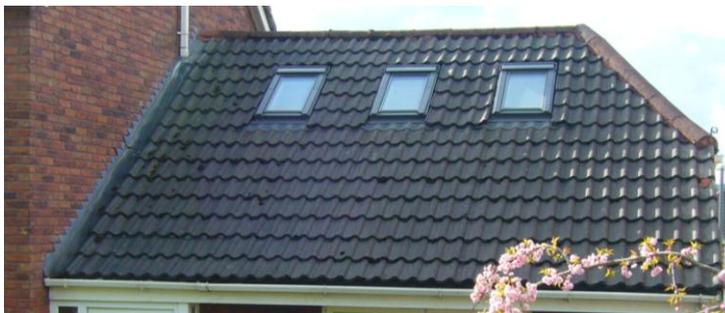
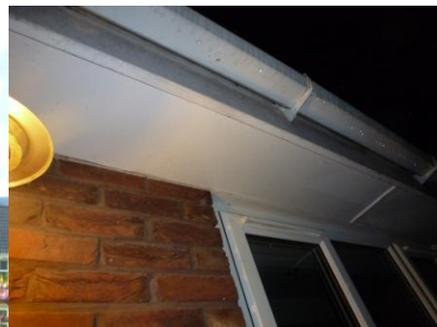
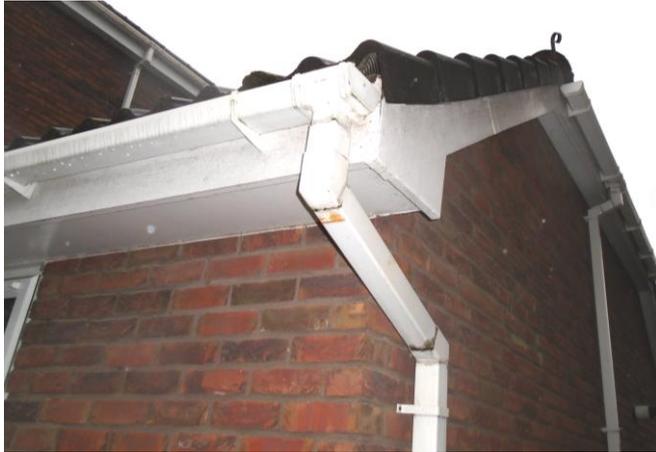
Eaves and gable soffits

The house roof is a profile tile, partially hipped roof with eaves overhang, as is the single storey garage with the addition of roof windows. The fascias have boarded soffits which are very tight fitting.

The roofs of the house and garage are in excellent condition with no loose slates or gaps between. The profile at the eaves has mesh infill to prevent any potential access.

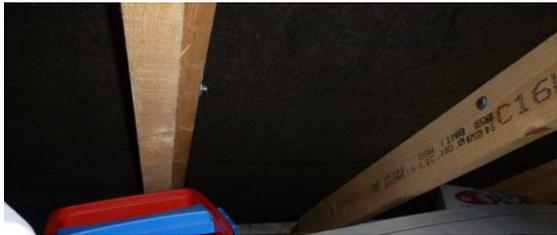
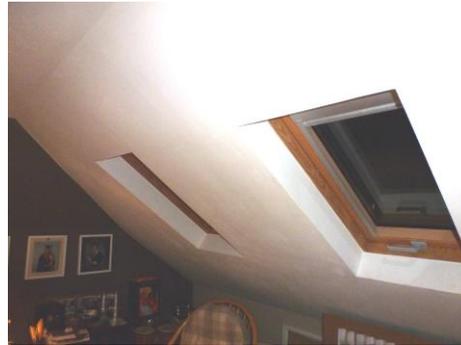
The roof space over the garage was accessed via a stair, the walls and roof are lined out with plaster board, the room is in regular use.

4no hatches are formed to access the eaves void which were used for storage, the felt and rafters were closely inspected they were found to be in perfect condition and the voids were clean and free from any dropping or insect evidence.

The space provides sub - optimal roost potential.
