**BAT SURVEY AT -**  
ROWAN COTTAGE  
CLOITHEROE OLD ROAD  
DUTTON

DATE AND TIME OF VISIT  
16th Jan 2017 10.30 am

REFERENCE. Mr and Mrs Livesley

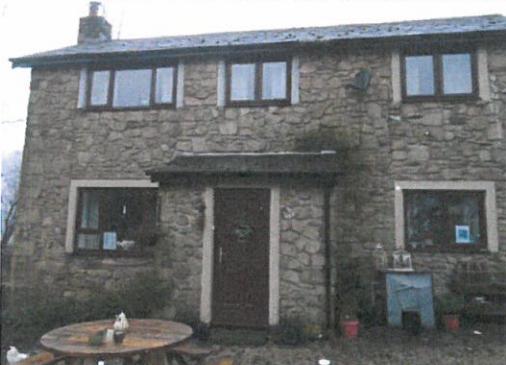
Front elevation

The property is a detached dwelling built in 1975. Within the site area is a detached dilapidated barn adjacent to the north gable of the house and various sheds in the garden.

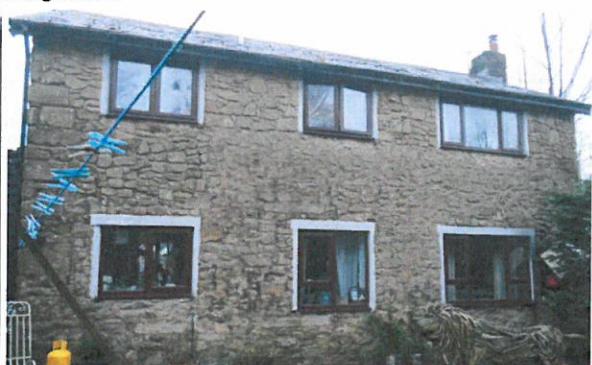
Rear elevation

The slates are tight fitting with some moss coverage. The ridge slates and lead flashing to the chimney appear to be in reasonable condition with no gaps. The soffits are generally in good condition and tight fitting with pointing at the abutment with the wall with the exception of some very small gaps in the rear elevation.

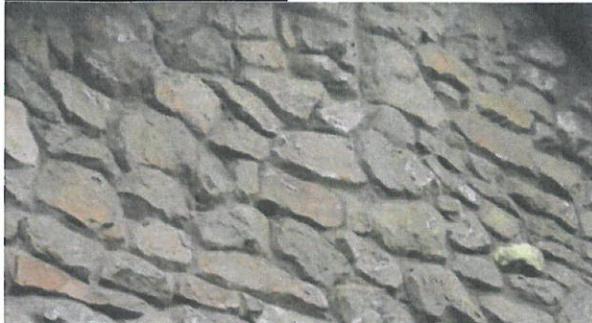
The walls are natural stone cavity construction with recessed pointing.

The walls and pointing are in excellent condition with no gaps, crevices or access points suitable for bats.

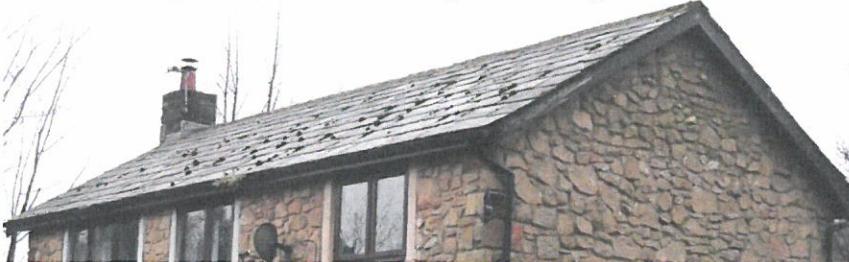
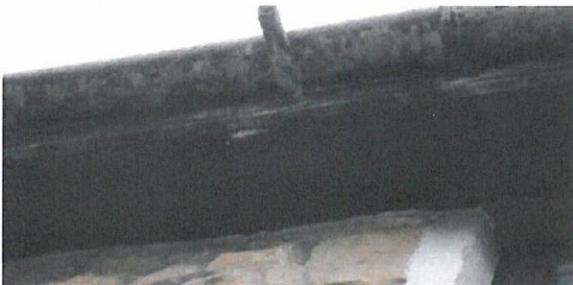
Boarded Soffit

The roof is slate pitched with an eaves and gable overhang and boarded soffits.

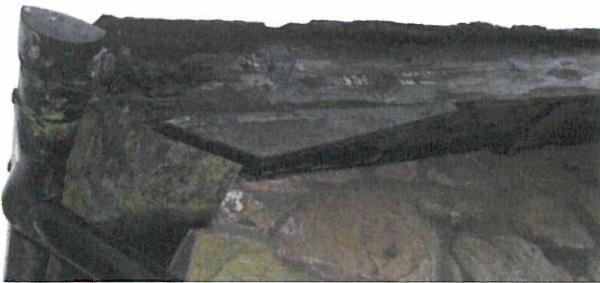
The NE corner of the barge board has rotted see below. This was examined closely with the aid of ladders.

The external features of the North elevation of the property and the roof space being affected by the development were the main focus of this scoping survey. The lead flashings, eaves, slates, stone work and any sills were visually examined for droppings, staining or feeding remains. The rotted barge board was inspected at close quarters for any grease /scratch marks .The results were negative.

The findings of this survey concur with that of 2010, however a potential access point in the rotten barge board has developed during the intermediate years, this was closely inspected and discounted from being used by the local bat population, it is however recommended that the opening be blocked to prevent access during the intervening months prior to commencement of works.

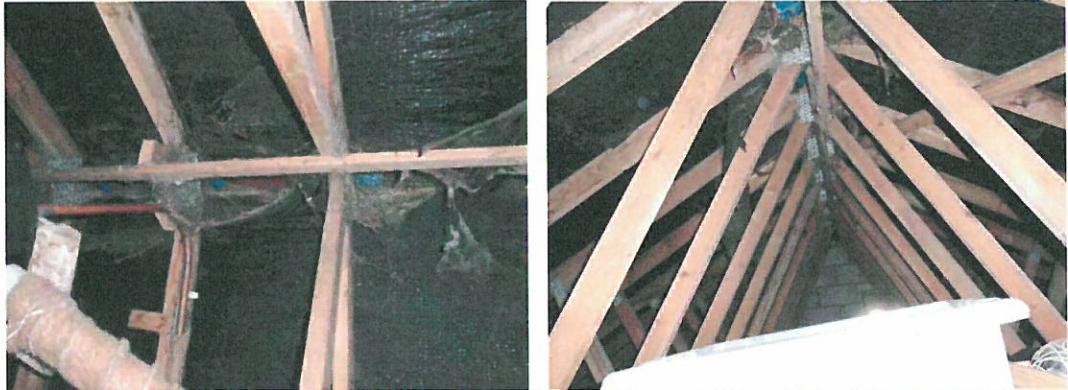
The roof space is accessed via a ceiling hatch, it is used for storage. The construction is truss rafter with felt over. The trusses are in very good condition, the felt is in reasonable condition with the exception of the ridge which is exposed to the underside the space is dry and the surfaces were clean and free from any dropping or insect evidence.

The careful inspection of the interior did not reveal any evidence that bats are present in the building or have been historically.

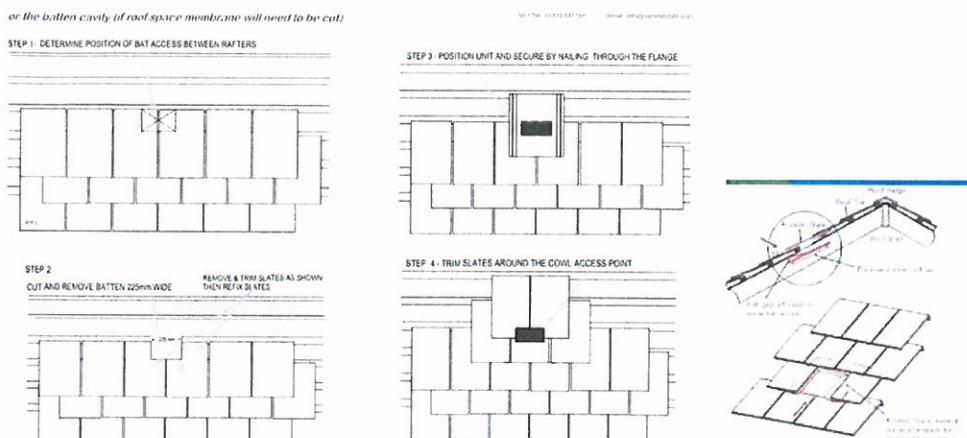
1 no bat slate in the south pitch of the new roof. See below.

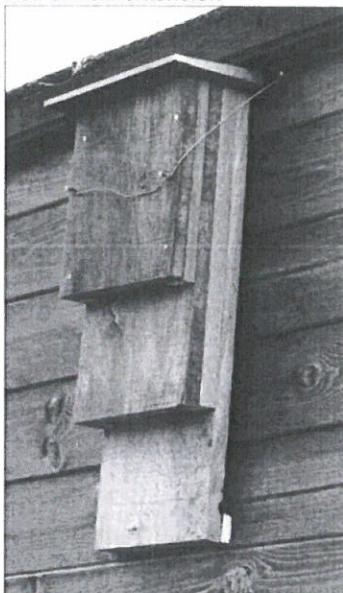
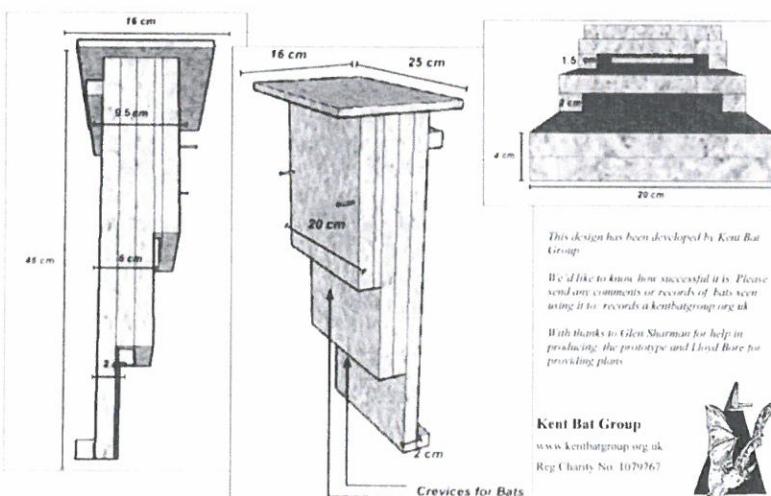
### **The Kent bat box**

Simple to construct, self-cleaning and low maintenance.

The only critical measurement is the width of the crevices—these should be no larger than suggested. Other measurements are approximate.

Box to be made from untreated rough-sawn timbers  
Timber should be c.20mm thick  
The box should be rainproof and draught-free  
Crevices can be between 15 and 25 mm wide  
Fixing may be by use of brackets, durable bands or wires

Boxes are best fixed as high as possible in a sheltered wind-free position, exposed to the sun for part of the day.  
They can be fitted to walls, other flat surfaces or trees  
A clear flight line to the entrance is important

1 no Kent bat box to be fixed on the gable wall of new extension
