## Manor House, Whalley: Bat Roost Assessment Report

Bowland Ecology Ltd was commissioned by Smith Sager Ltd to undertake an inspection of detached garages at Manor House, Brookes Lane, Whalley (NGR SD 73517, 36495). The aims of the survey were to assess the presence of (or potential for) bats to roost within the garages, and to highlight any potential constraints to the works together with any necessary mitigation measures. The garages are proposed for demolition with erection of a new garage structure in a different location on the property.

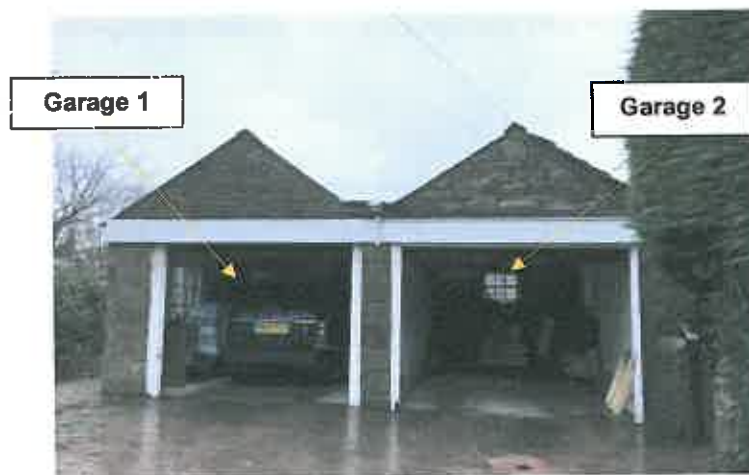
**Photograph 1: External View of Front of Garages**

The site consists of two adjacent garages (Garage 1 and Garage 2, see Photograph 1 and building location plan) with attached outbuildings at the rear of the property. The site is located on the eastern edge of the village of Whalley. It is considered that there are good potential bat foraging habitats within the site, in the immediate surrounding area and the wider landscape. On site there are trees and gardens which provide potential feeding habitats for bats. Tree lined tracks, gardens, woodland and grassland provide suitable bat feeding habitats in the surrounding area. The River Calder is approximately 500 m to the south.

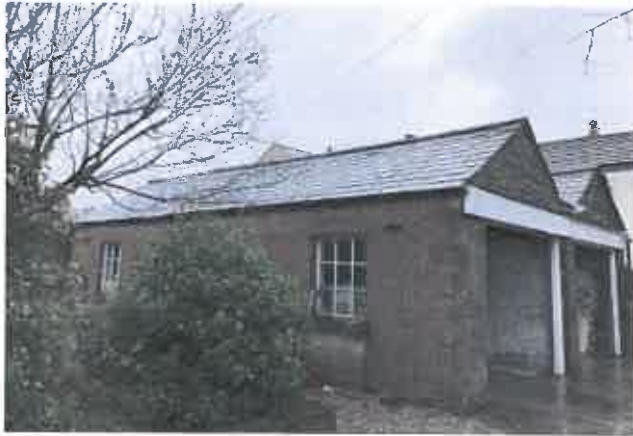
**Photograph 2:** External View of Garage 1

Garage 1 consisted of a brick building with stone cladding and pebble dashing. The roof had a single pitch and was covered in slate. The Garage was split in to two areas internally – One being the garage and the second being the garden store (Photograph 3). The external stone work was in good condition and did not provide potential bat roosting features. The slate roof was in a poor state

of repair with pointing missing from the majority of the ridge tiles. Approximately 20 lifted/raised slates were also present and these provide potential access or roosting areas for bats.

The survey did not record any evidence of roosting bats. The building has features that could be used by roosting bats (e.g. lifted roof tiles, pointing missing on ridge tiles, gaps in stone slates and missing pointing), therefore it is possible that low numbers of bats/individual bats may use these features as occasional/transient roost sites. The features present are unsuitable for maternity roost and roosts of large numbers. Therefore the garages and outbuildings are considered to be low risk for providing a bat roost.

- Ensuring all contractors are made aware of the possible presence of bat roost features, and the signs that may indicate evidence of bats (see Bat Awareness Sheets at Appendix 1).
- All roofing material to be removed by hand.
- Care to be taken when removing the stone cladding on the front (above the doors), this should be undertaken by hand.
- If evidence of bats or a bat is found, works must stop and an ecologist must be consulted immediately.

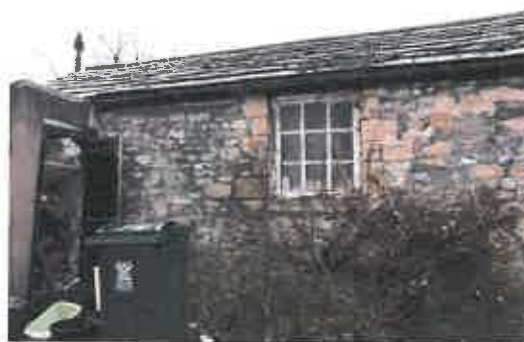
**Photograph 4:** External View of Garage 2 South Eastern Elevation showing stone tiles

Garage 2 consists of a brick building with external stone cladding. The single pitched roof has a mixture of slate and stone tile covering. The stone tiles form the roof covering on the south eastern elevation with traditional slate covering the north western elevation. The external stone cladding was in good condition with only one small area of pointing missing. The missing pointing was located above the garage door near the roof gully between the two garages. The roof appeared to be in reasonable condition with the ridge well pointed. There were gaps under the stone tiles that provide a potential roosting opportunity for bats. These gaps generally occurred where the stone tiles overlapped. Where visible, the slates on the north western roof slope appeared to be in good condition and provided little opportunity for roosting bats.

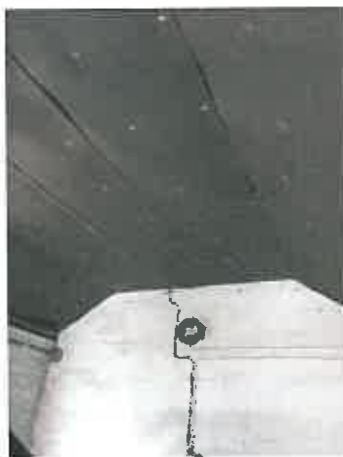
***Photograph 5: Internal View of Garage 1***

Garage 1 consisted of painted brick work and a boarded ceiling. The ceiling boarding was in reasonable condition and creates a void at the apex of the roof. There was no access in to the void. Localised small damp patches were evident on the boarding in two places. A small gap was evident adjacent to the steel beam above the door. This gap could provide access to a wall cavity if present or provide space for low numbers of crevice dwelling bats to roost. The walls were clean and the building was used to store a car and is likely to have disturbance throughout the year. No evidence of bat presence was found during the internal inspection.

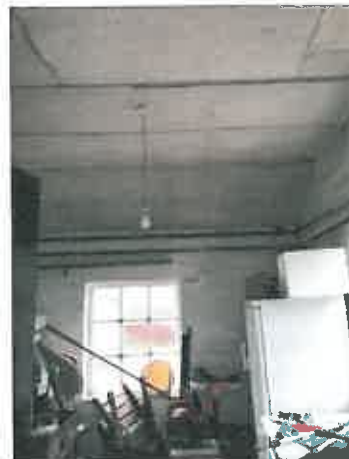
***Photograph 6: Internal View of Garden Store***

The garden store is of the same structure as Garage 1, with white painted walls and a boarded ceiling that created a void at the apex. The building was well used and would be heavily disturbed throughout the year. This storage building is well lit due to the presence of two windows and glass panelling to the door. No evidence of bat presence was found during the internal inspection.

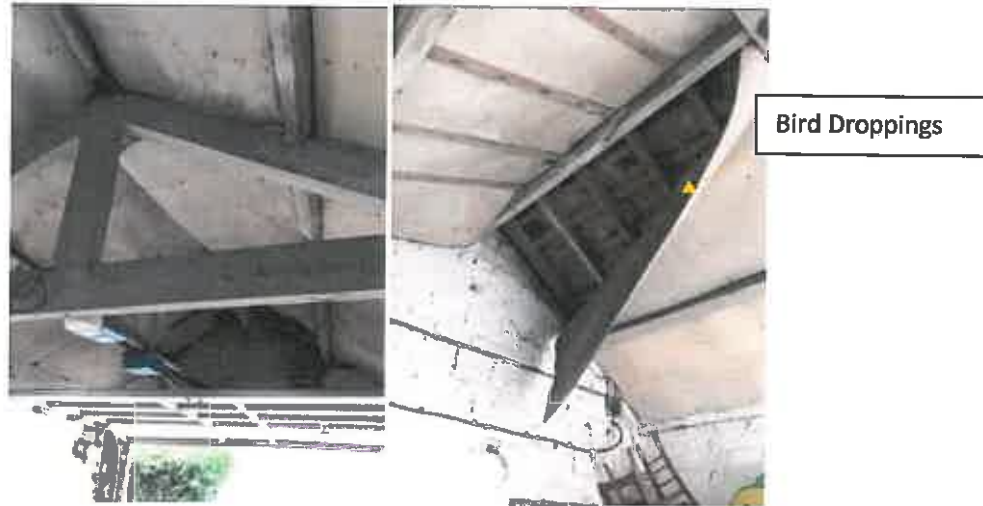
**Photographs 7: Internal View of Garage 2**

Garage 2 consists of white painted brick work with a boarded ceiling. The brick work as in good condition, and due to the white painted walls bat droppings would easily be found had they been present. The ceiling boarding was in a poor state of repair with extensive damp. The boarding was peeling from the rafters in places creating large holes and access in to the garage. Where the boarding was still intact a small void was present that could provide potentially suitable habitat for roosting bats. As the visible boarding and rafters were damp it is unlikely that bat would be present in the voids. Two gaps were present in the boarding on the north western roof elevation, where these spaces were present an underfelt had been used to line the gap. The roofing felt was in good condition and would prevent bats access in the garage space. It was unclear if the roofing felt was only present in the two gaps described or extends through the whole north western roof elevation. Two windows were present within the garage making the well-lit which limits the suitability of the internal area of the building for roosting bats.

Bird droppings were present on one of the peeling roofing boards – no droppings were found elsewhere within the garage and it is likely that the droppings were old as access to the garage would be limited to when the doors are open.
