**BAT SURVEY AT -  
LAND OFF DAVIS STREET  
LONGRIDGE  
PR3 3NL**

DATE AND TIME OF VISIT  
16th Jan 2017 9.30 am

REFERENCE NO. 5219

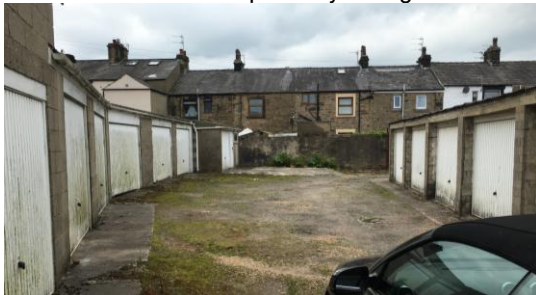
Southern block

The buildings comprise of 2 no blocks of single garages both being attached to a two storey building at the east end of the site. The southern block in its entirety probably dates from the 1970/80 s, it consists of 6no single storey garages and a two storey section with garage spaces at ground floor and storage space at first floor. The northern block of garages is being demolished with the exception of the original stone built building ( originally constructed as stables probably dating from the 1800's ) which is being retained as existing.

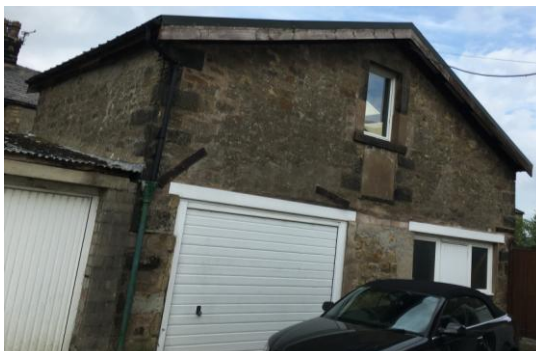
Two storey section at the east end of the northern block. Building to be retained

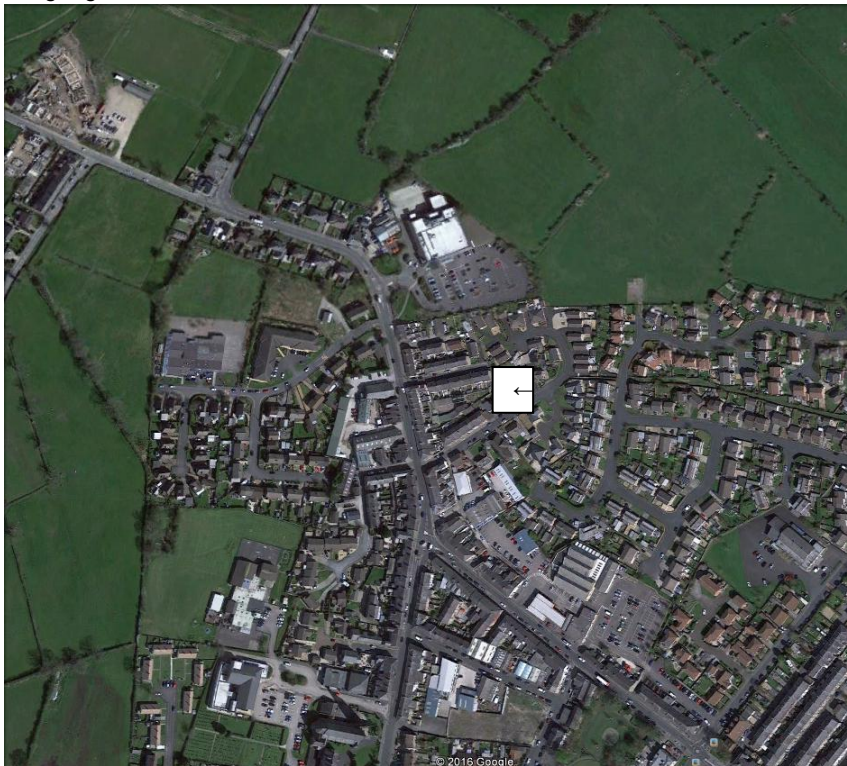
**LOCATION SD:602 377**

The site is located towards the edge of the built up area of Longridge just off Inglewhite road, (a main thoroughfare running through the town).The site is accessed via Davis street, it is situated immediately behind the terrace row on Inglewhite road. The buildings lining Inglewhite road and the proposed site are within the Longridge conservation area.

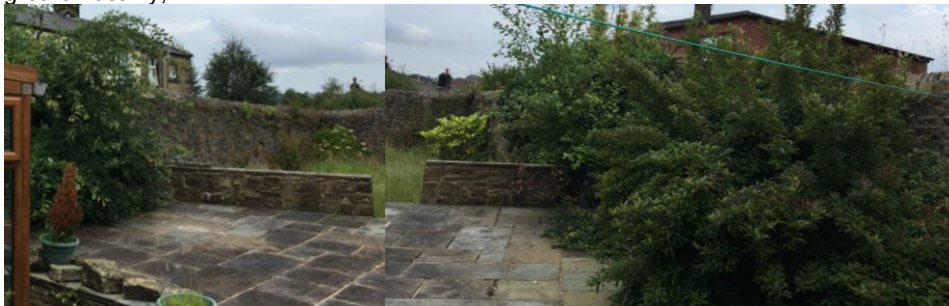
Garden

The site is a virtual triangular shape, the easterly point being a small garden which is mainly paved with a small lawn area and some overgrown shrub planting, the remainder of the site is hard standing surrounded by a stone wall which forms the rear wall of the garages and the boundary wall of the yards of the terraced houses which surround the site on all three sides.

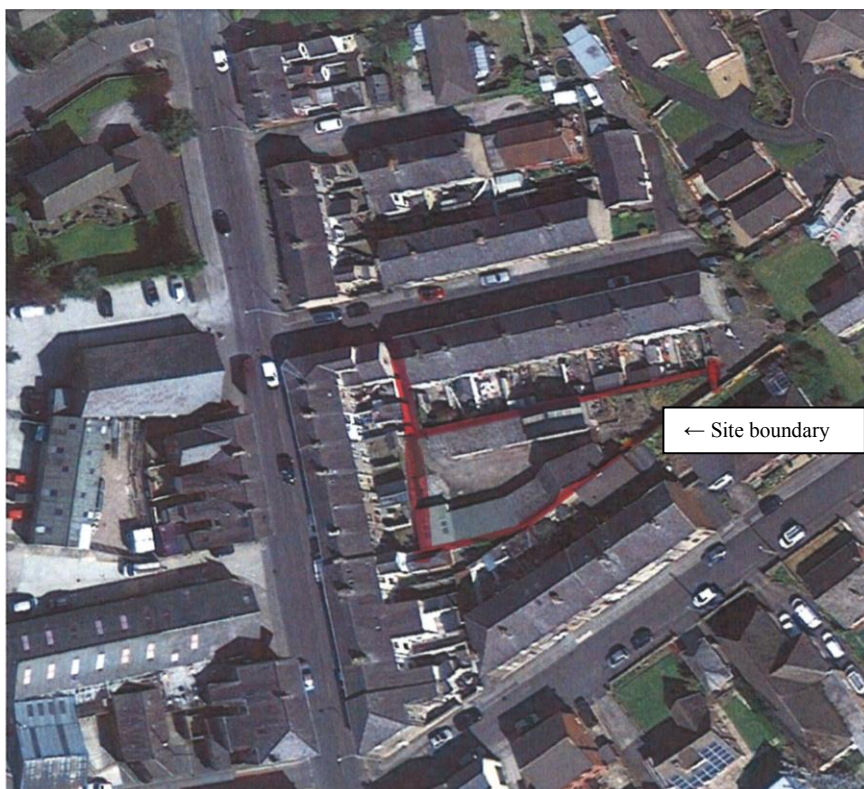
The site is remote ( min 150m radius) from any mature trees, pasture land is located at 115m to the north of the site and 250m to the west. There are no significant bodies of water within ½ km , the exception being a small pond to the north east at 380m. The location is considered to provide minimal forage potential, it also lacks any connectivity to the pastureland located in the greater locality.

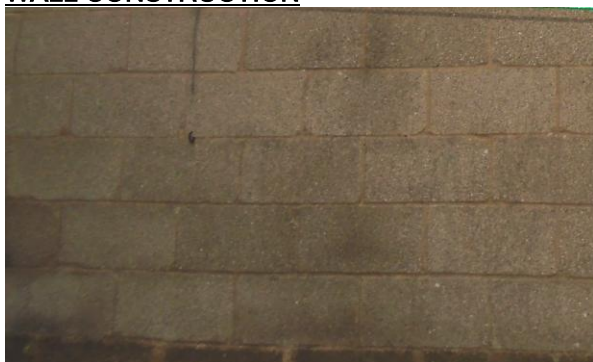
The side, front and party walls of the garages are constructed in solid concrete block. The rear walls which also form the rear yard boundary walls of the adjacent terraced houses.

The walls are in good condition with no access points or cracks and crevices suitable for bat use.

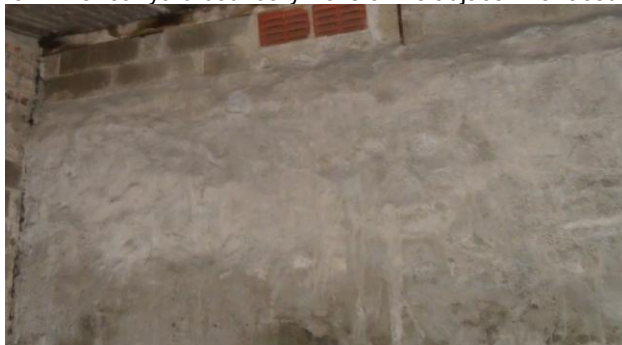
The rear wall of the garage( internal) / boundary wall (with the adjacent yards).

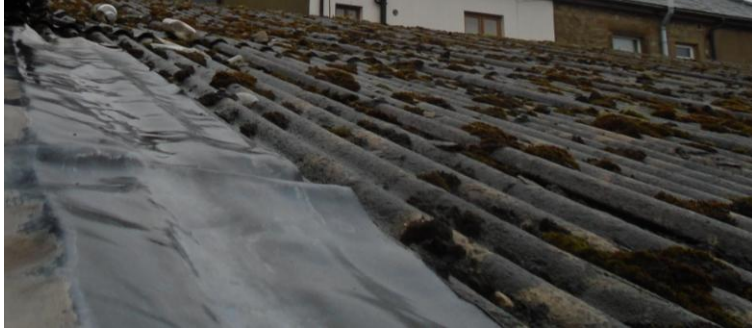
The garage roofs have a slight mono pitch roof falling to the front elevation. They have either corrugated fibre cement or profile steel sheet covering.

The single storey garage roofs have slight gaps at the eaves due to the nature of the material however the interior of the garages do not provide any potential roost habitat for bats and no indication of access could be found.

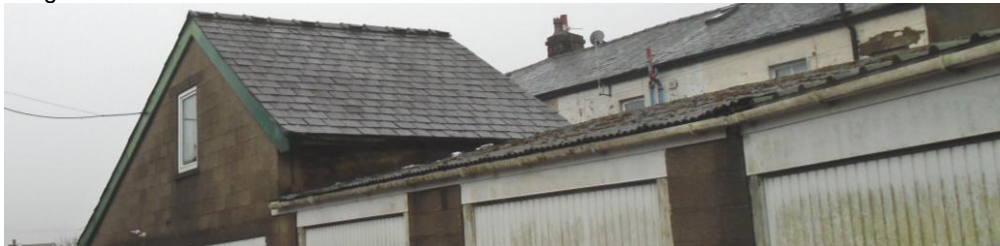
The two storey section has a pitched roof with a slate finish, a slight overhang at the eaves and barge boards to the gable.

The slate finish of the two storey section appeared to be in reasonable condition with no slipped slates or significant gaps, the ridge tiles are well bedded. The small gap behind the barge boards was examined, no access points were evident. The eaves overhang adjacent to the garage roofs was examined closely the front corner could potentially be accessed but there was no grease mark, scratching or dropping evidence.

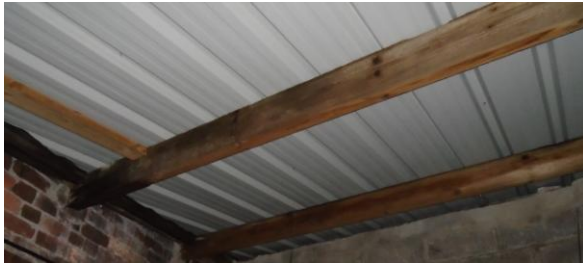
The garages have no enclosed roof void, the timber purlins are exposed internally with the sheets fixed directly over. The spaces do not provide any potential roosting habitat.

Garages Steel sheet

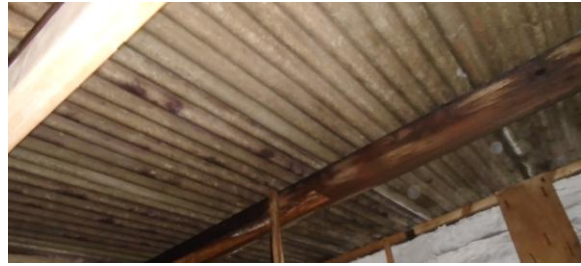
Corrugated fibre cement

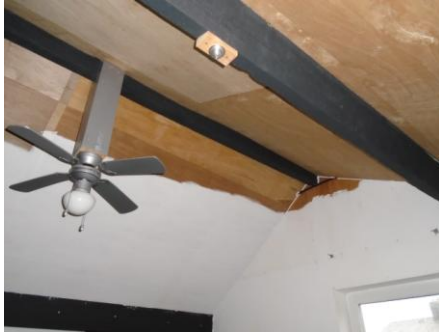
The first floor room was accessed via a stair the space is completely boarded out to the underside of the rafters. There was no potential habitat visible and the space did not provide any foraging potential.
