**BAT SURVEY**

**SOUTHPORT HOUSE  
SAWLEY**

**DATE AND TIME OF VISIT  
12<sup>th</sup> FEB 2015 9.00am**

REFERENCE NO. 5011

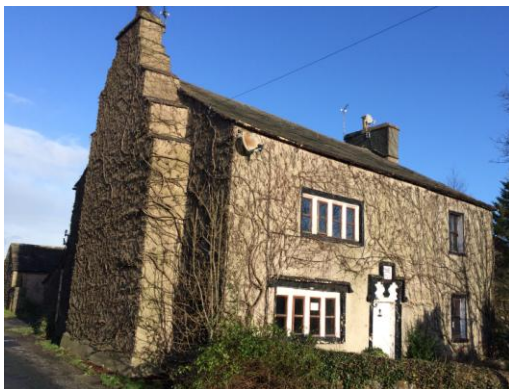
Front elevation

The house render is generally in reasonable condition however the front and side elevations are covered in ivy, no access points could be observed in the render. The rear stone wall had a shallow crevice adjacent to the window where pointing was missing but no other significant cracks or crevices.

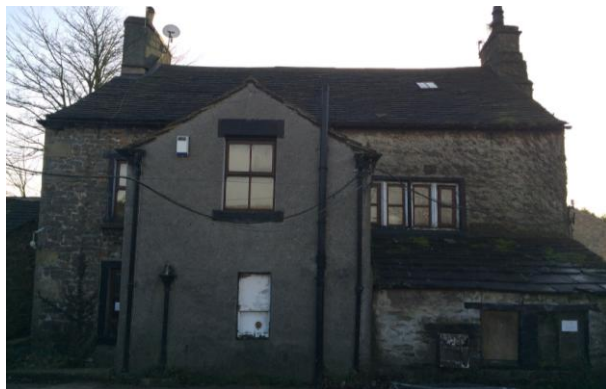
Rear elevation

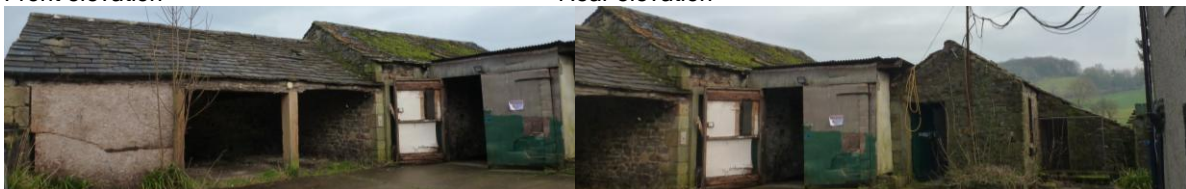
Out buildings to the rear of the house

The outbuildings were in a poor condition with many cracks and crevices and free access to the interior via cart and door openings.

The outbuilding roofs were in very bad condition with significant moss coverage, particularly the corner outbuilding which would prevent bat access. There were numerous slipped and broken slates in the roofs.

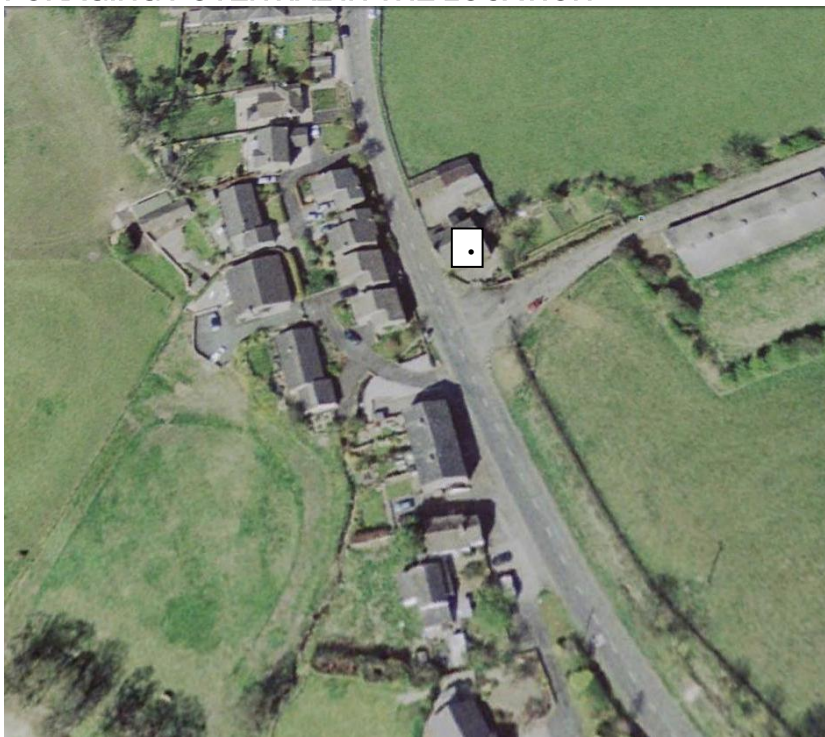
Sawley Road is immediately to the south west of the building, there is hard standing yard to the north west with outbuildings lining the N.W and NE sides. A garden is located adjacent to the North east gable of the house. On the opposite side of the road to the north and south are other dwellings of differing periods. Pasture land is to the north, south and west, the river Ribble flows in a north south direction approx 120 m from the house. Whilst trees line the road and the river bank towards the A59 and the houses located in this area provide a high level of foraging and roosting potential, the immediate locality of the house has broken connectivity to the high value foraging areas.

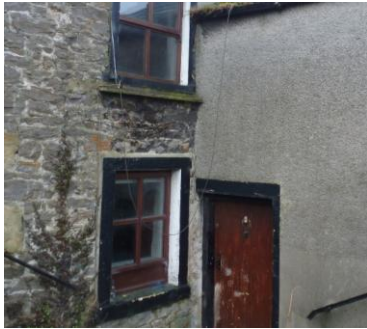
The main house is constructed in natural random stone, the front and side elevations and a rear outrigger have a render finish. The rear wall is pointed stone.

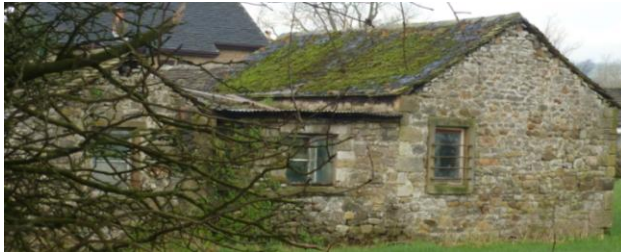
The outbuildings are random natural stone.

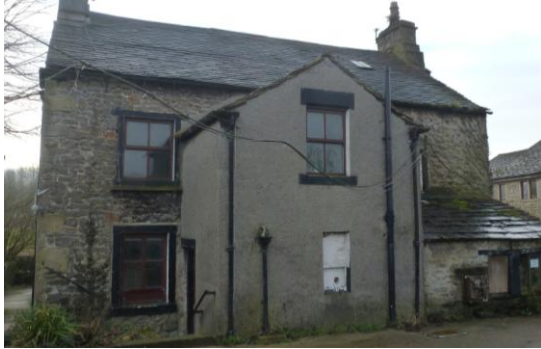
Outrigger to the rear of the house

The roof of the main house is pitched with a roof light in the rear pitch the finish is blue slate. The outrigger and single storey Lean -to at the rear of the house do not connect into the main roof and the finish is grey slate.

The main house roof was inspected with the use of Binoculars, there didn't appear to be any slates which had slipped or any significant gaps. The lean to roof is in poor condition with some broken slates and significant gaps. It was difficult to closely inspect the out rigger roof but no significant potential access points where apparent.

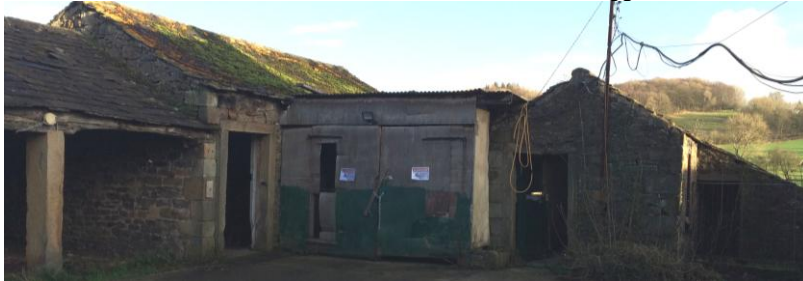
The outbuildings have pitched grey slate roofs with the exception of the link which has a mono pitch corrugated steel sheet roof.

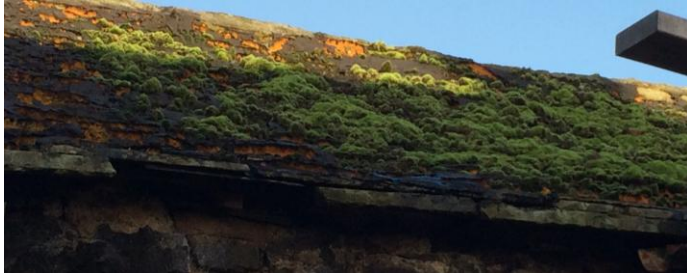
The corner outbuilding roof.

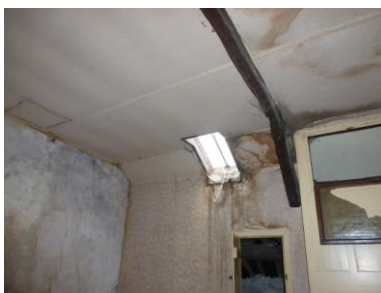
Room interiors

The main house roof space was accessed via a staircase, the space is divided into bedroom accommodation with the rafters lined out except for the small voids at the eaves which were accessible via hatches. There is no felt and the voids are cold draughty and full of old dusty cobwebs. North west section of roof void (not being affected by extension) The timber purlins, rafters and felt are in reasonable condition. The timbers do not have any significant cracks or crevices. There is a substantial amount of quilt insulation laid over the ceiling joists, the area accessed was quite clean with no signs of droppings or excessive insect remains (feeding evidence).

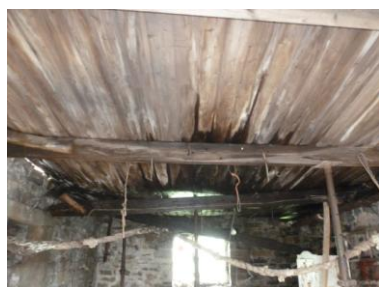
Outbuilding interiors Link

The outbuildings are open to the underside of the rafters except the corner outbuilding which has a suspended ceiling. All the buildings were draughty and damp and generally provided sub optimal roosting potential especially for hibernation.

The outbuildings interiors did not have any suitable hibernation habitat and no droppings or feeding remains could be found.

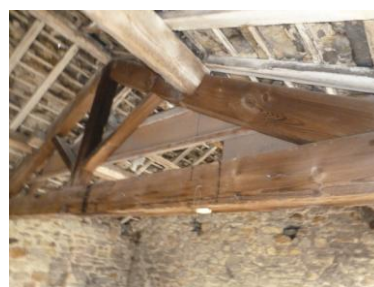
Cart store

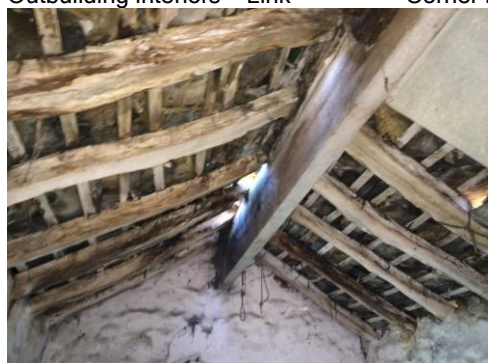
Store

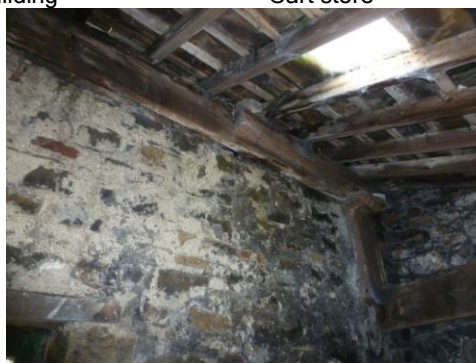
with lean -to coal store adjacent.
