Land at Higgins
Brook, East of
Chipping Lane,
Longridge -
Revised Scheme

Tree Quality
Survey & Outline
Development
Implications

Report Number: 2001_R09a_JB_HM

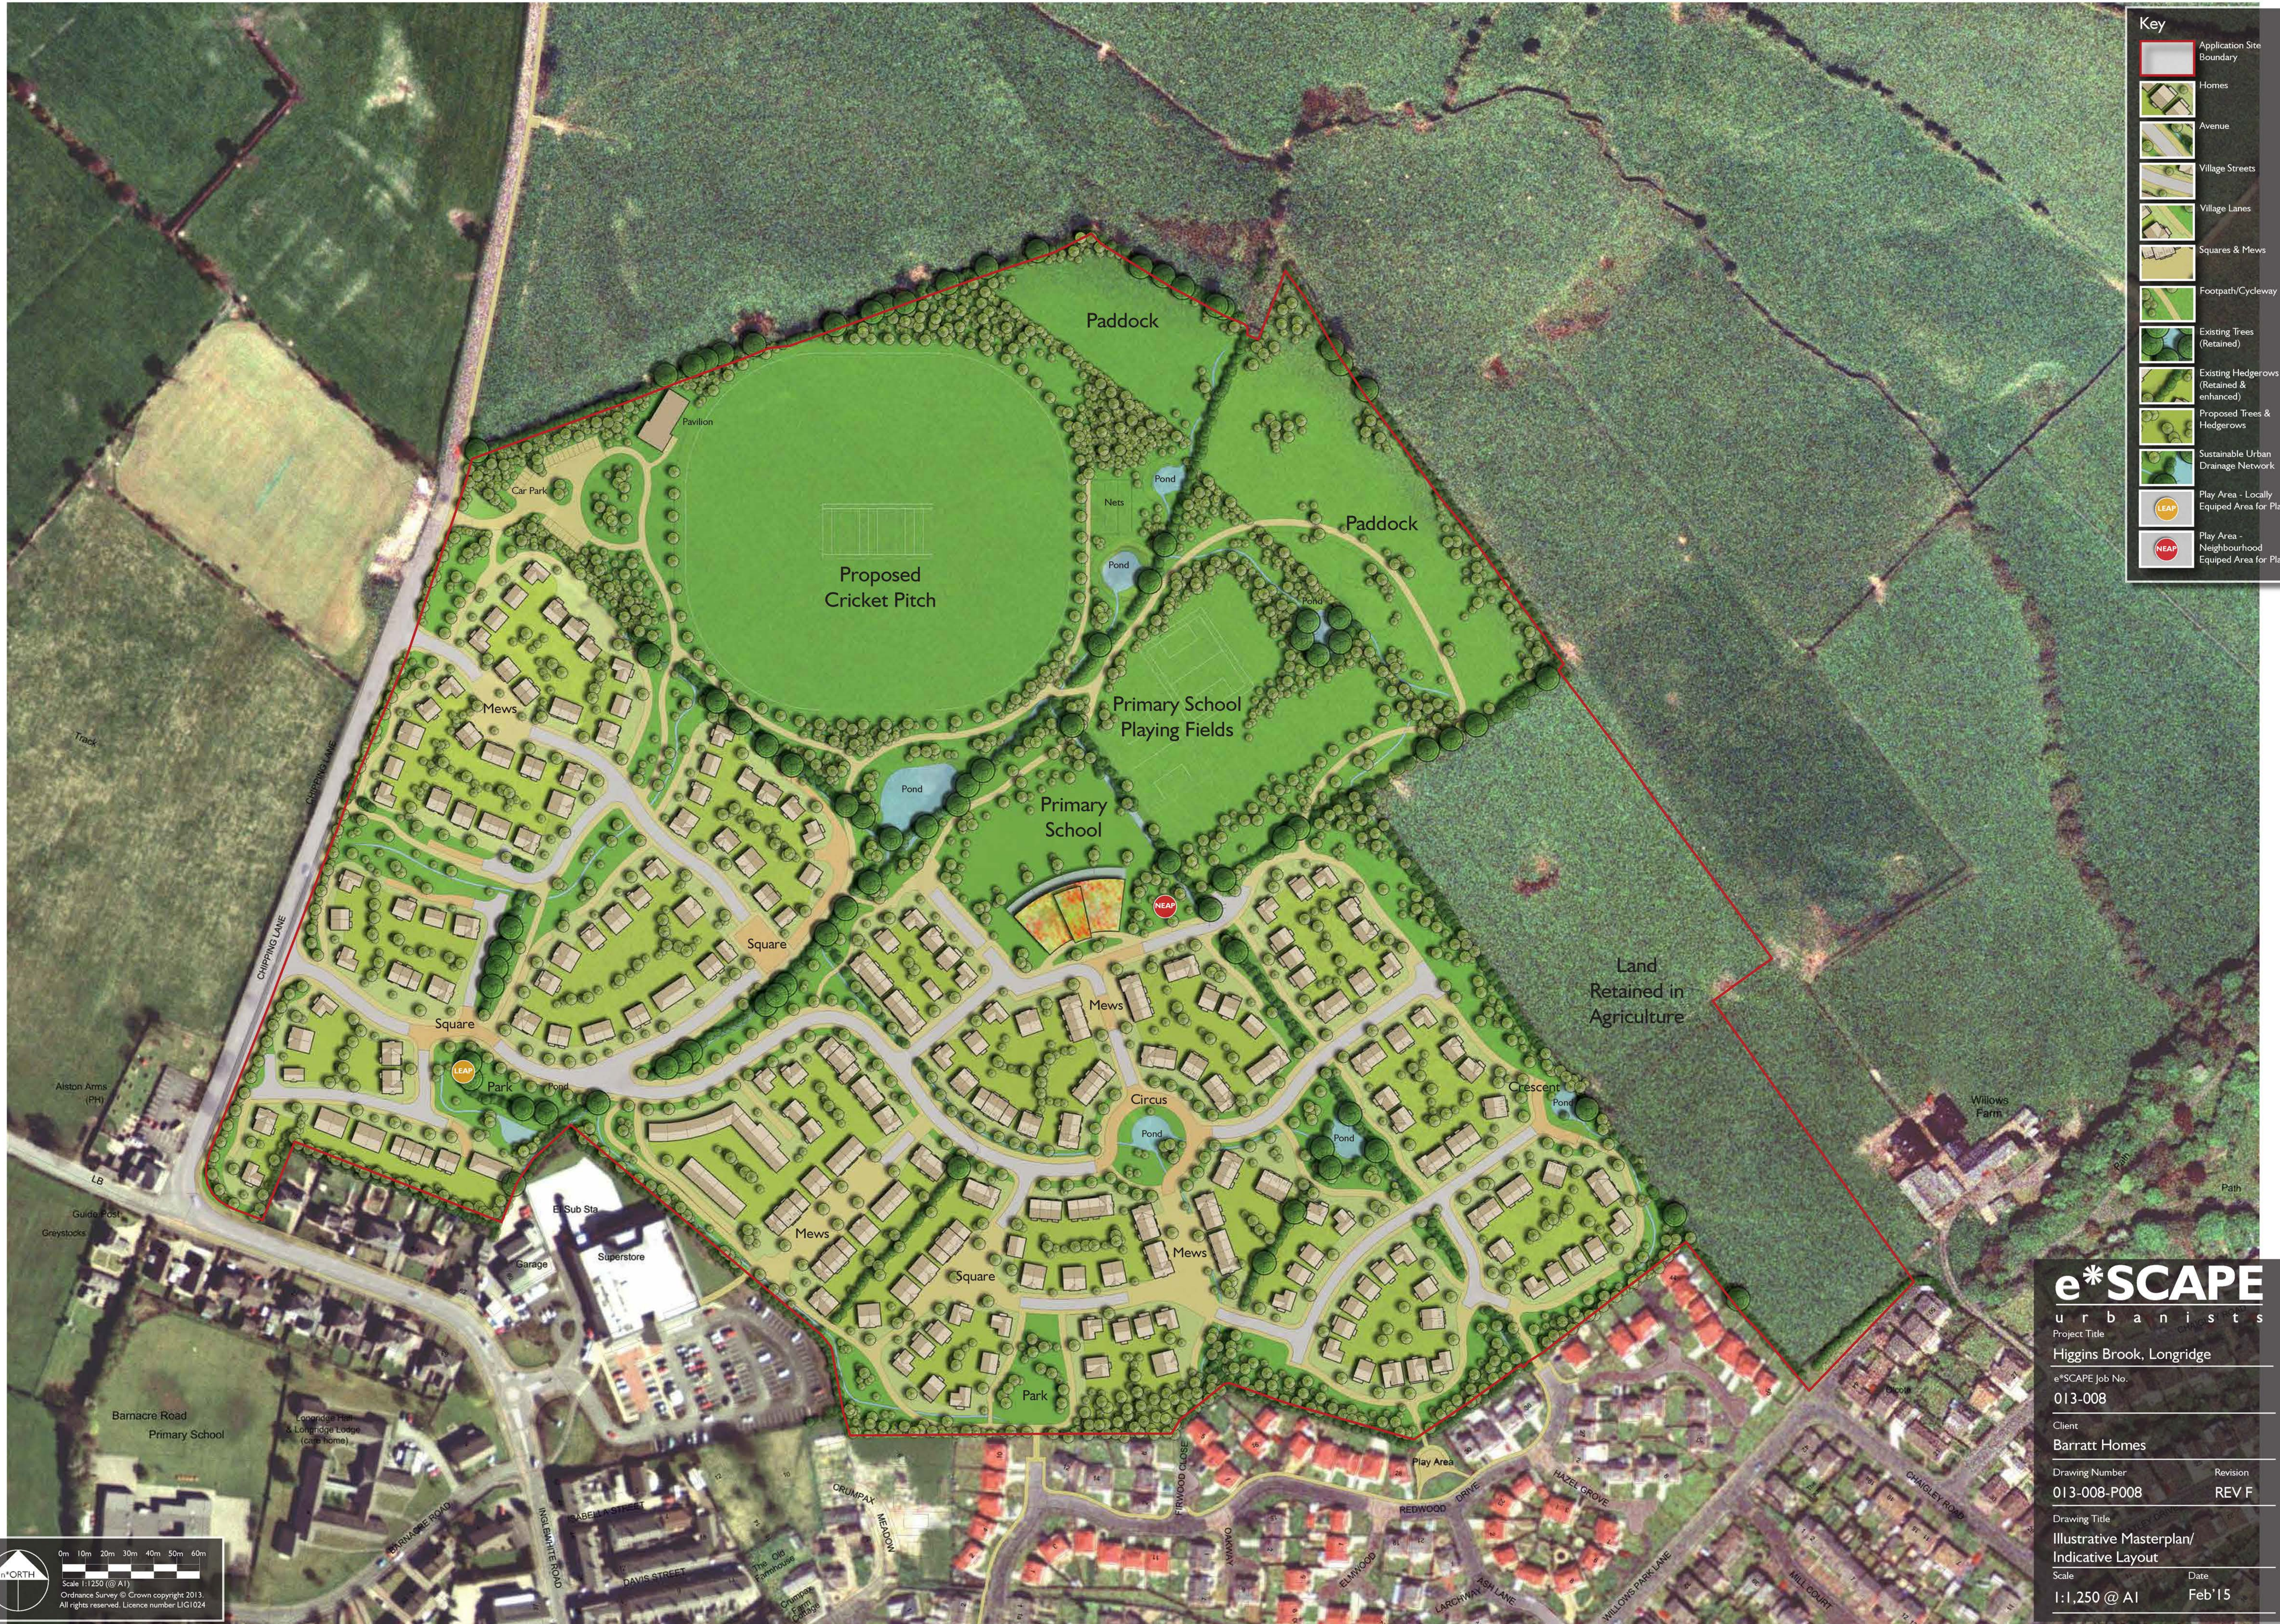
Appendix 3: Revised Illustrative Masterplan (Ref: 013-008-008 Rev F)

- 1.3. A copy of the revised Illustrative Masterplan is included at **Appendix 3**; and, an overlay of the Masterplan and Tree Survey findings is contained at **Appendix 4**.

- 3.4. Given the consideration of the existing agricultural context of the site, it is likely that the proposed outline development parameters will have an impact upon some of the tree stock and hedgerows surveyed (with the possible loss of approximately 445 metres of hedgerow). The wider site to the north will remain largely unaffected by the placement of the relocated cricket pitch and associated ecological mitigation and enhancement areas.
- 3.5. Where possible, detailed design and highways layout should minimise hedgerow loss by utilising existing access points and ditch crossings.
- 3.6. The following implications are predicted in relation to the indicative development layout illustrated at **Appendix 3**:

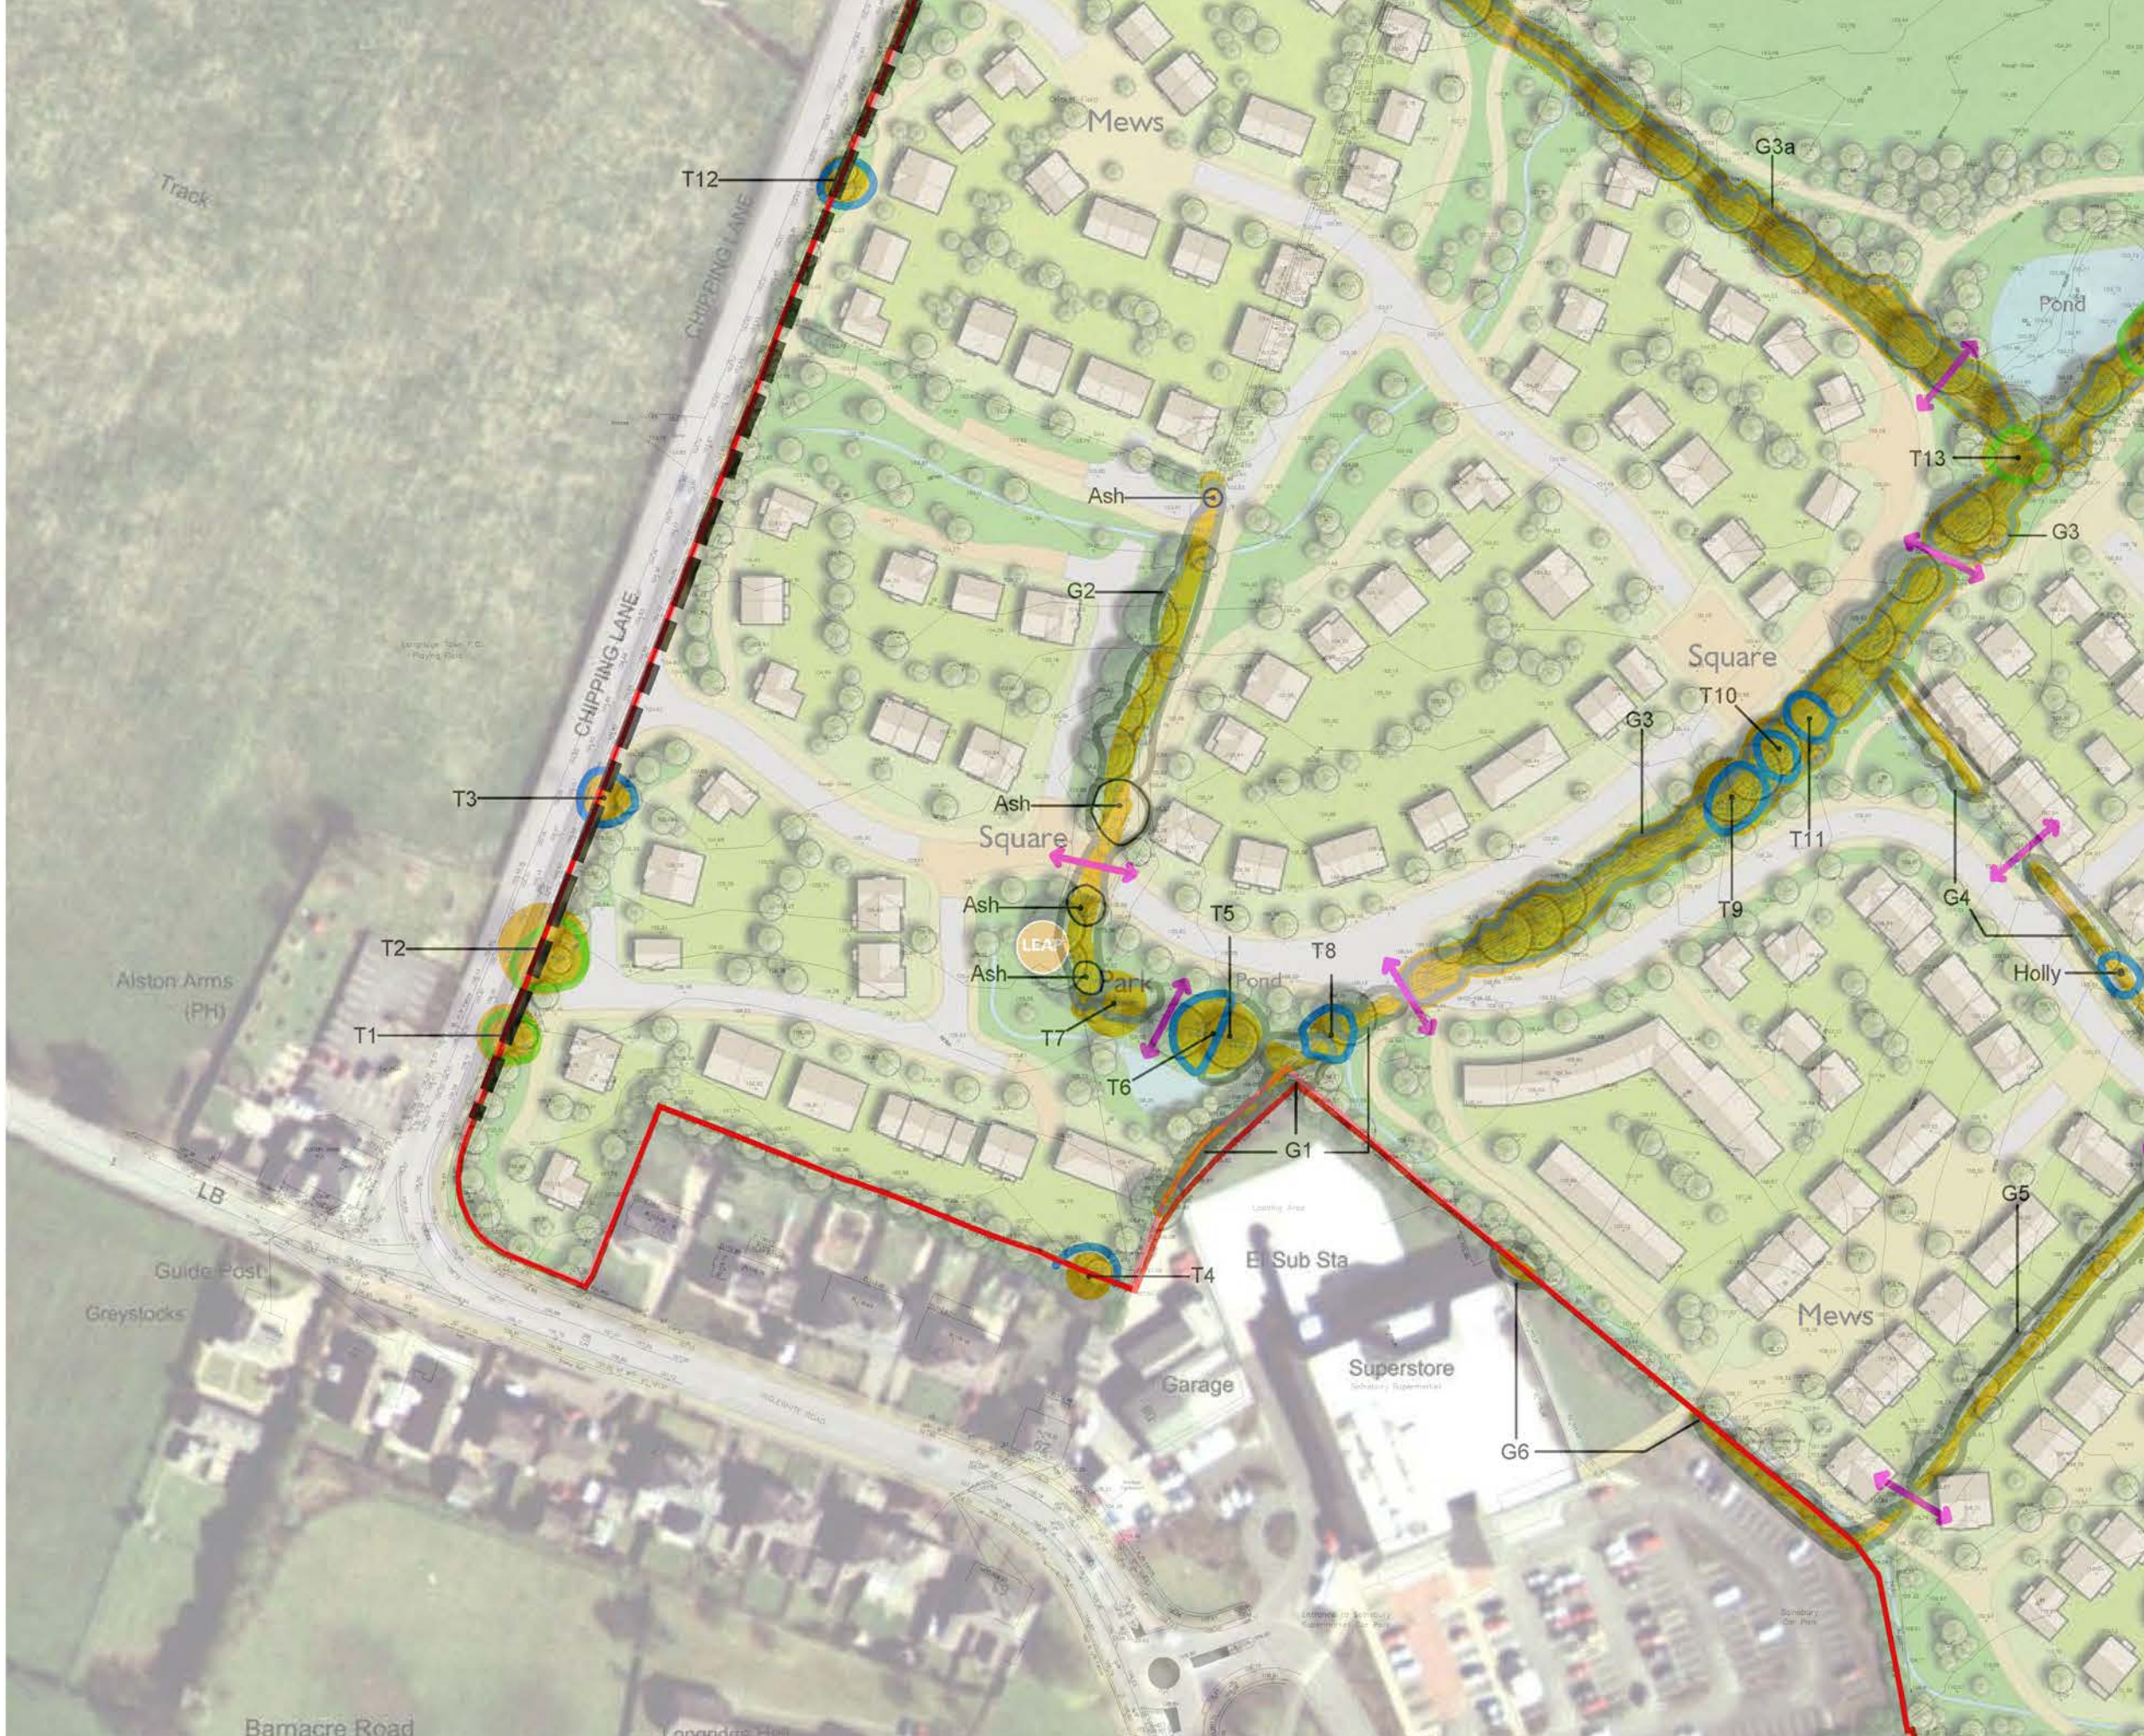
Appendix 4: Development Implications - Overlay of Revised Illustrative Masterplan

- 3.1. The other purpose of **Plan 1 (Sheets 1 to 5) (2001/P38 to P42)** and **Appendix 4** is to show the influence that the existing trees have upon adjacent land and upon any future development proposals. The approximate extent of Root Protection Areas (RPAs) have been illustrated to represent the worst case concentric area that should be left undisturbed around any retained tree in order to avoid damage to roots or the rooting environment.

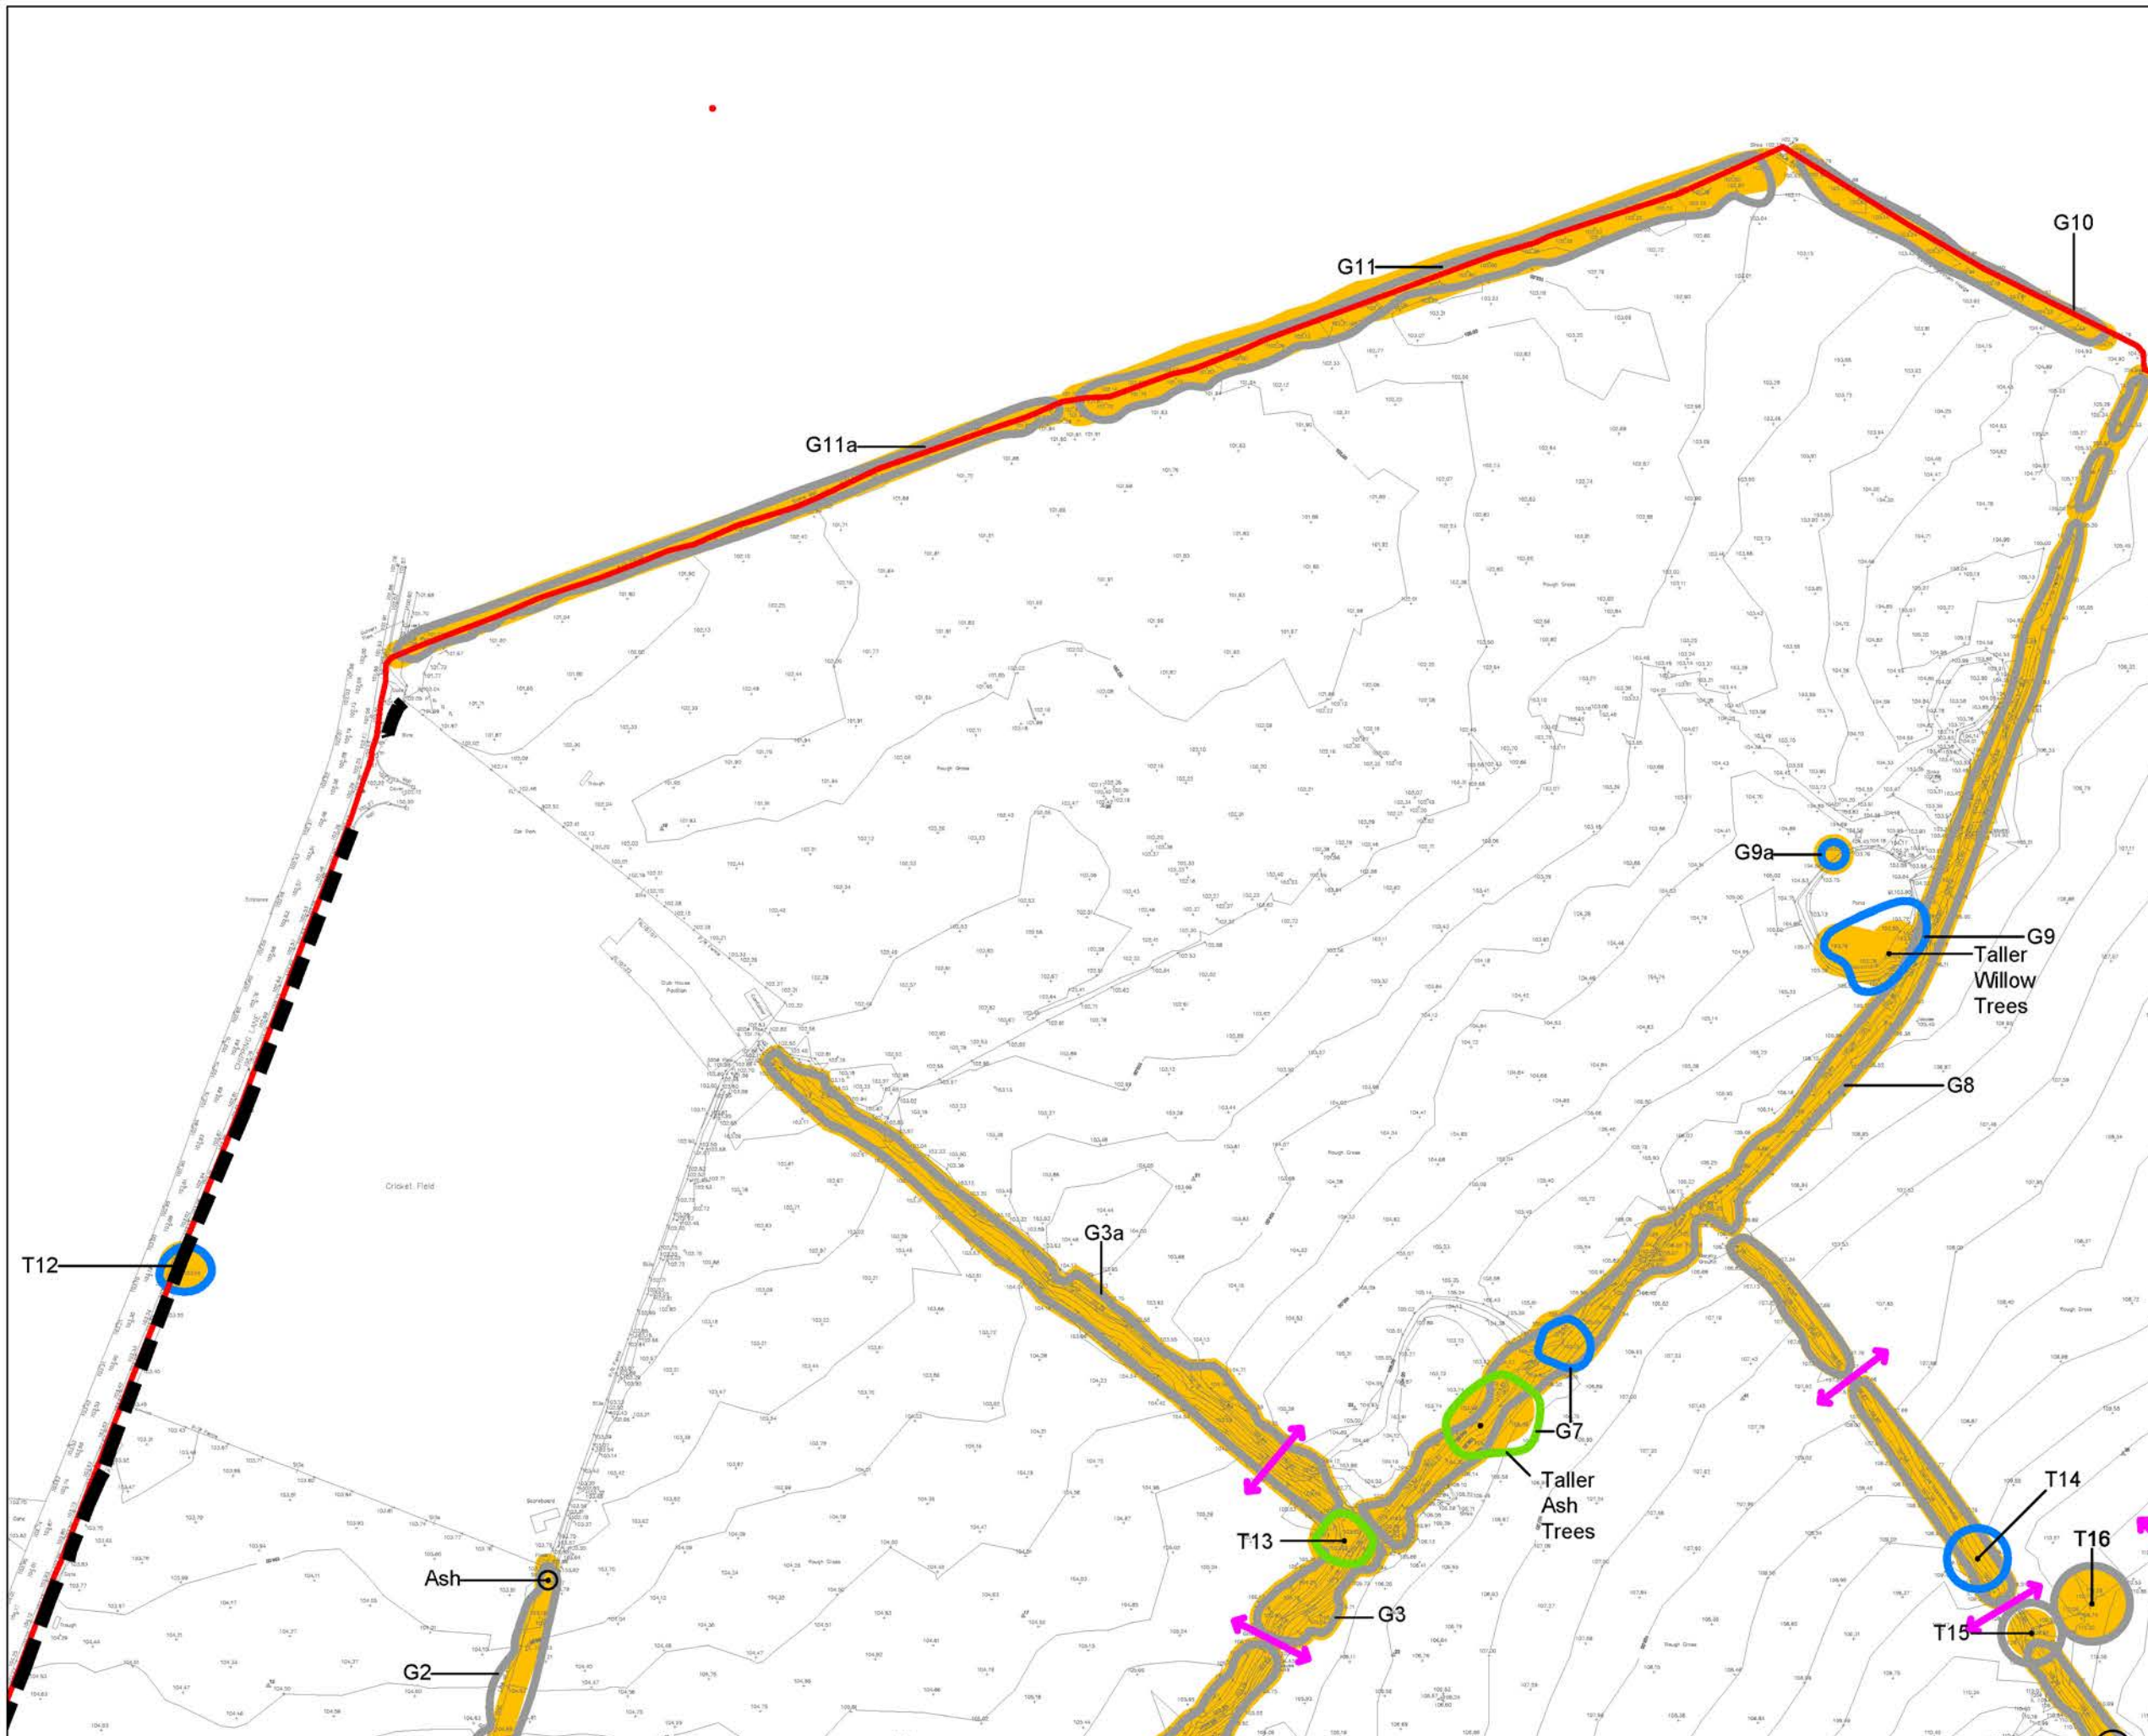
Project	Land at Higgins Brook, East of Chipping Lane, Longridge 2001/P38a
Drawing No	
Date	August 2014

Plan 1: Findings of Tree Quality Survey & Root Protection Areas (Sheet 1 of 5)
(2001/P38a March 2015)

- 2.4. A total of 31 individual trees were surveyed along and 14 groups, as shown on **Plan 1: Findings of Tree Quality Survey and Root Protection Areas (2001/P38 to P42) (Sheets 1 to 5)**, located to the rear of this report.
