## PHASE I GEO-ENVIRONMENTAL SITE ASSESSMENT

62 Moor Lane,  
Clitheroe

Report Ref: 11-597  
Date Issued: December 2016

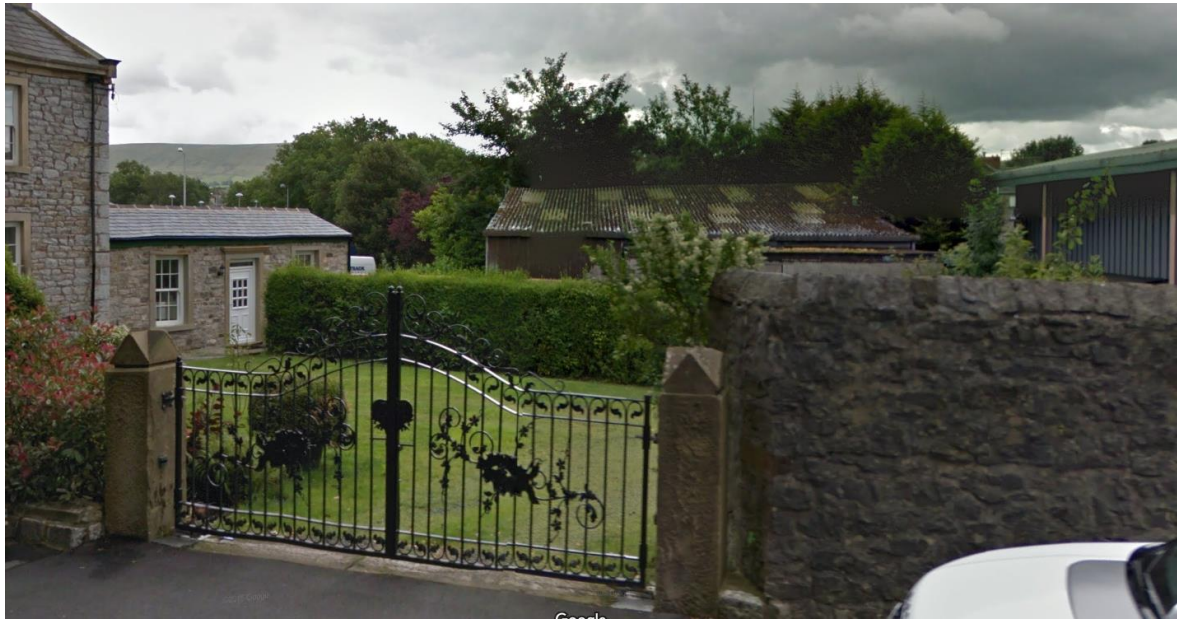
**PLATE 1 – SHOWING THE SOUTH WESTERN SECTOR OF THE SITE**

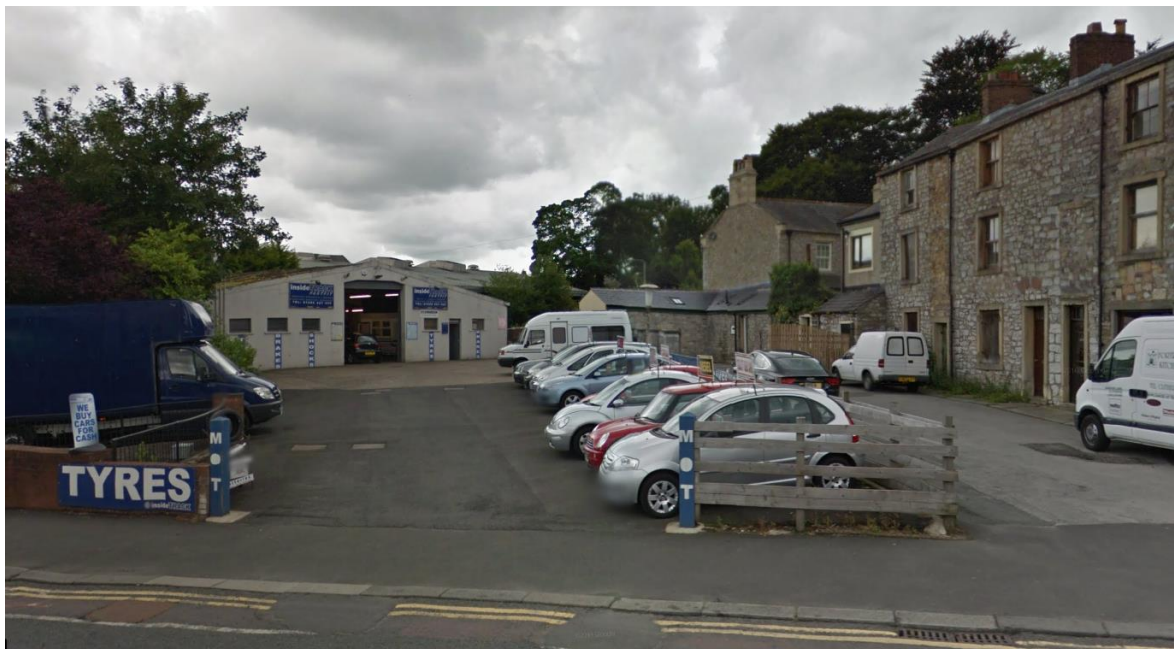
**PLATE 2 – LOOKING AT THE NORTH EASTERN SECTOR OF THE SITE**
