Re: EPS – Daylight scoping survey: Holmlea, Vicarage Lane, Wilpshire, Blackburn, BB1 9HX

## PRELIMINARY ROOST ASSESSMENT – BAT / BARN OWL SURVEY REPORT

Holmlea, Vicarage Lane, Wilpshire, Blackburn, BB1 9HX

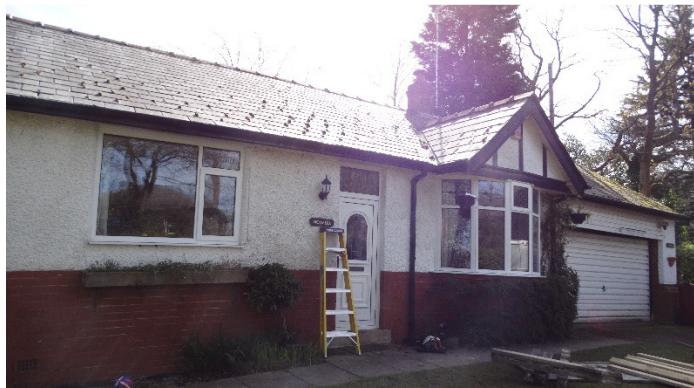
Figure 1: front elevation

The property is an extended bungalow with standard brick cavity wall construction and duo-pitched rafter-with-purlin slate roofs (figures 1 and 2). The bungalow has been extended at the rear to provide a kitchen and lounge with flat bitumen roof (figure 3). A garage with enclosed roof void (figure 8) to the side of the property is an earlier extension on the south-east elevation.

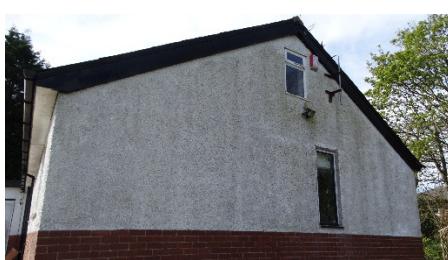
Figure 4: NW elevation

Externally the building is well-sealed and all roof areas appear to be very secure. The building has an exposed brick plinth with rendered and pebble-dashed upper walls. The timber fascias and soffits are all well-sealed with the exception of a narrow gap beneath the timber fascia on the NW gable end wall (figure 4).

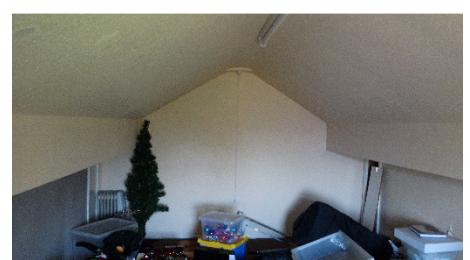
Figure 5: existing roof conversion

- (1) The small eaves void is located beside the existing roof conversion (figure 5); the studwork wall is insulated with glass fibre material and the area is clean, dry and well ventilated; there is no evidence of access by bats.
- (2) The main roof void is partly boarded for access; the void is cool, dry and well-ventilated; the slate roof is back-pointed and remains unlined. A layer of glass fibre insulation is present between the rafters. The area has a considerable accumulation of dust and spider webbing and cluster flies are present.
- (3) The garage has a rafter-with-purlin roof construction and the slate roof lined with bitumen felt. The void is not insulated above the rafters and the area is cool, dry and well-ventilated; there is no evidence of access by roosting bats or nesting wild birds.
