**BAT SURVEY AT -
25 BUCCLEUCH AVENUE
CLITHEROE**

DATE AND TIME OF VISIT
12th April 2017 3.30pm

Rear extension to existing bungalow.

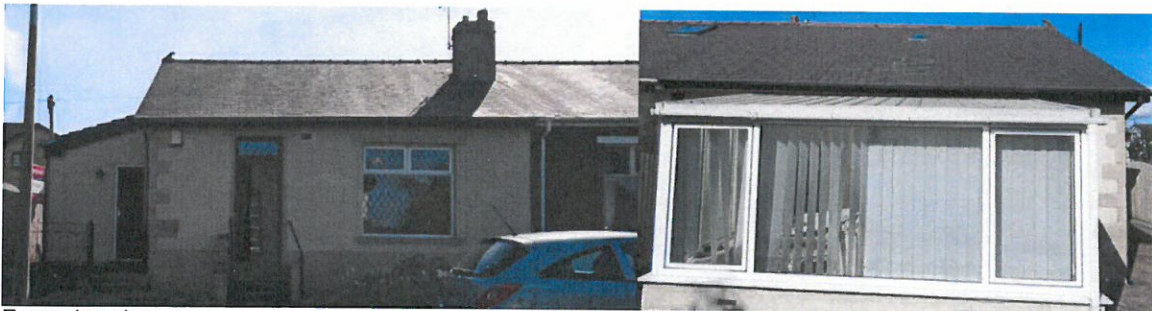
The property is a semi detached bungalow. With a lean too on the side and a conservatory to the rear both being extensions to the original house which probably dates from the 1940's /50's

Front elevation

Rear elevation

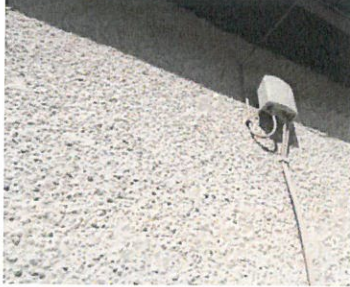
The walls are brick with a rough render finish which is painted.

The render finish is in perfect condition with no cracks or possible access points in the walls.

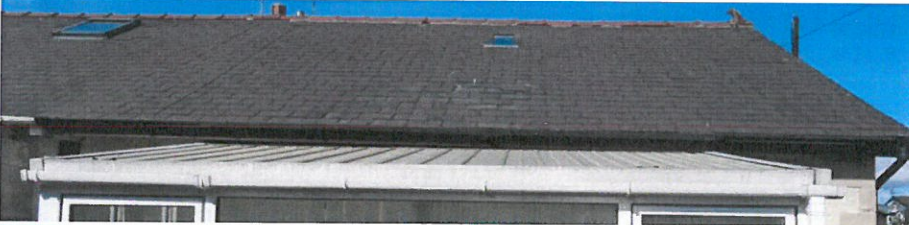
Rear pitch

The roof is a conventional pitched construction with a blue slate finish and a tile ridge detail, there is an overhang at the eaves and to the barge boards on the gable. There is a glazed roof light in the rear pitch. The soffits are upvc boarded. The conservatory is a upvc construction on base walls. The roof on the side lean -too is not being affected.

The slates are tight fitting with no crevices or slipped slates, the ridge tiles have some gaps in the pointing but are generally in reasonable condition. The soffits are very tight fitting and provide no access points to the roof space or crevices. The upvc clear roof does not provide any suitable habitat for bats.

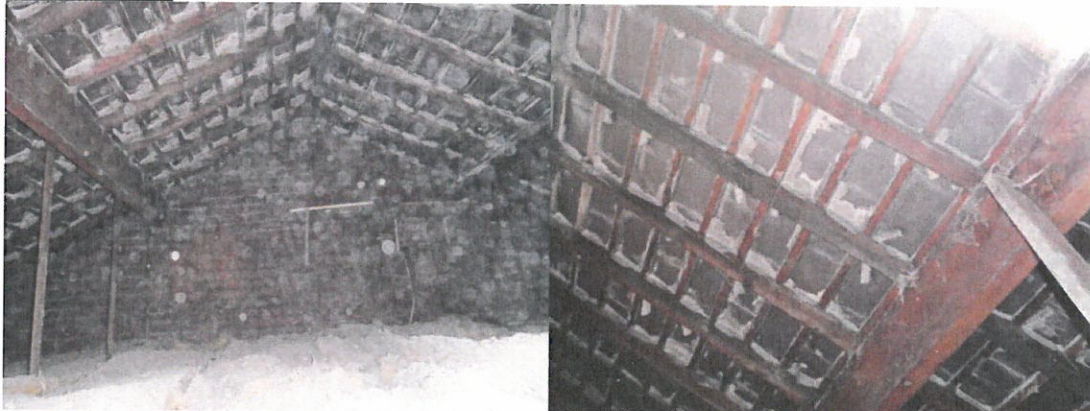
ROOF SPACE

The roof space was accessed via a ceiling hatch the space was insulated with quilt at ceiling level, the surface was very dusty. The timber purlins, rafters and battens are all in reasonable condition with no evidence of rot. There is no felt and the slates are pointed on to the battens. The space does not provide suitable habitat for bats.
