**BAT SURVEY AT -  
SUNNYMEADE  
OFF SAWLEY ROAD  
GRINDLETON**

**DATE AND TIME OF VISIT  
3<sup>rd</sup> May 2017 10.00am**

**REFERENCE NO. 5374**

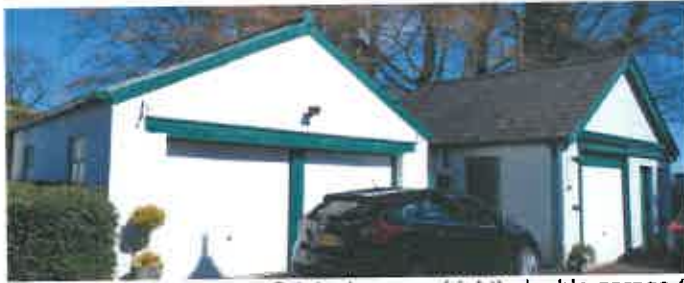
2no Detached garages Original garage (right) double garage (left)

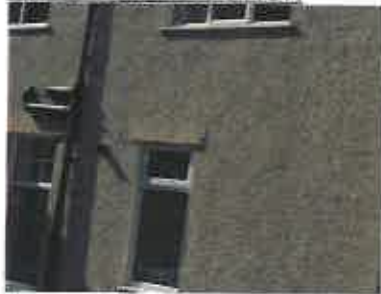
House walls

The walls are brick cavity construction with rough cast render finish. The outbuildings are constructed in the same materials with a white paint finish. The dormer windows in the south east elevation have slate hung cheeks.

The render walls are in good condition with no cracks , crevices or access points.

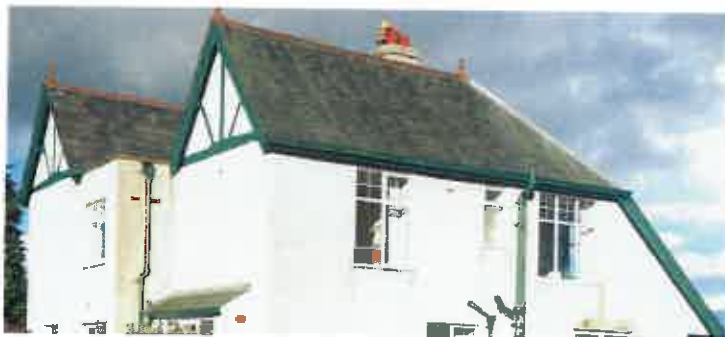
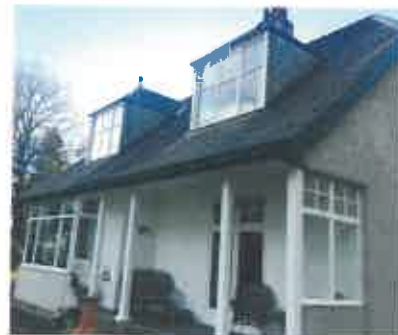
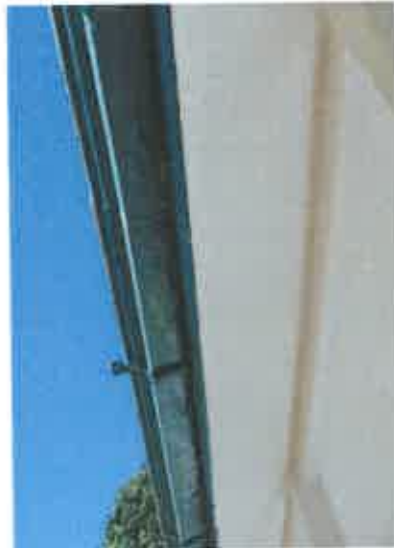
The house roof is a combination of 2 no. gabled pitches to the north west with a section of flat roof between. The gables have barge boards with slight overhang. The south east elevation is a mono pitch (2no. dormer windows ) down to single storey forming a covered veranda which is boarded to the underside.

Barge board overhang    Veranda overhang.

The house roof could only be examined with the aid of binoculars, the slates appeared to be in reasonable condition with no slipped slates or obvious gaps. The eaves and roof slates could be closely examined on the lower section of the south east elevation, as could the veranda soffit. The flat roof section was not visible. No obvious access points could be identified.

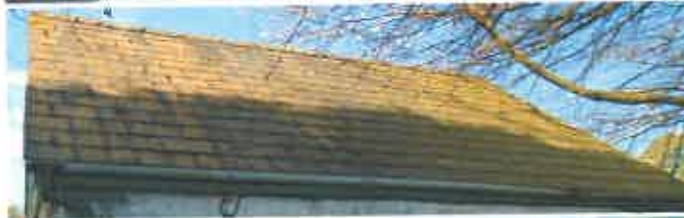
Garage gable

The original garage roof is pitched with barge boards and slates all matching the existing house. The fascias at the eaves are boarded to the underside.

The garage roof had no slipped slates all are tight fitting, inspection of the eaves revealed no gaps or possible entry points.

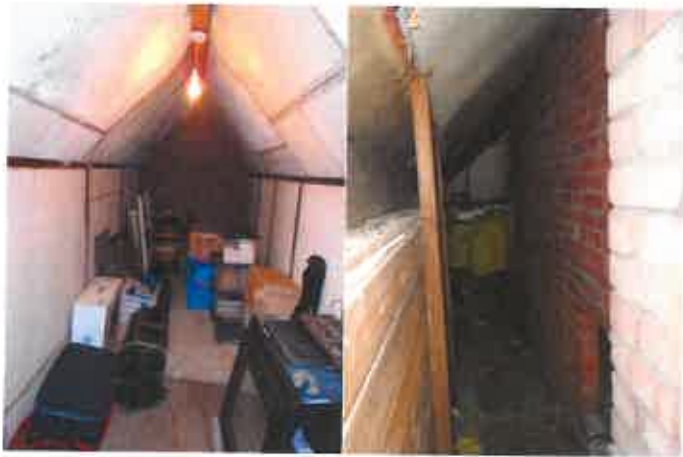
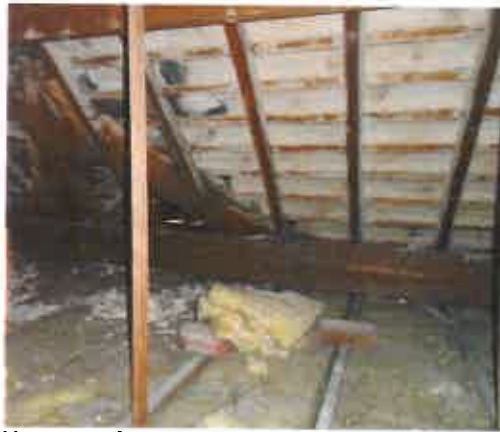
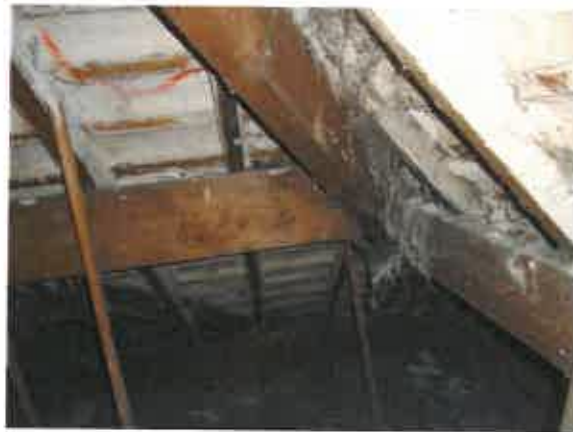
House roof space

The roof void is divided into various areas, not all of them being easily accessed, the initial section has been boarded to the underside of the rafters and is used for storage. However the majority of the roof is slate with mortared joints to the timbers. There is insulation quilt between the joists but the space is generally draughty and very dusty due to deterioration of the mortar, there are also extensive undisturbed cobwebs.

The interior of the house roof space was examined, as were the garages and potting shed but in their entirety. The house roof did not reveal any current bat presence nor any feeding or dropping evidence. The outbuildings were clean and free from any insect remains or droppings, however as frequently accessed buildings it is unlikely that debris will remain in situ, no current presence was visible internally.

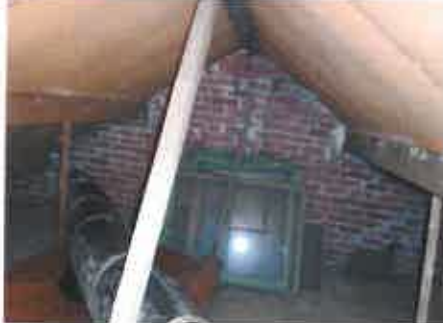
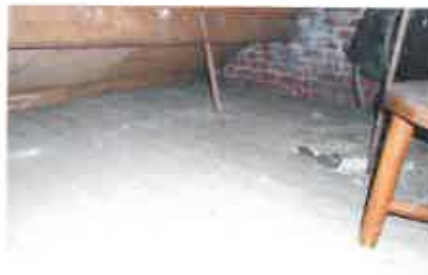
### **Garage roof void**

The void was accessed via a ladder, it had a timber boarded floor and the rafters were lined to the underside with chipboard. The visible timbers were in reasonable condition.

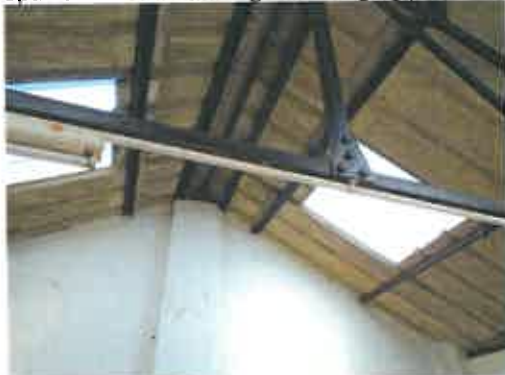
Double garage roof space.

Fibre cement sheets fixed directly over a steel truss and purlin structure. There is no enclosed roof void, the space is light and clean, and all abutments with the wall seem tight. The interior of this building provides sub-optimal level of roosting and foraging potential.

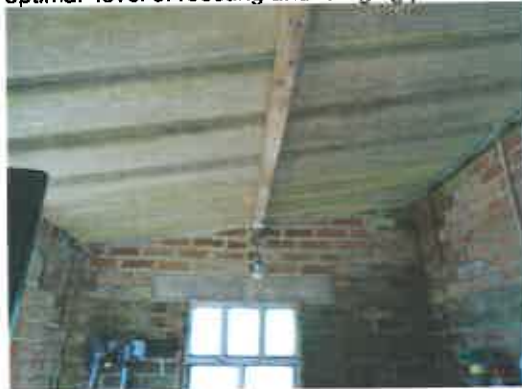
The potting shed sheets have no gaps at the laps however there are gaps at the eaves at the corrugation points.

Potting shed interior- Fibre cement sheets fixed directly over a timber purlin, There is no enclosed roof void, the space is light and clean, and all abutments with the wall seem tight. The interior of this building provides sub-optimal level of roosting and foraging potential.
