## PHASE I GEO-ENVIRONMENTAL SITE ASSESSMENT

Land off Henthorn Road  
Clitheroe

Prepared for  
Strategic Land Group

Report Ref: 10-699-R1  
Date Issued: March 2017

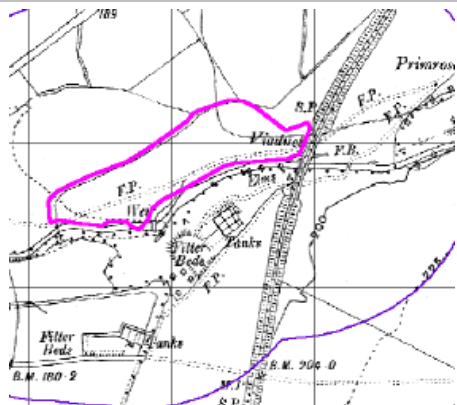
| MAP EDITION | HISTORICAL LAND USE | HISTORICAL MAP EXCERPT |
|---|---|---|
| 1914<br>1:10,560 | The site remains undeveloped.<br>Additional filter beds and tanks are shown to the south. | |

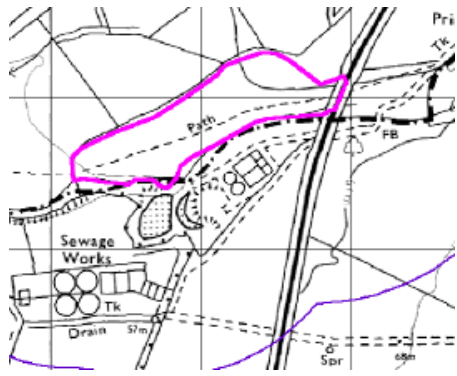
| <p><b>1970-72</b><br/><b>1:10,000</b></p> | <p>The filter beds and tanks to the south are identified as a sewage works.</p> | |

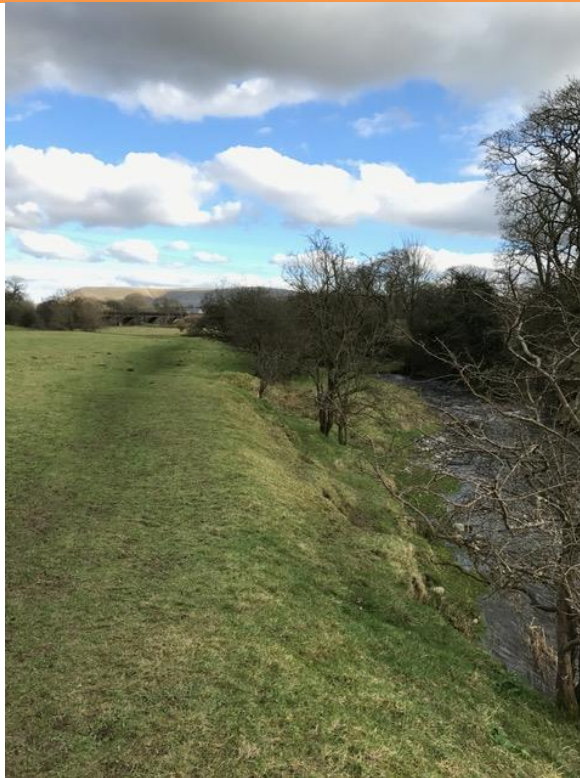
**PLATE 1 – PENDLETON BROOK ON SOUTHERN BOUNDARY**

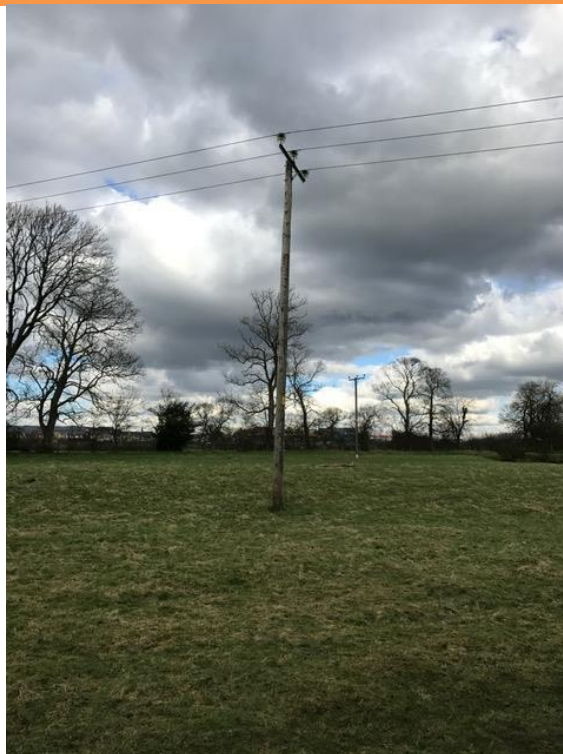
**PLATE 2 – OVERHEAD ELECTRICITY CABLES IN WEST SECTOR**

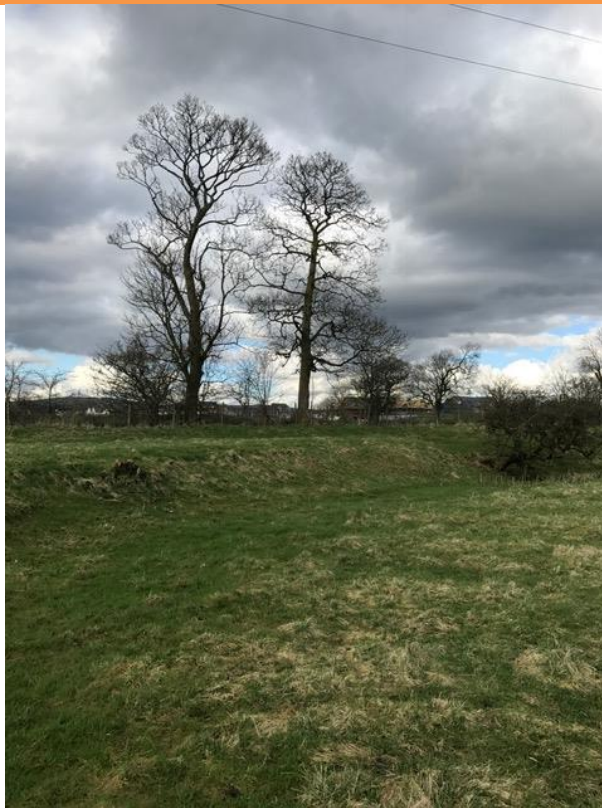
**PLATE 3 – ROUGH GRASSLAND AND TREES ON SITE**

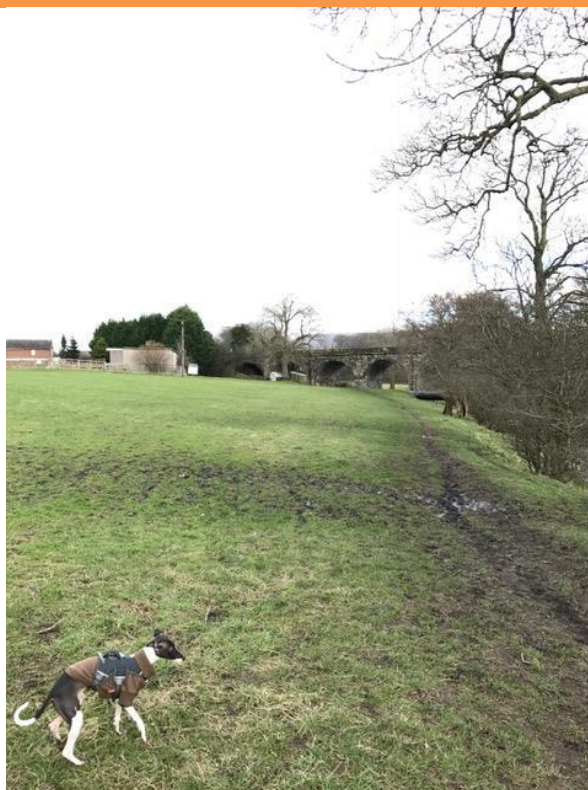
**PLATE 4 – STABLES AND RAILWAY ADJACENT TO NORTHEAST BOUNDARY**

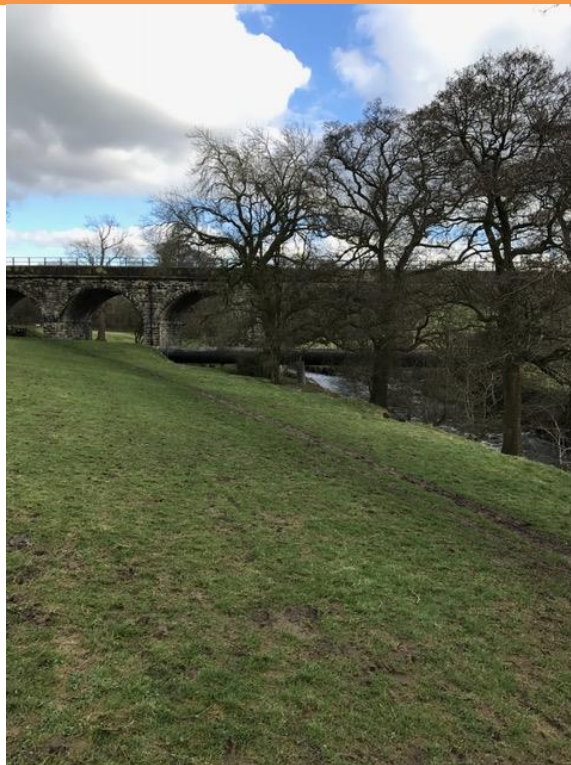
A formal drainage survey has not been completed. A large metal pipe emerges from the riverbank in the southeast sector and crosses (over) Pendleton Brook.

**PLATE 5 – RAILWAY VIADUCT AND PIPE CROSSING ADJACENT TO SOUTHEAST BOUNDARY**

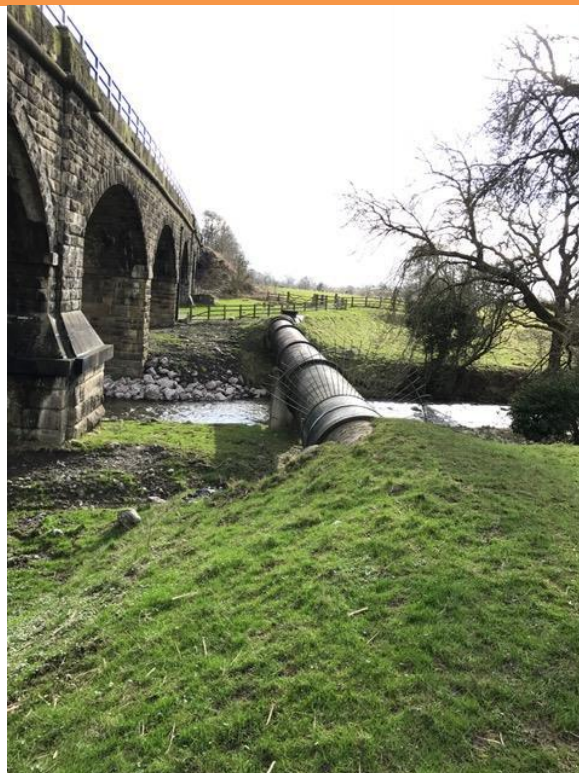
**PLATE 6 – RAILWAY VIADUCT AND PIPE CROSSING ADJACENT TO SOUTHEAST BOUNDARY**
