**BAT SURVEY AT -**

SAGAR WOOD  
BIRDY BROW  
CHAIGLEY

DATE AND TIME OF VISIT  
19<sup>TH</sup> April 2017 2.30pm

REFERENCE NO. 5279

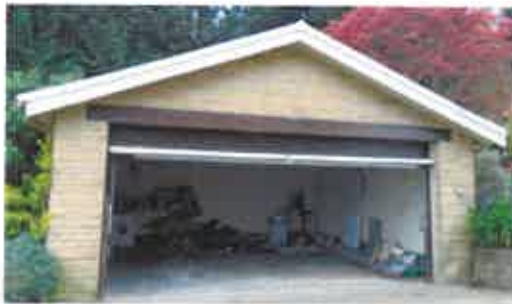
The building is a detached garage in the garden of a period detached dwelling. The garage dates from much later than the main house. It is set into a banking which contains domestic planting. The garage is regularly accessed. There are further outbuildings located on the south west boundary of the garden.

Front elevation

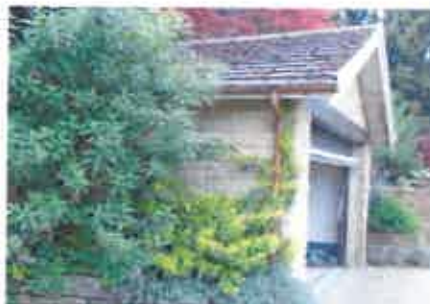
Side elevation

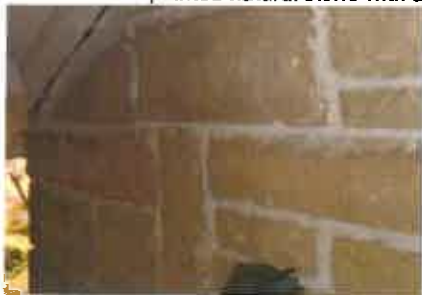
The walls are pointed natural stone with a cavity, the internal leaf is blockwork with a plaster finish.

The stone work and pointing is in perfect condition, no cracks, crevices or access points.

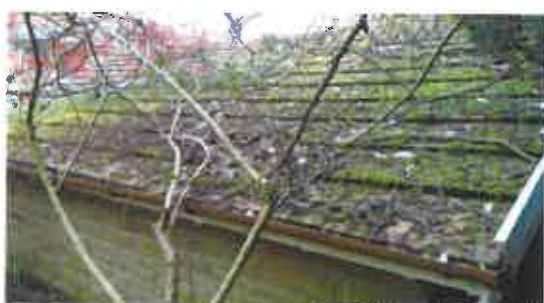
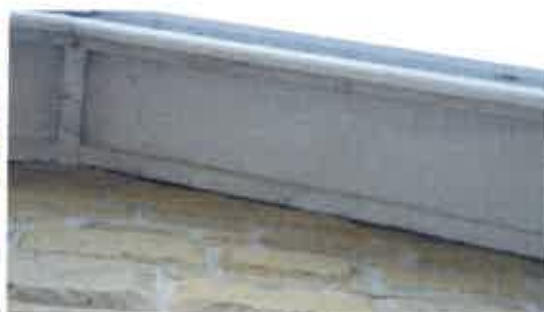
The roof is a pitched construction with overhangs at the eaves and gables with boarded soffits. The finish is tile.

The tiles have an extensive covering of moss, but are generally in reasonable condition, very tight fitting and no slipped tiles. The boarded soffits to the front gable and south east side eaves have some slight gaps at abutment with the stone. It was possible to closely examine any potential access points in the eaves and gable, no grease marks, staining or droppings were found to be present. There was no indication of any current or historic use of the crevices by bats.

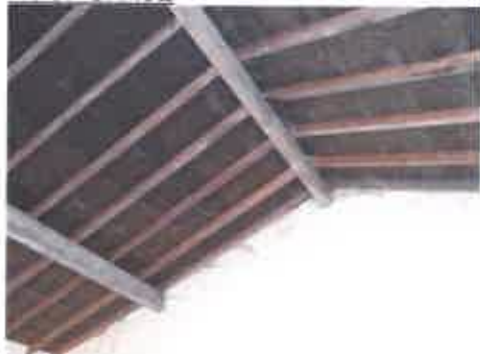
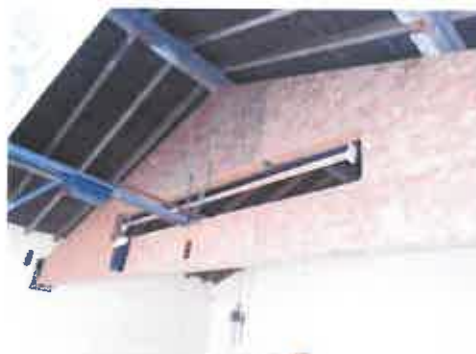
There is no enclosed roof space in the building timber purlins and rafters are exposed, the truss however has been boxed out with OSB sheets. The timbers are in reasonable condition with no cracks, crevices or rot. The felt is damp but with the exception of a few sheets which have curled at the edges it has no rips or tears.
