BAT SURVEY AT

Willow Spring

Author	Andrew Gardner	Date	22/12/2016
Checked by	Andrew Gardner	Date	22/12/2016
Report Version	1		
Field data entered	<input checked="" type="checkbox"/>		
Report Reference	3766

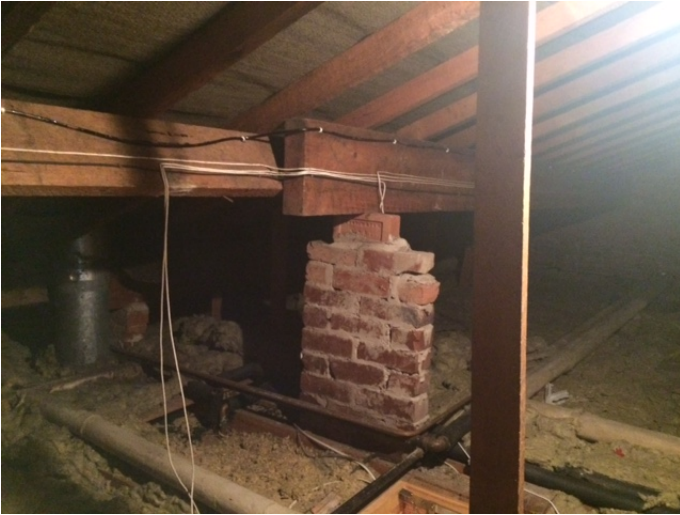
The timber beams in the roof were found to be in excellent condition with no rot, splits or gaps suitable for roosting or hibernating bats. The roof void could be fully inspected, no evidence of use by bats was found. The roof void is regularly accessed by occupants of the property and used for storage.

Roof void lit by electric lights and used for storage. Fully assessed, no signs of bats
