**BAT SURVEY AT -
11 VICTORIA COURT
CHATBURN**

DATE AND TIME OF VISIT
20th June 2017 5.45 pm

The property is a detached dwelling dating from 1990's

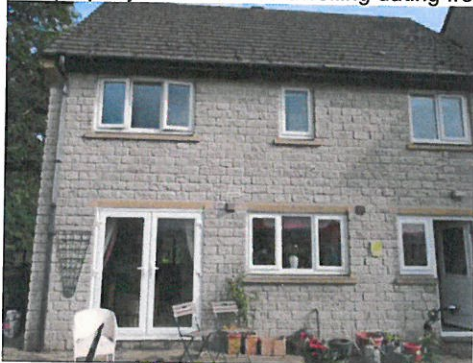
Rear north west elevation

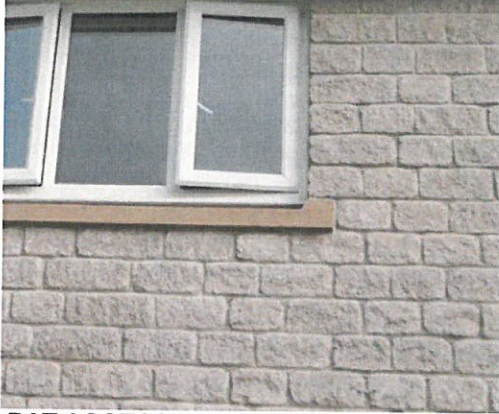
The walls are coursed stone cavity construction.

The stone walls are in perfect condition with no possible access points.
