# Bat Survey Report

Lower Clerk Hill Farm  
Clerk Hill Road  
Sabden  
Clitheroe  
BB7 9FR

07.06.2017

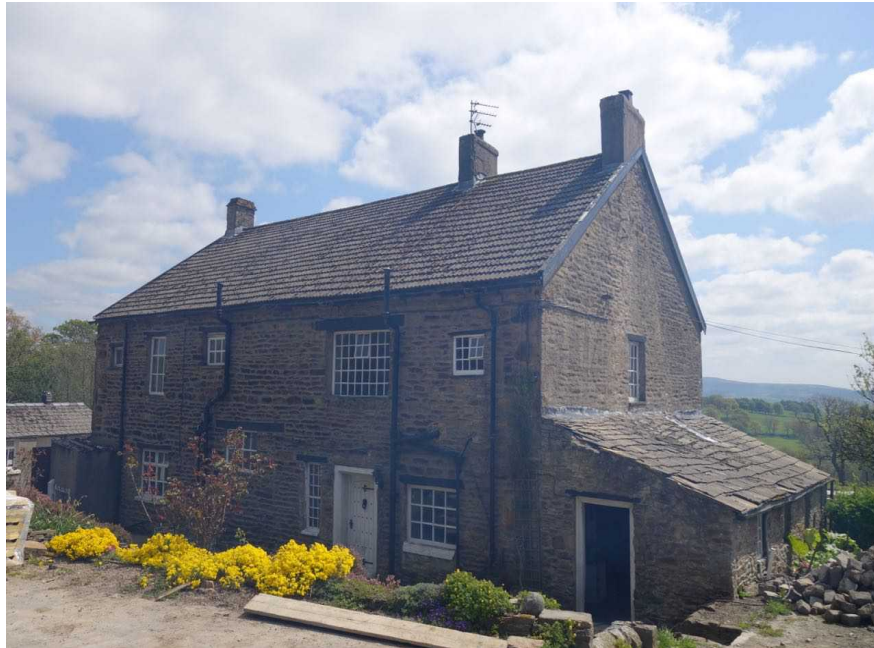
The property is a traditional stone built two storey farm house with a double pitched pantiled roof. Pointing is in good condition with no cracks or crevices present.

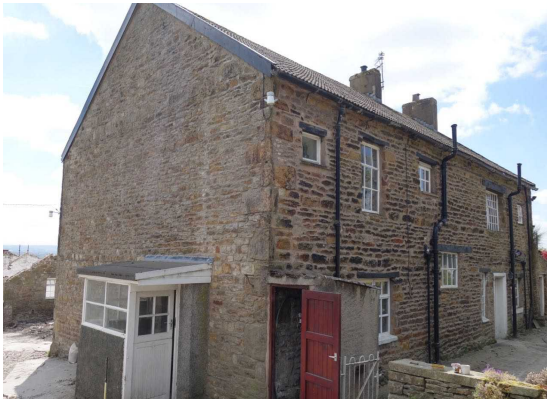
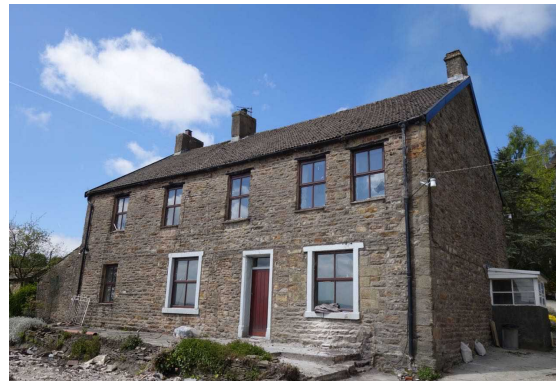
Roof tiles are in good general condition with no missing slates and few lifted slates present. To the west of the building a single storey adjoining extension features a single pitch stone slate roof. Lead flashing around chimney places appears to be in good condition and close fitting.

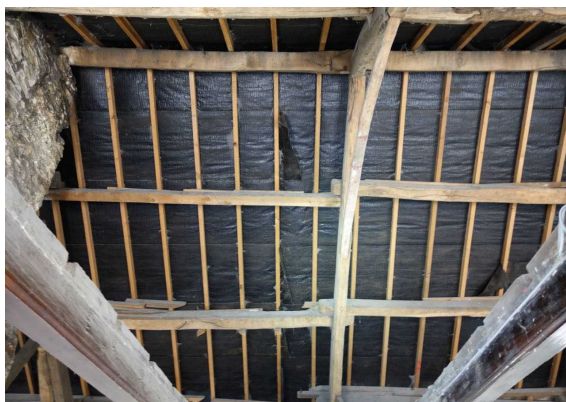
Ceilings to the property were removed as part of renovation works in September 2016. The pantiles have underfelt present which appears to be in good condition with no obvious rips or tears.

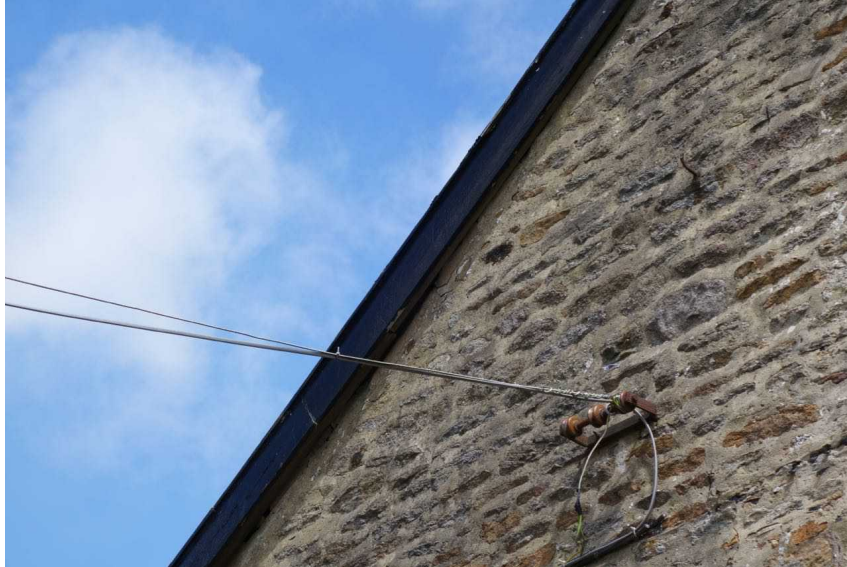
Gaps are present behind barge boards on the western aspect of the building..

Overall the building can be considered of moderate potential for roosting bats.

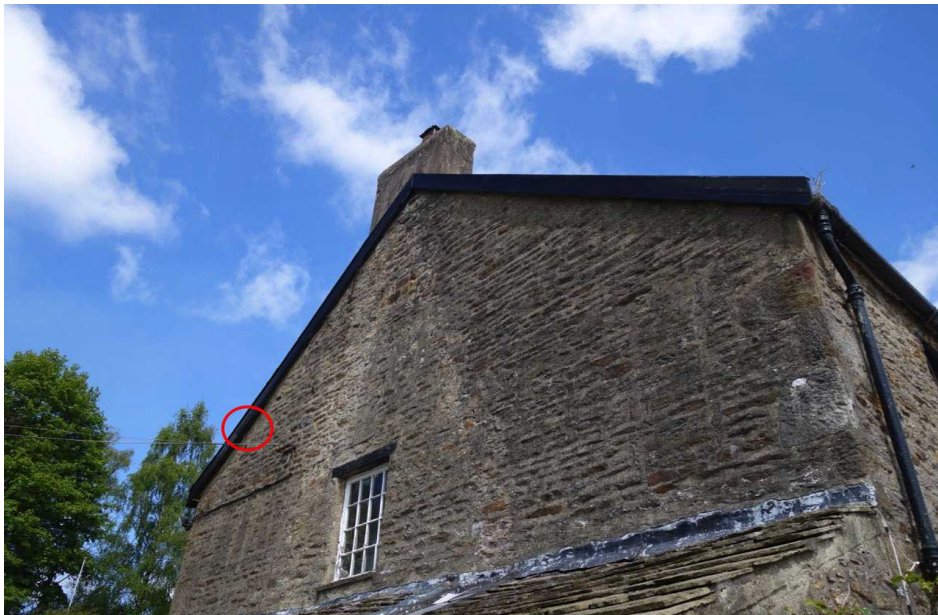
Gaps behind the barge board on the western aspect of the farmhouse were observed with low levels of droppings adhering to stonework below one prominent gap.

*Gap behind bargeboards with droppings recorded adhering to stonework below.*

A low number of common pipistrelle <20 were observed emerging from the gap behind barge boarding on the evening of the 9<sup>th</sup> May. No other emergence was noted.

On the 18<sup>th</sup> of May 17 bats were counted emerging from the gap behind barge boarding. No other emergence was noted.

Lower Clerk Hill Farmhouse is host to a small satellite roost of non breeding common pipistrelle bats. The roost is located under pantiles and bargeboards on the western aspect of the farmhouse.

Timing of works - demolition of the building should be carried out between September and March, a period when bats are likely to not be present. One an EPS licence is in place.

Soft Demolition - The roof area around the roost entrance should be dismantled by hand under supervision of a suitably licenced bat worker.

Replacement Roosts – Two Schwegler 2F bat boxes should be positioned on site prior to works commencing in order to provide a suitable shelter for bats discovered during licenced works.

Permanent Replacement Roosts - Two pole mounted crevice boxes to be located in suitable positions to provide one 'hot' roost and one 'cool' roost.
