**BAT SURVEY AT -  
HIGHER COLLEGE FARM  
LOWER ROAD  
LONGRIDGE  
PR3 2YY**

DATE AND TIME OF VISIT  
1<sup>ST</sup> June 2017 9.00 pm

REFERENCE NO. 5296

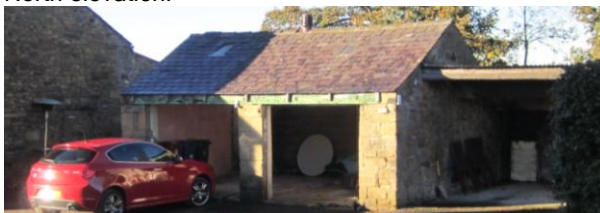
Garage outbuilding

The garage roof slates were in reasonable condition and were generally tight fitting and did not provide any crevices suitable for bat entry. The car port sheet was also in reasonable condition with no holes or gaps. However the interior of the buildings are freely accessible via the door openings.

Garage roof : There is no enclosed roof space, timber trusses, purlins and rafters, rafters boarded out to the underside. Timber structure was easily examined but not possible to fully inspect behind the boarding. Gaps in the boarding were checked for any signs of grease marks, droppings or staining. The result was negative.

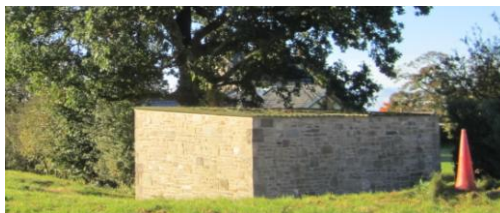
Store building

The store steel sheet covering and pointing appeared to be relatively new both were in perfect condition with no possible access points.

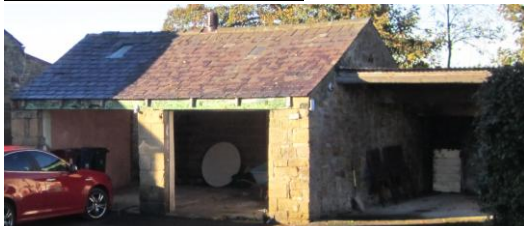
The garage roof is a pitched natural slate construction with a couple of glazed lights. There is a car port to the north elevation which has a mono pitch corrugated fibre cement sheet covering.

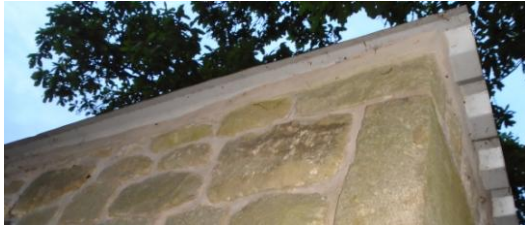
The store has a mono pitch roof with a corrugated steel sheet roof, the abutments with the wall are pointed.

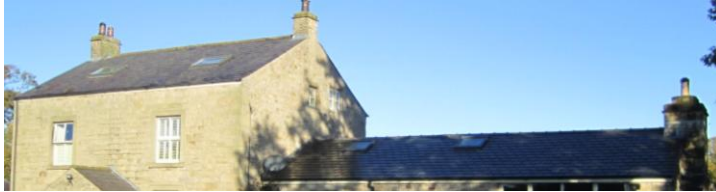
House roof south elevation

The house roof is pitched over the main two storey section and the single storey wing. All the roof coverings are natural blue slate, with roof windows in the southern facing pitches. The gutters are fixed to a timber fascia flush to the wall.

The house slates, ridge slates and flashings are in perfect condition with no gaps which could provide any possible access for bats.

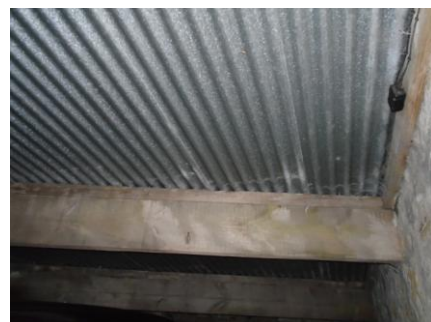
Car port roof : There was no enclosed roof space, the sheet was fixed directly to timber purlins. All the structure was easily examined. The space did not provide any potential habitat for bats.

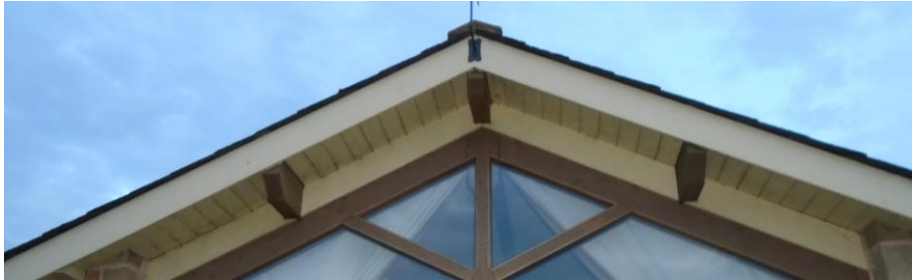
The roof void in the main house is lined out with plaster board to the underside of the rafters to form bedroom accommodation with roof windows. There is no enclosed roof space in the single storey wing the rafters also being lined out with plaster board.

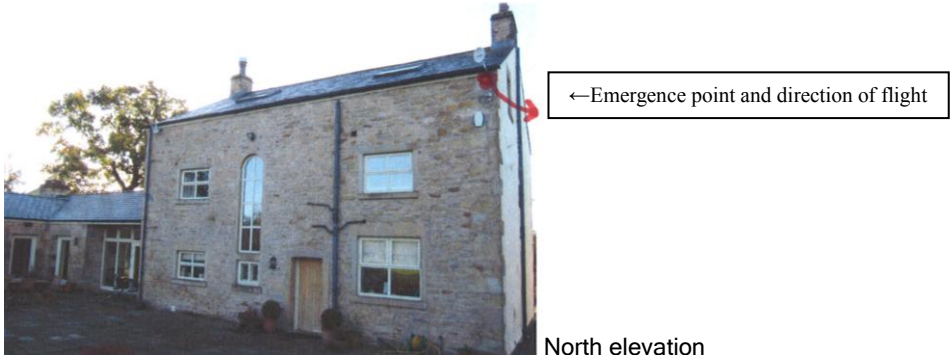
North elevation

At dusk two number surveyors were located to the north and south of the house, with clear visibility to the store and garage .At 9.30pm a bat emerged from the south west corner of the main farmhouse from behind the timber fascia. Over the next ¾ hour approx 30 bats emerged from this point. At 9.45 pm 6 no bats emerged from the north west corner also from behind the timber fascia, the Pipistrelle bat foraging activity is indicated on the aerial photo below.
