LIDL UK GMBH

Shawbridge Street, Clitherbe

Desk Study Assessment Report

JW/C3598/1388

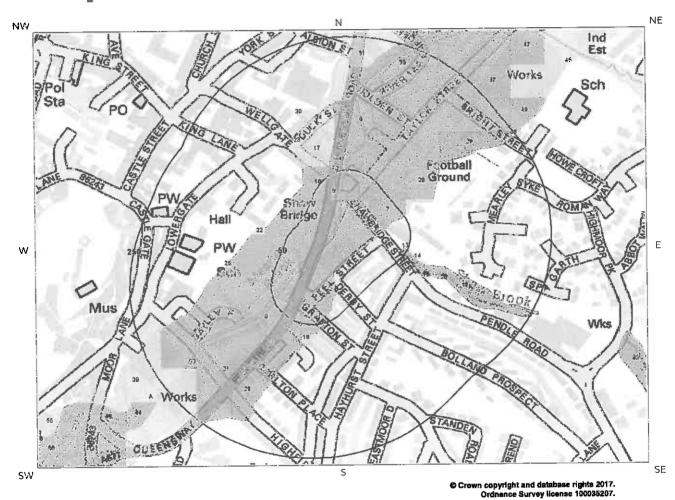
7b. Environment Agency/Natural Resources Wales Risk of Flooding from Rivers and the Sea (RoFRaS) Map

The Environment Agency/Natural Resources Wales RoFRaS database provides an indication of river and coastal flood risk at a national level on a 50m grid with the flood rating at the centre of the grid calculated and given above. The data considers the probability that the flood defences will overtop or breach by considering their location, type, condition and standard of protection.
