Clitheroe Community Hospital, Chatburn Road, Clitheroe, BB7 1QJ

UPDATED DAYLIGHT LICENSED BAT SURVEY AND MITIGATION STRATEGY

June 2017

[ERAP (Consultant Ecologists) Ltd ref: 2017-150]

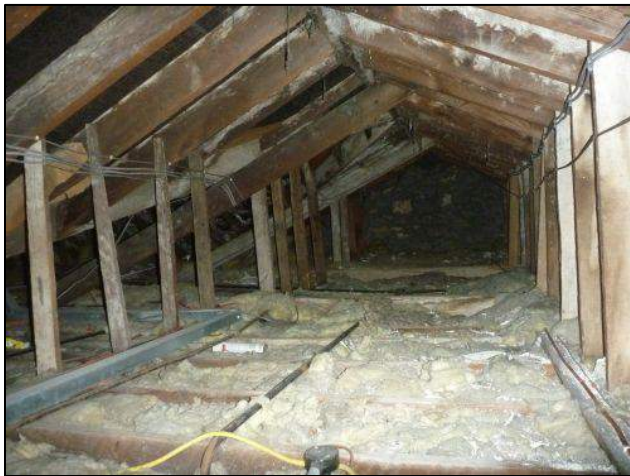
- 3.2.4 The building has several roof voids. The largest void is located over the two-storey section at the north-western end of the building; this void (1.a on **Figure 8.3,** refer to **Photos 15 and 16**) is approximately 1.5 metres tall, with a floor lined with fibreglass insulation. The roof is supported on traditional timber trusses, purlins and rafters. The roofing slates are largely unlined, with areas of degraded horse-hair parging present, and localised sections supporting bitumastic roofing felt.

Photo 15: Building 1, northern section of roof void above two-storey section of building (1a)

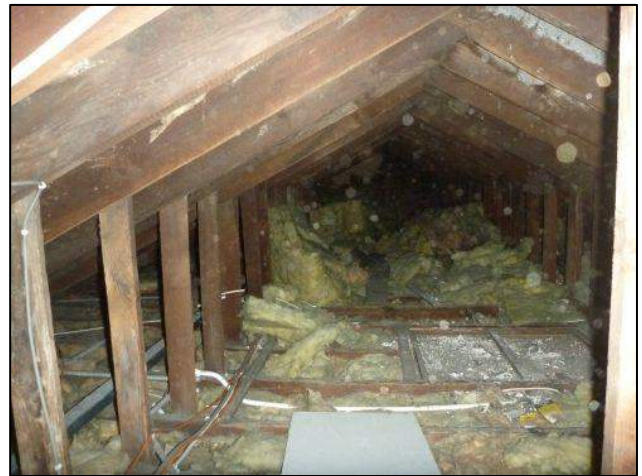
Photo 16: Building 1, southern section of roof void above two-storey section of building (1a)

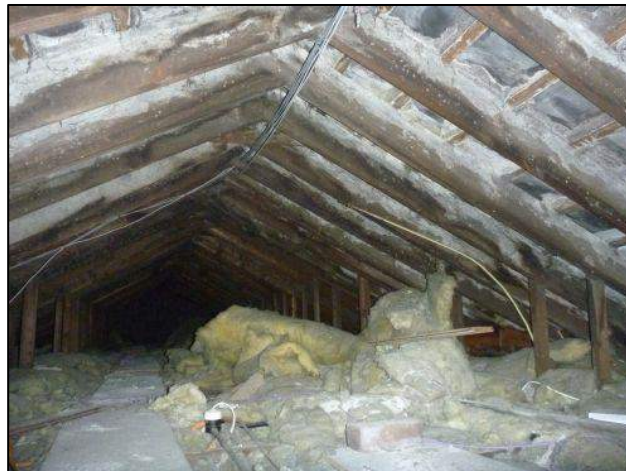
- 3.2.6 No further signs of roosting bats were detected in the other roof voids present at the building, all of which are located above the single-storey extensions at the building's south-eastern end, are approximately two metres tall, with the roofing slates largely unlined but with degraded horse-hair parging present, and are uninsulated, with the exception of the roof void at the north-eastern end of the building (1d), which has fibreglass insulation on the floor.

Photo 20: Building 1, roof void above single-storey section of building at eastern end of the building (1d)

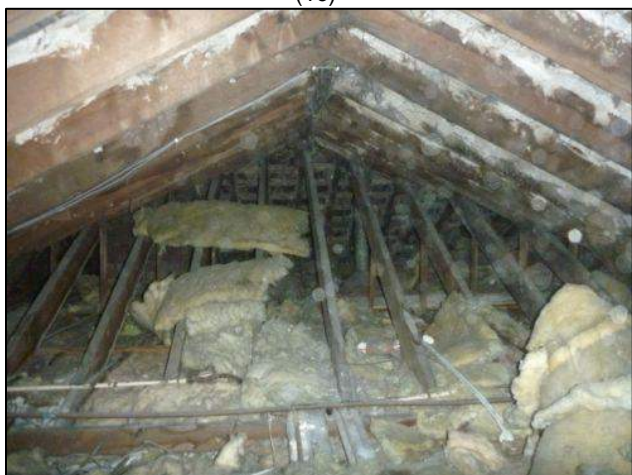
Photo 21: Building 1, roof void at northern end of the single-storey section of the building, at the building's eastern end (1d)

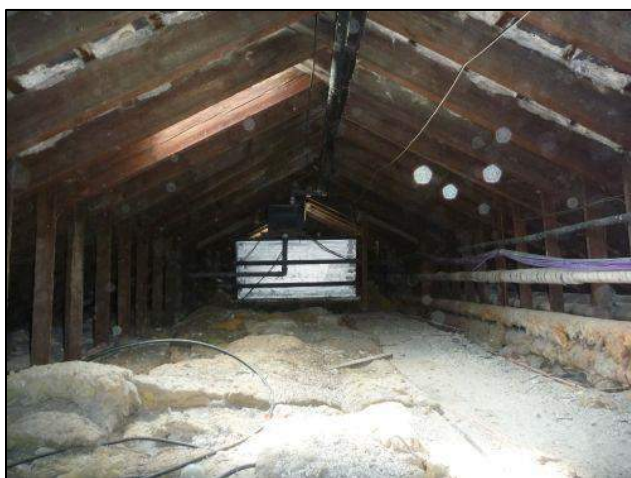
- 3.2.13 A single roof void is present, which is approximately 1.5 metres tall, and largely unlined with degraded horsehair parging present. The roof is supported on traditional timber purlins and rafters and the void is well lit throughout via regular glass skylights. The floor of the void is lined with fibreglass insulation.

Photo 33: Building 3, roof void.

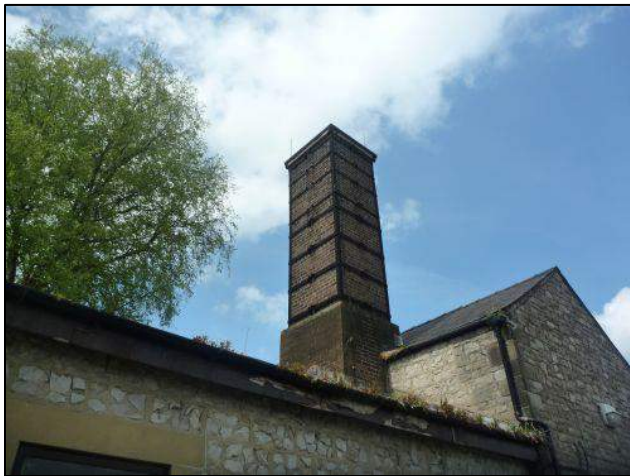
- 3.1.14 The chimney tower is hereafter referred to as Roost 2016-A.
- 3.1.15 Two common pipistrelle were detected to emerge from two separate locations at the southern elevation of Building 3 during the dusk survey conducted on the 15th June 2016 (Roosts 2016-B and 2016-C). A brown long-eared bat was suspected to have also emerged at 2016-C, as a bat was observed which made no echolocation calls⁷. A single common pipistrelle was suspected to have emerged from Roost 2016-A.
- 3.1.16 Photographs of the roosting locations are presented at **Photos 51 to 53, Section 8.1.** and the locations of the roosts are presented at **Figure 8.3.**

Photo 45: Building 7, tower

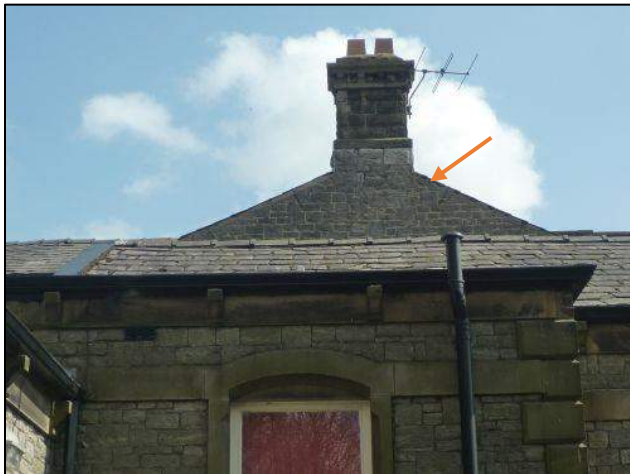
a. Main Building (A) = 20 – 30 old bat droppings indicative of Pipistrelle were noted at the west gable interior wall.

Photo 48: 20 to 30 droppings detected at western gable interior wall of Building 1 in 2008 (Roost 2008-A)

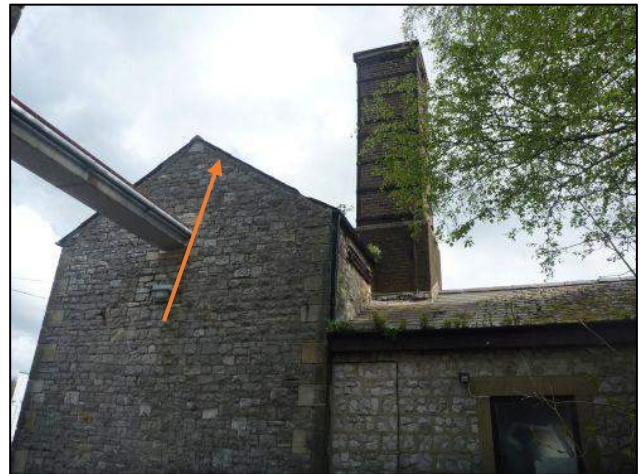
Photo 49: 15 to 20 bat droppings, indicative of pipistrelle bats, present on the upper floor and walls beneath gap in the ceiling below the roof void, at the western elevation of Building 7 (Roost 2008-B)

- 9.3.19 15 to 20 droppings, indicative of pipistrelle bats, were detected at the internal wall of the western gable elevation of Building 7 in 2008 (day roost 2008-B). 16 common pipistrelle bats were observed emerging from under the metal banding at the chimney of this building in 2017; this was assessed to be a maternity colony of common pipistrelle.

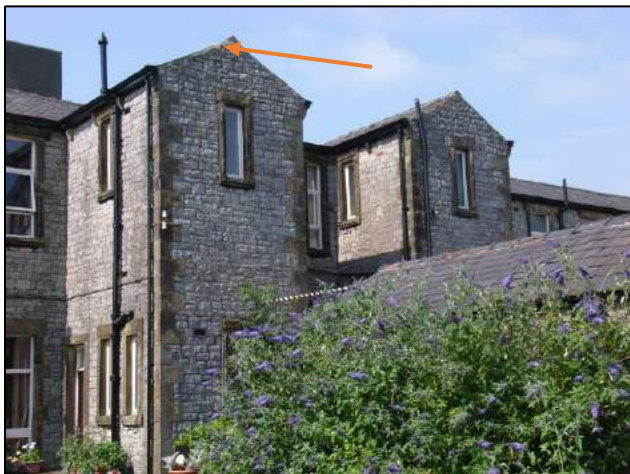
Photo 50: One common pipistrelle emerged from beneath ridge tile at 21:30 on 22nd July 2008 (Roost 2008-C)

- 9.3.18 Building 3 supports three day roosts of common pipistrelle, detected during the bat activity surveys conducted in 2008 and 2016. Each roost is at the south-eastern elevation roof verge, where individual common pipistrelle bats have been observed emerging or re-entering at the roof-line. Roosts 2008-C, 2016-B and 2016-C all comprise day roosts of common pipistrelle.

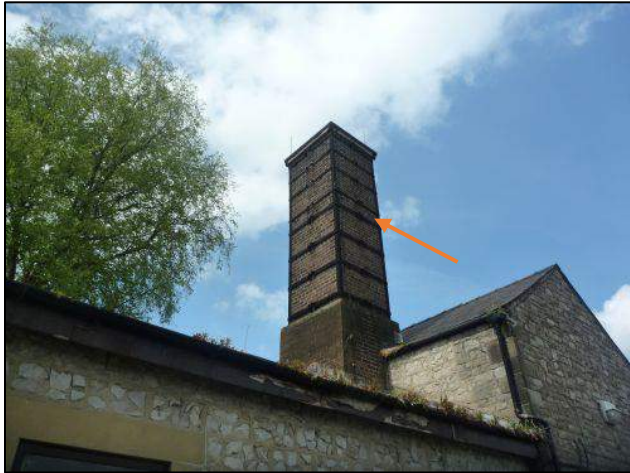
'In total sixteen common pipistrelle were confirmed to emerge from the chimney tower of Building 7. In addition a suspected emergence of a brown long-eared bat from this building was also noted⁶.'

Photo 51: 16 common pipistrelle and one (suspected) brown long-eared bat were observed to have emerged from behind the metal bands of the chimney on 1st June 2016. One common pipistrelle emerged on 15th June 2016 (Roost 2016-A)

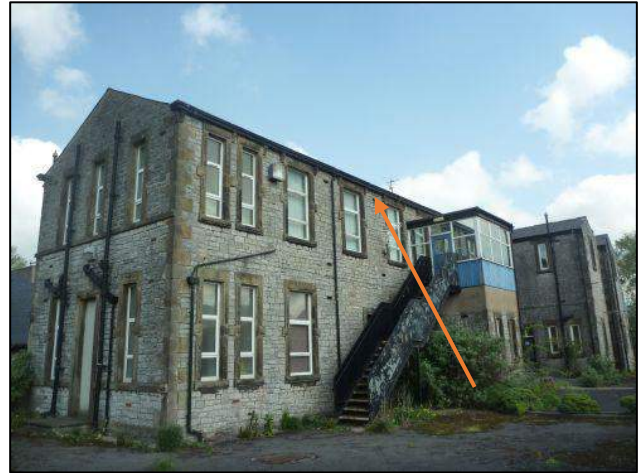
Photo 52: One common pipistrelle emergence from roof or upper floor level of southern elevation of Building 3 on 15th June 2016¹⁰ (Roost 2016-B).

¹⁰ The arrow points to the approximate location indicated on Figure 3 of the 2016 WYG report.

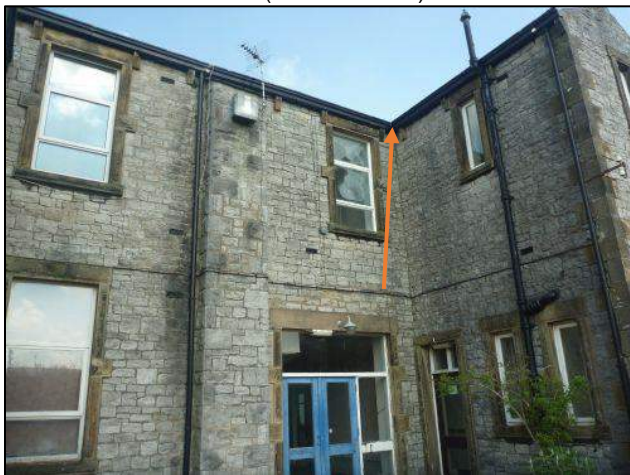
Photo 53: One common pipistrelle emerged from roof edge in the northern corner of the alcove at the southern elevation of Building 3 on 15th June 2016¹¹. It is suspected that one brown long-eared bat was also detected emerging from this location (Roost 2016-C)

¹¹ The arrow points to the approximate location indicated on Figure 3 of the 2016 WYG report.

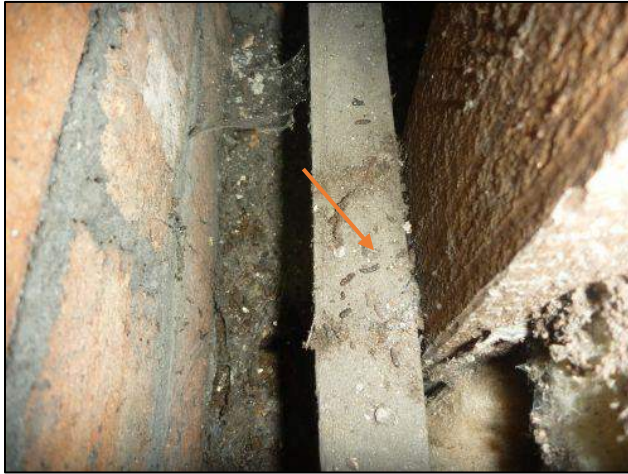
Photo 54: 10 droppings detected (indicative of pipistrelle species) in May 2017 at same location as Roost 2008-A

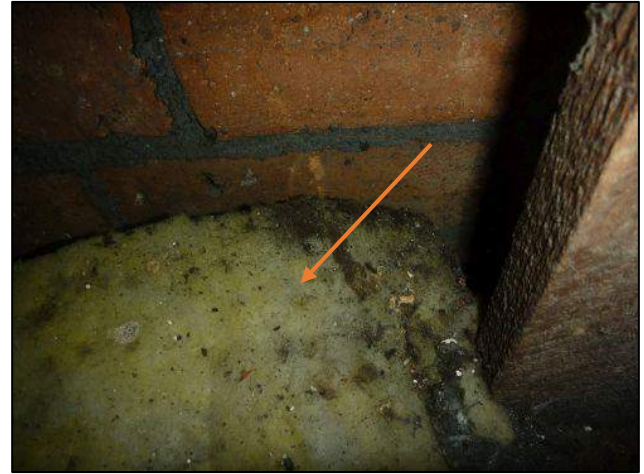
Photo 55: 10 recent and 50+ old and very old droppings detected at west facing gable at southern end of two-storey section of Building 1, May 2017 (Roost 2017-A)

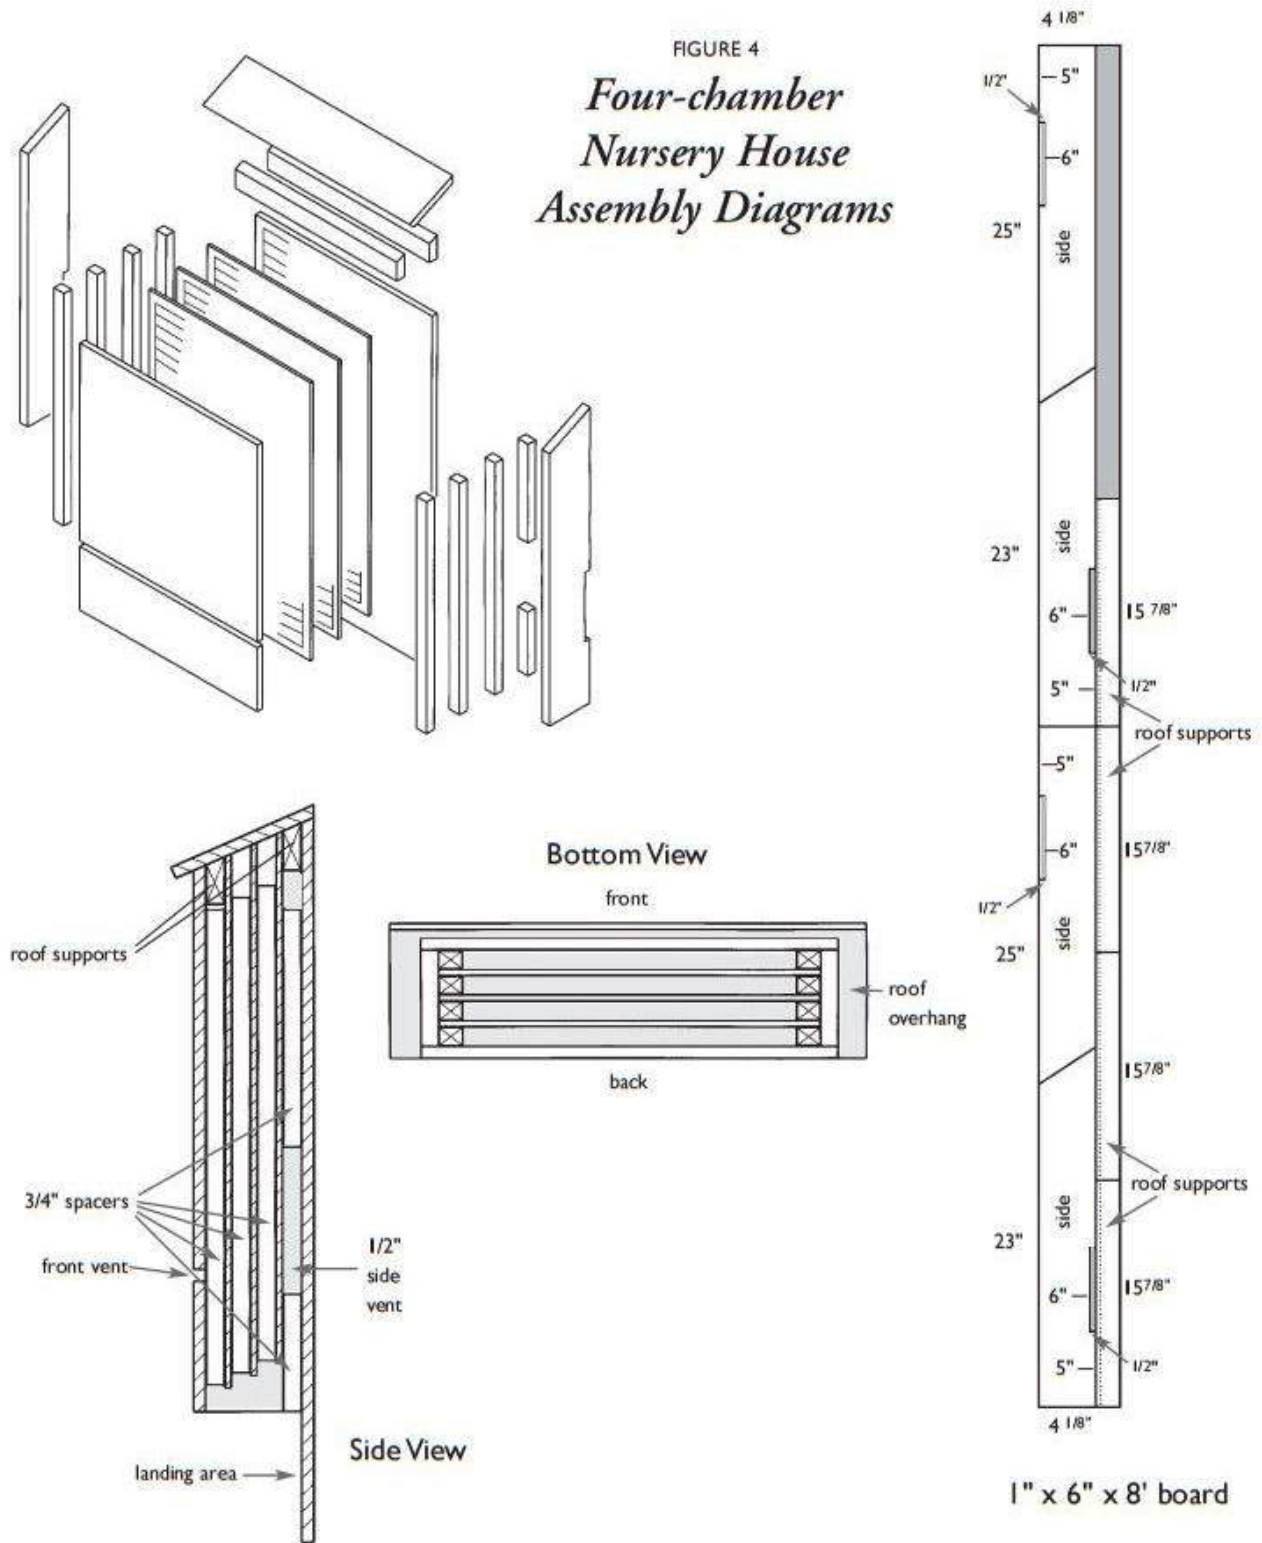
FIGURE 4
*Four-chamber
Nursery House
Assembly Diagrams*
