**The Former Clitheroe Hospital,  
Chatburn Road, Clitheroe**

**Draft Factual and Interpretative Ground  
Investigation Report**

**A094939 – February 2017**

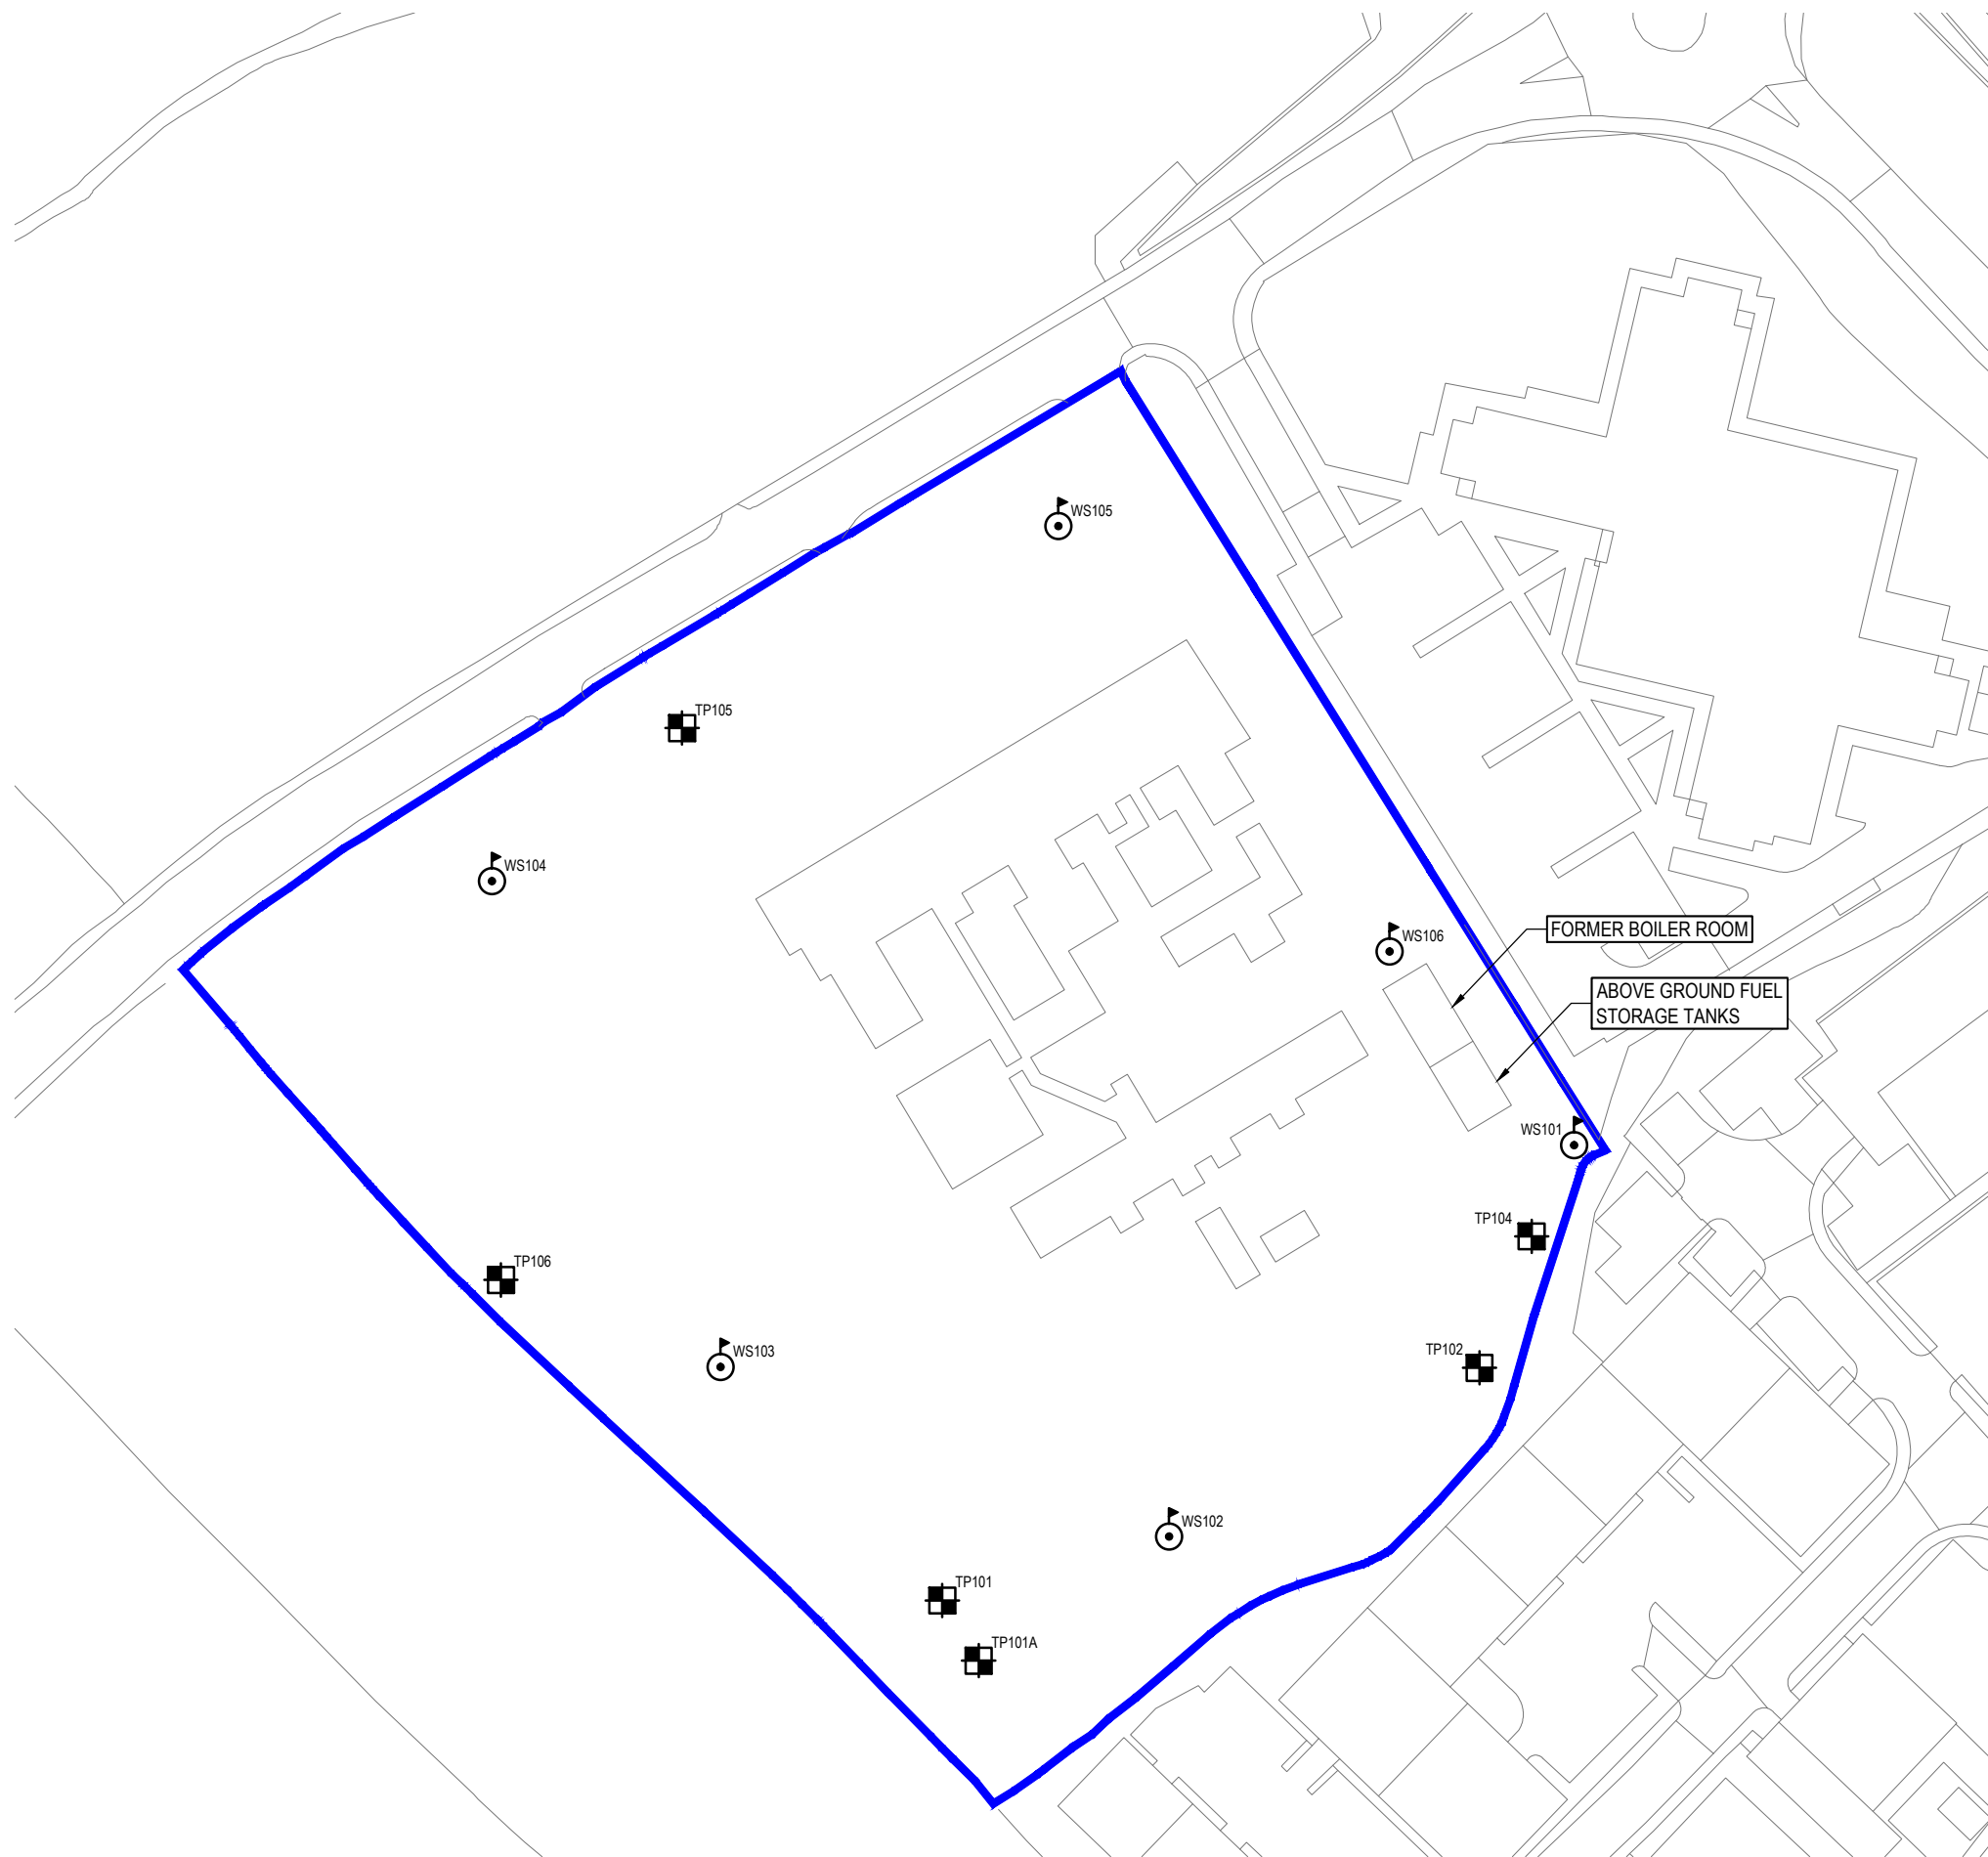
Drawing No. A094939-MAN-N-02 - Exploratory Hole Location Plan

An exploratory hole location plan is enclosed as Drawing No. A094939-MAN-N-02.

DYNAMIC SAMPLE (ALL LOCATIONS INSTALLED AS MONITORING WELLS)
