Wittons Farm, Bolton By Bowland BB7 4NZ

Proposed development: Conversion of barn to dwelling.  
Replacement of agricultural buildings with a garage, creation of a curtilage and installation of package treatment plant and ground source heat pump coil.

Heritage Statement

July 2017

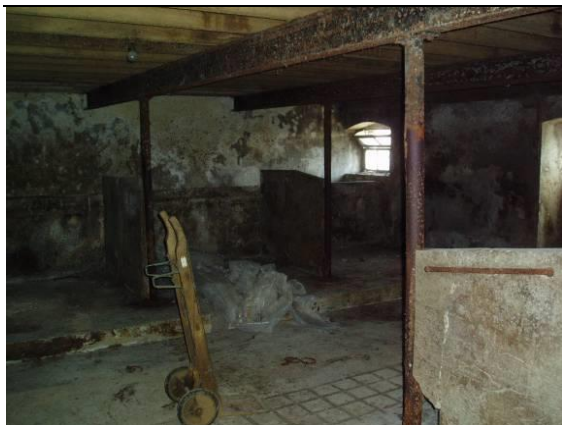
- 3.5 The main part of the barn is two storeys high and rectangular in plan, but the floor level is split. The upper section is the full height of the building. The lower section on the east side appears to have originally been a shippon with two entrance doors (now made into windows) in the east gable. This arrangement has been altered at a later date with a new entrance for cattle through a sliding door in the centre of the gable giving access to stalls with concrete partitions. The hay loft above is carried on metal columns and beams.

Shippon with hay loft on metal columns

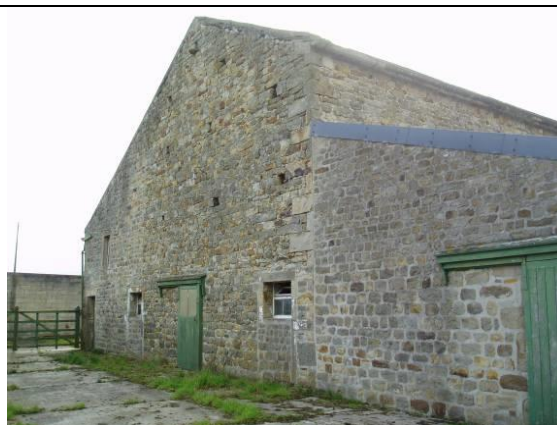
East gable

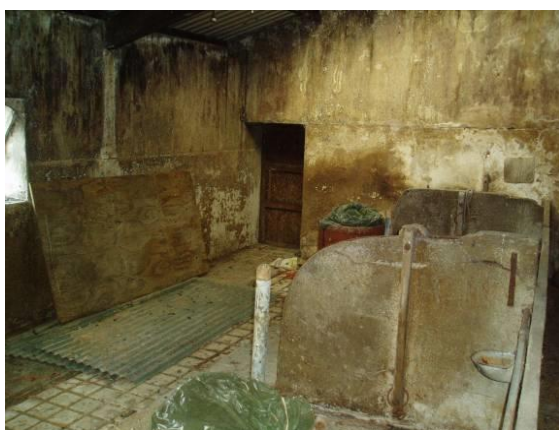
- 3.6 The western gable has a forking hole both gables have breathing holes. The north elevation of the main barn also has a line of breathing holes just above the point where the lean to roof meets the wall.
- 3.7 On the north side of the main barn is a single storey lean to. The interior of this lean-to is a shippon with concrete stalls for cattle. Access into this area is through an external door in the north wall and an external door in the east gable. There are two windows in the north wall. Internal access into the main barn is through the door which is thought to be a threshing door opposite the wagon entrance. The yard wall on the northern side of the barn is positioned quite close and is of a substantial dry stone construction.

Interior of new shippon in lean-to

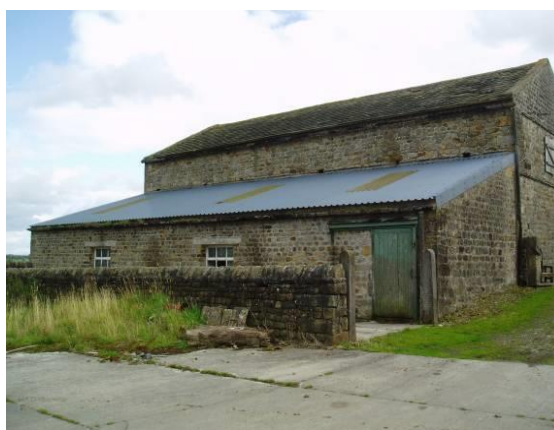
North Elevation

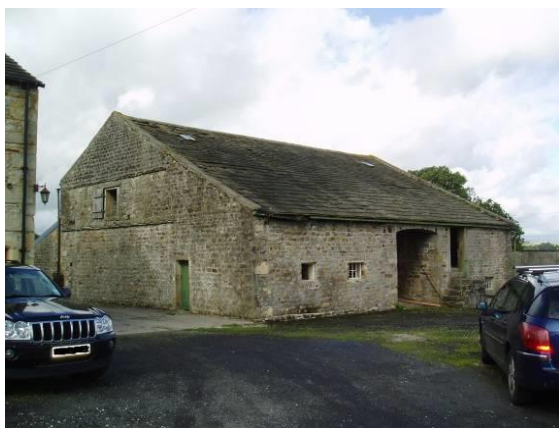
South elevation with wagon entrance

- 4.4 The retention and reuse of all the existing openings in the barn, including the wagon entrance, has been the guiding factor in the design of the conversion of the barn using these openings for windows and doors where possible and keeping the introduction of new window openings to a minimum. In additional alterations by the inclusion of new openings has been restricted to the least sensitive elevations of the building. We have identified the southern elevation with the wagon entrance as being the most significant and we have avoided alterations to this elevation.

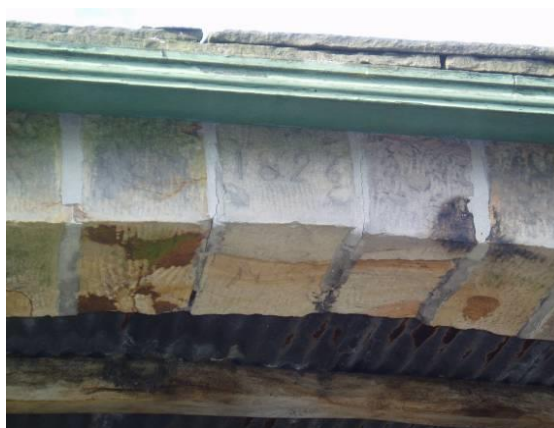
Date stone above wagon entrance 1826.

2.8 The barn itself has a date stone in the arch over the wagon entrance dating the building to 1826.

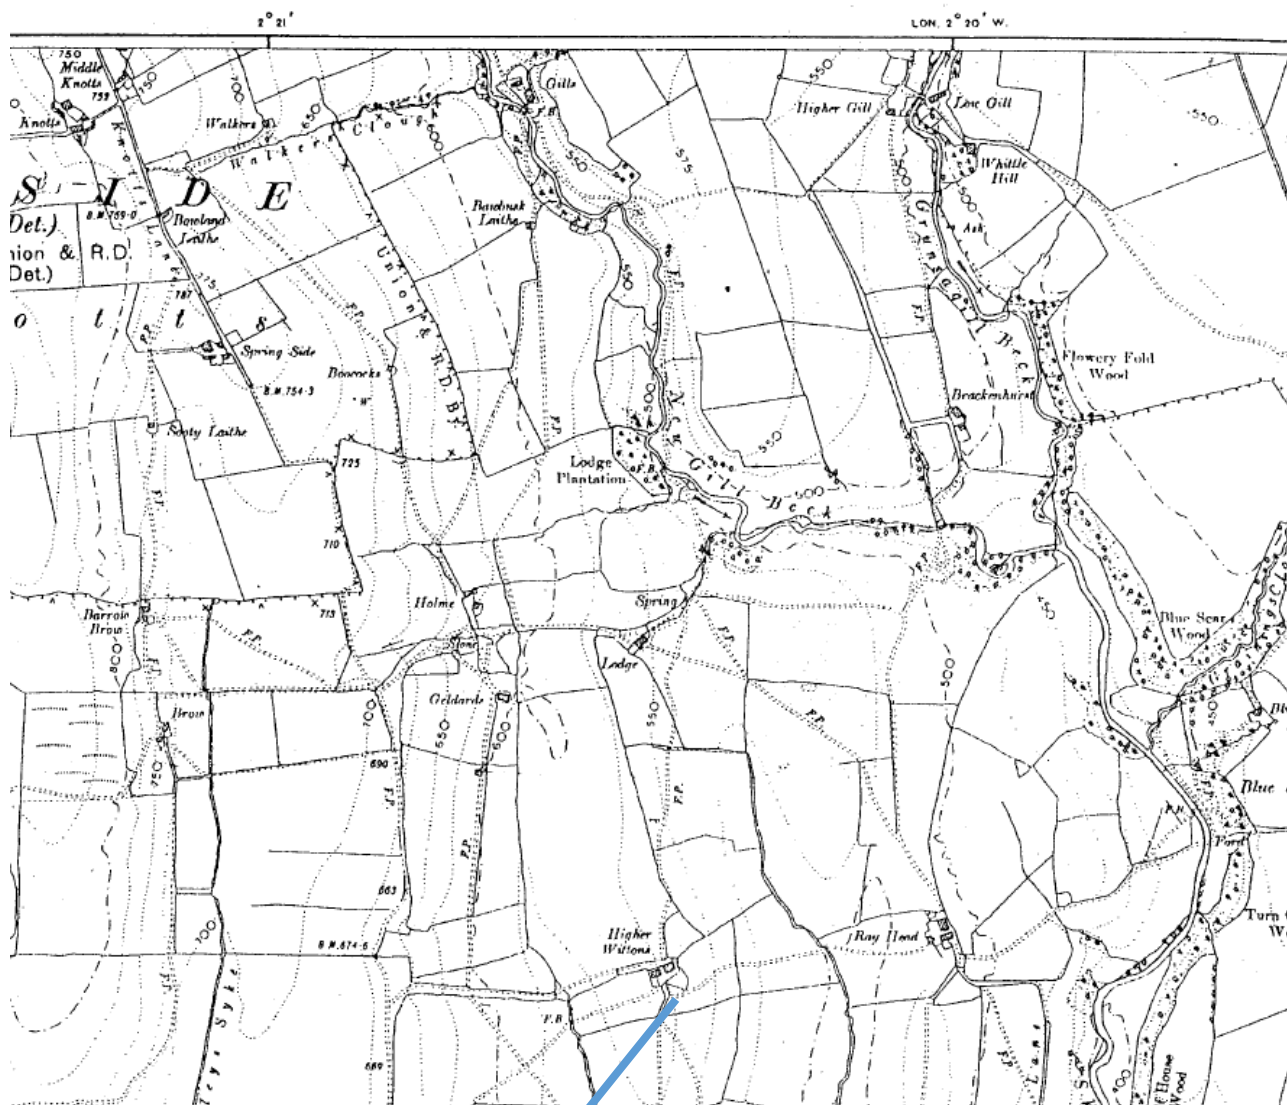
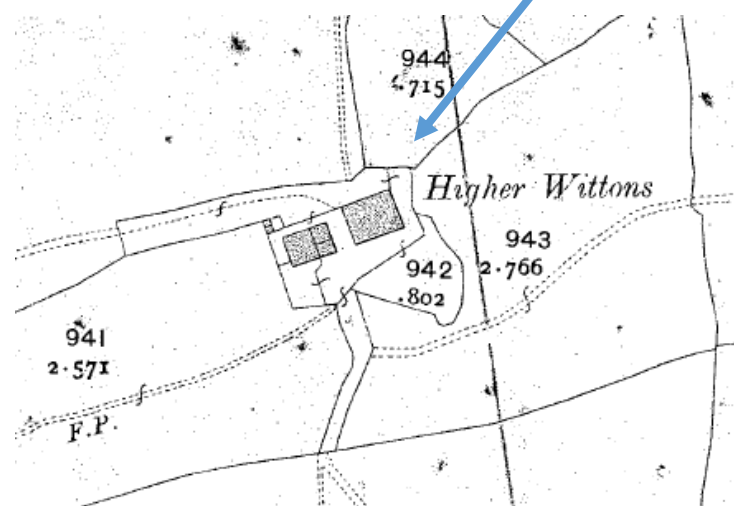
1910 above 1909 below

- 2.7 We have consulted the Community History Section of Clitheroe Library who has provided the maps attached in the appendix. The map of 1850 shows three buildings on the site in the positions as the three traditional stone buildings which are on the site today. This is repeated on the maps of 1896, 1909 and 1910. None of the modern buildings are shown on the 1909 map and the footprint of the barn is smaller than it is today suggesting that the stone lean-to section on the rear of the barn was added after 1909.
