**Phase II
Intrusive
Ground
Investigation**

**Land off Chatburn Road,
Clitheroe**

PROPOSED RESIDENTIAL DEVELOPMENT, CHATBURN ROAD, CLITHEROE

Phase II Geo-Environmental Assessment Report

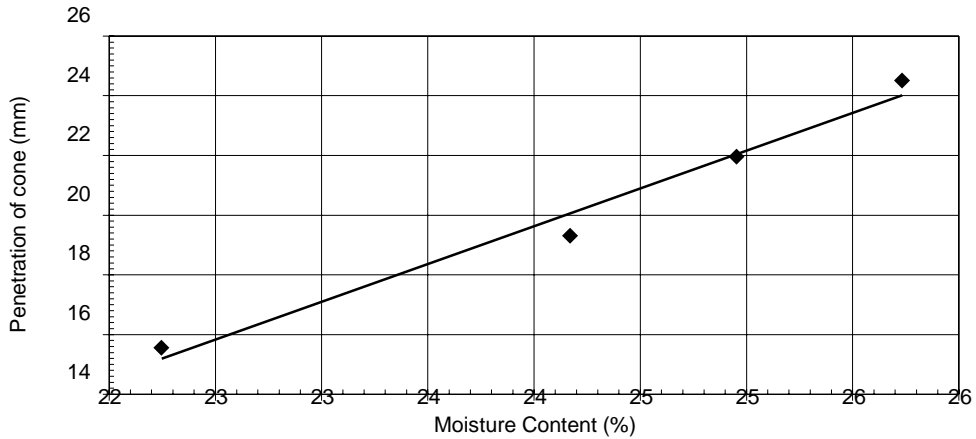
Moisture content : (BS1377:Part 2:Clause 3:1990)	4.9 %
Percentage passing 425µm sieve :	28 %
Liquid Limit :	24 %
Plastic Limit :	13 %
Plasticity Index :	11
Equivalent moisture content of material passing 425µm sieve :	18 %
Liquidity Index :	0.42

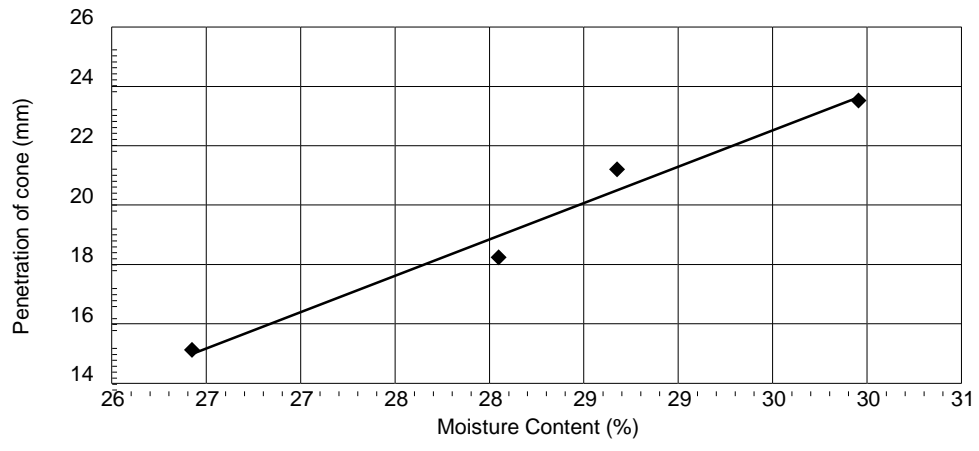
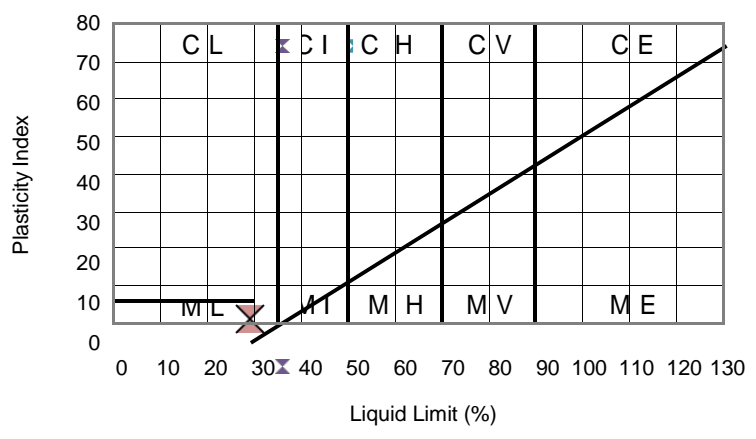
Moisture content : (BS1377:Part 2:Clause 3:1990)	14 %
Percentage passing 425µm sieve :	54 %
Liquid Limit :	28 %
Plastic Limit :	16 %
Plasticity Index :	12
Equivalent moisture content of material passing 425µm sieve :	26 %
Liquidity Index :	0.84

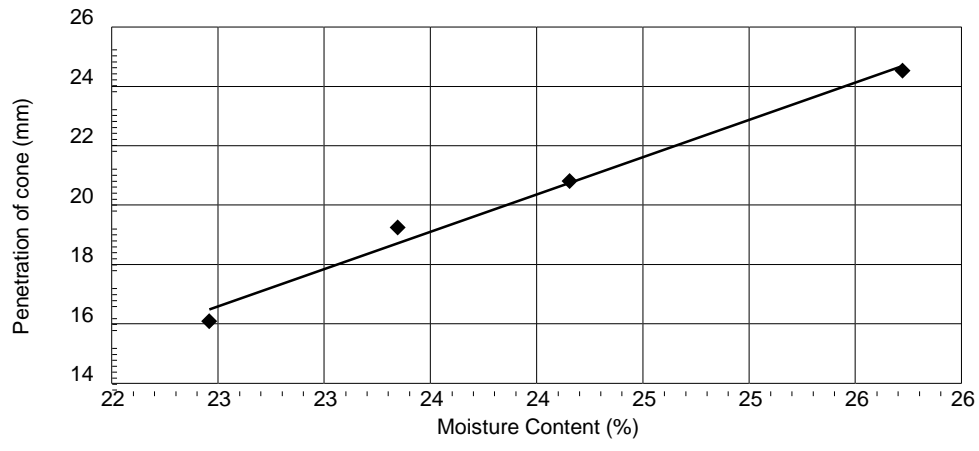
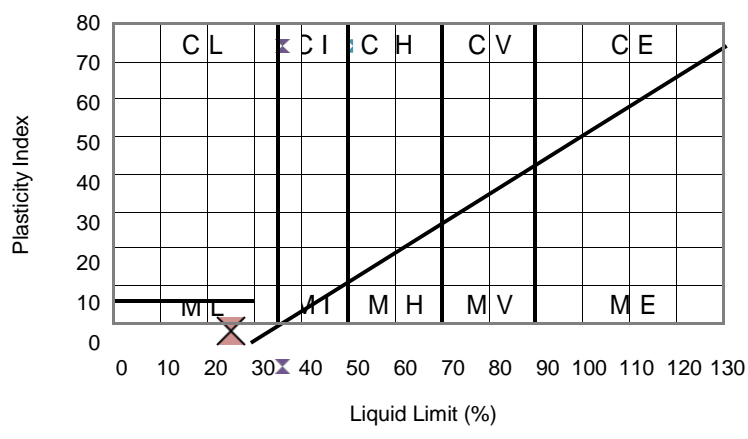
Moisture content : (BS1377:Part 2:Clause 3:1990)	9.5 %
Percentage passing 425µm sieve :	60 %
Liquid Limit :	24 %
Plastic Limit :	15 %
Plasticity Index :	9.0
Equivalent moisture content of material passing 425µm sieve :	16 %
Liquidity Index :	0.08

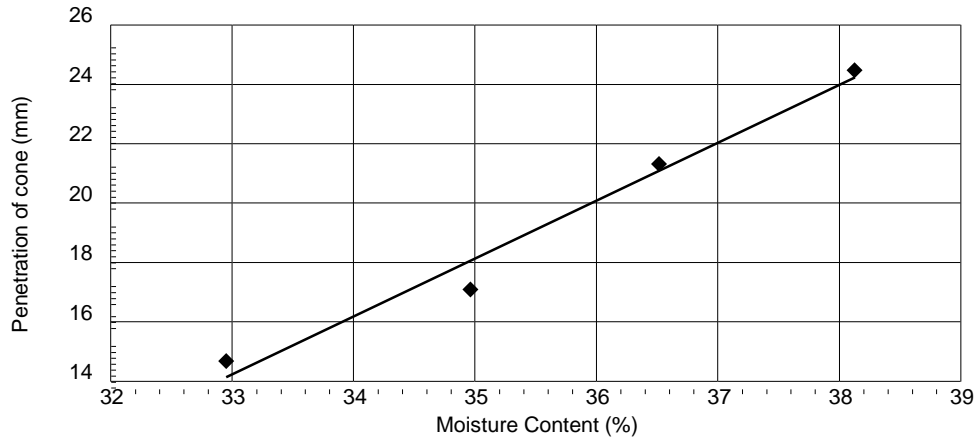
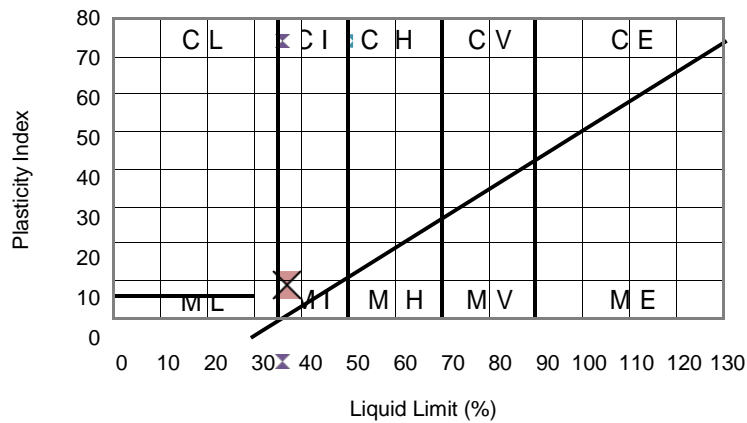
Moisture content : (BS1377:Part 2:Clause 3:1990)	18 %
Percentage passing 425µm sieve :	56 %
Liquid Limit :	36 %
Plastic Limit :	17 %
Plasticity Index :	19
Equivalent moisture content of material passing 425µm sieve :	32 %
Liquidity Index :	0.79

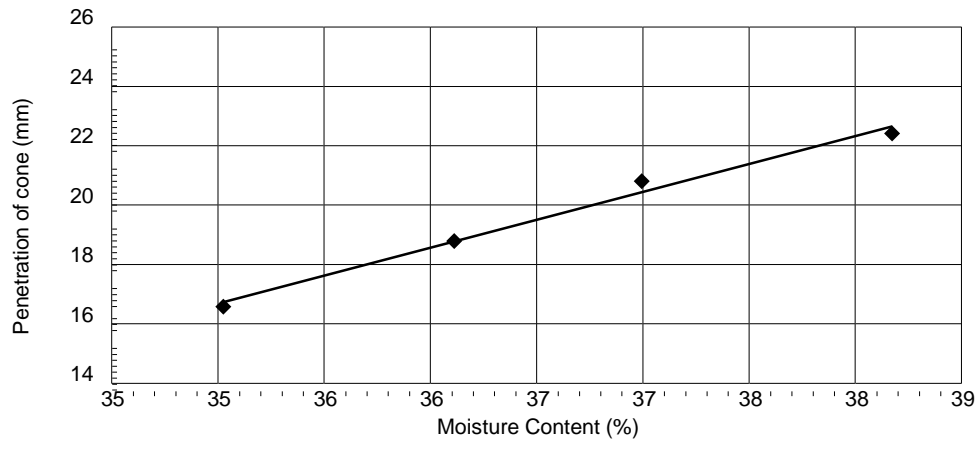
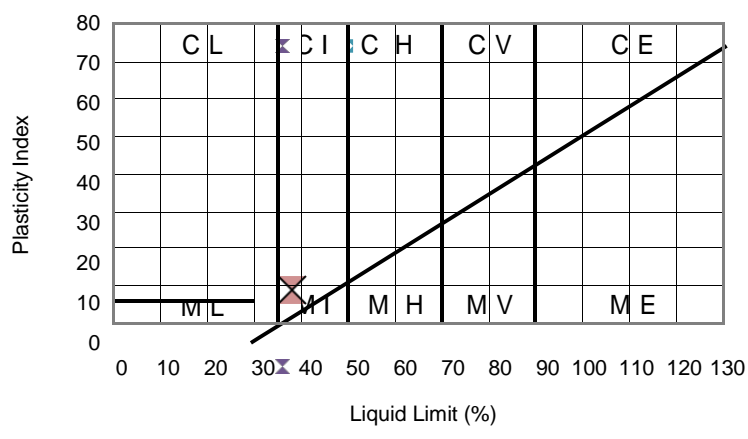
Moisture content : (BS1377:Part 2:Clause 3:1990)	17 %
Percentage passing 425µm sieve :	56 %
Liquid Limit :	37 %
Plastic Limit :	18 %
Plasticity Index :	19
Equivalent moisture content of material passing 425µm sieve :	31 %
Liquidity Index :	0.66

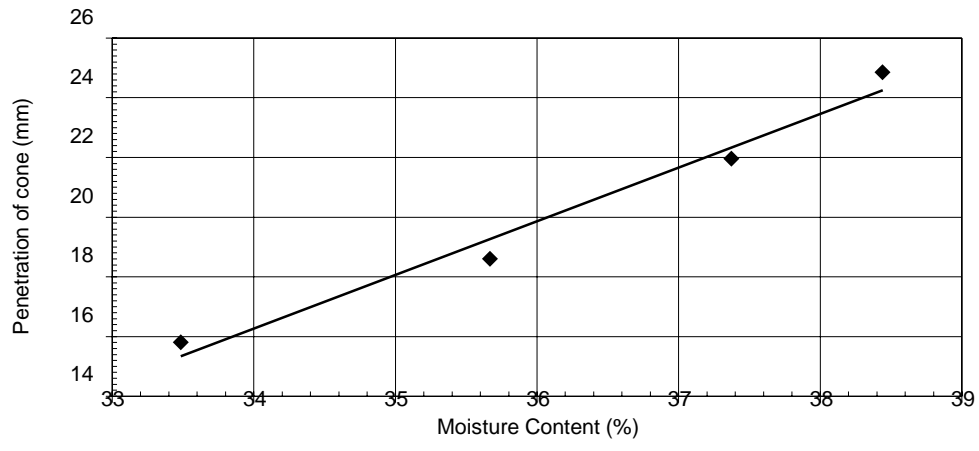
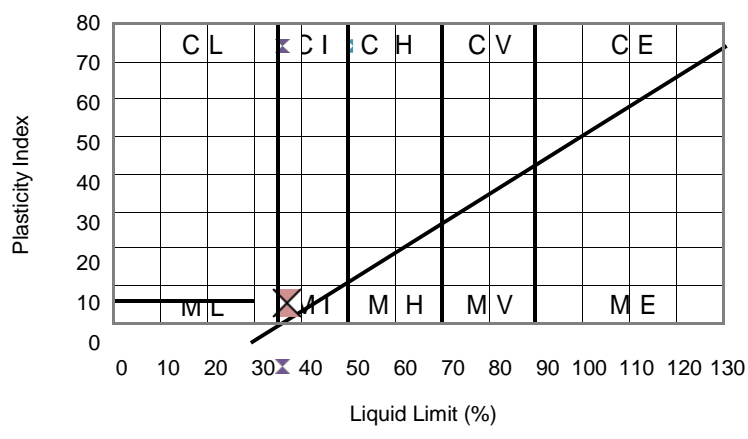
Moisture content : (BS1377:Part 2:Clause 3:1990)	17 %
Percentage passing 425µm sieve :	67 %
Liquid Limit :	36 %
Plastic Limit :	20 %
Plasticity Index :	16
Equivalent moisture content of material passing 425µm sieve :	25 %
Liquidity Index :	0.33

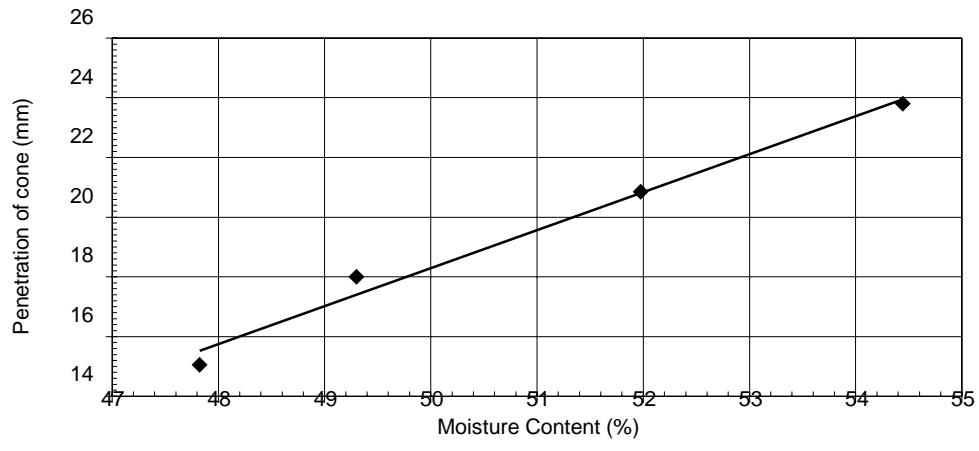
Moisture content : (BS1377:Part 2:Clause 3:1990)	28 %
Percentage passing 425µm sieve :	100 %
Liquid Limit :	51 %
Plastic Limit :	27 %
Plasticity Index :	24
Equivalent moisture content of material passing 425µm sieve :	28 %
Liquidity Index :	0.04

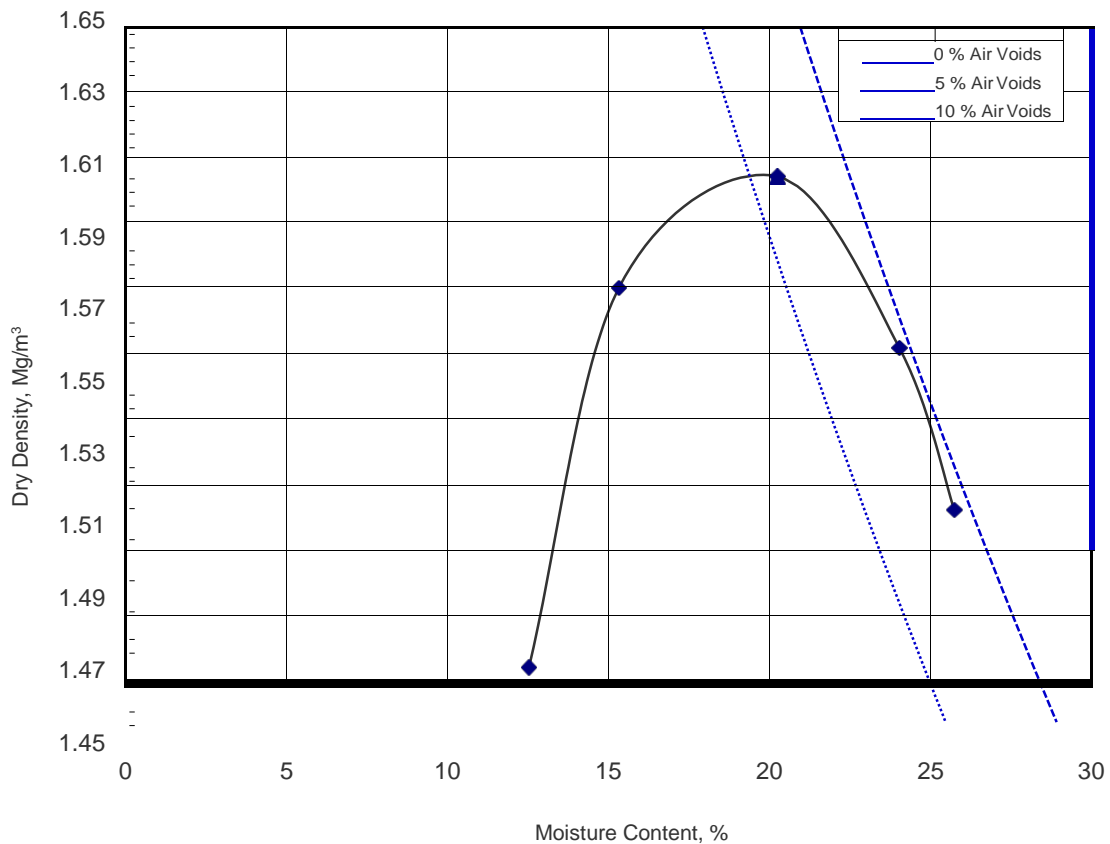
Determination		1	2	3	4	5
Moisture Content	%	12	15	20	24	26
Dry Density	Mg/m ³	1.47	1.57	1.61	1.56	1.51
