**18 PARSON LANE, CLITHEROE**

# 18 PARSON LANE, CLITHEROE, LANCASHIRE:

## HERITAGE ASSESSMENT

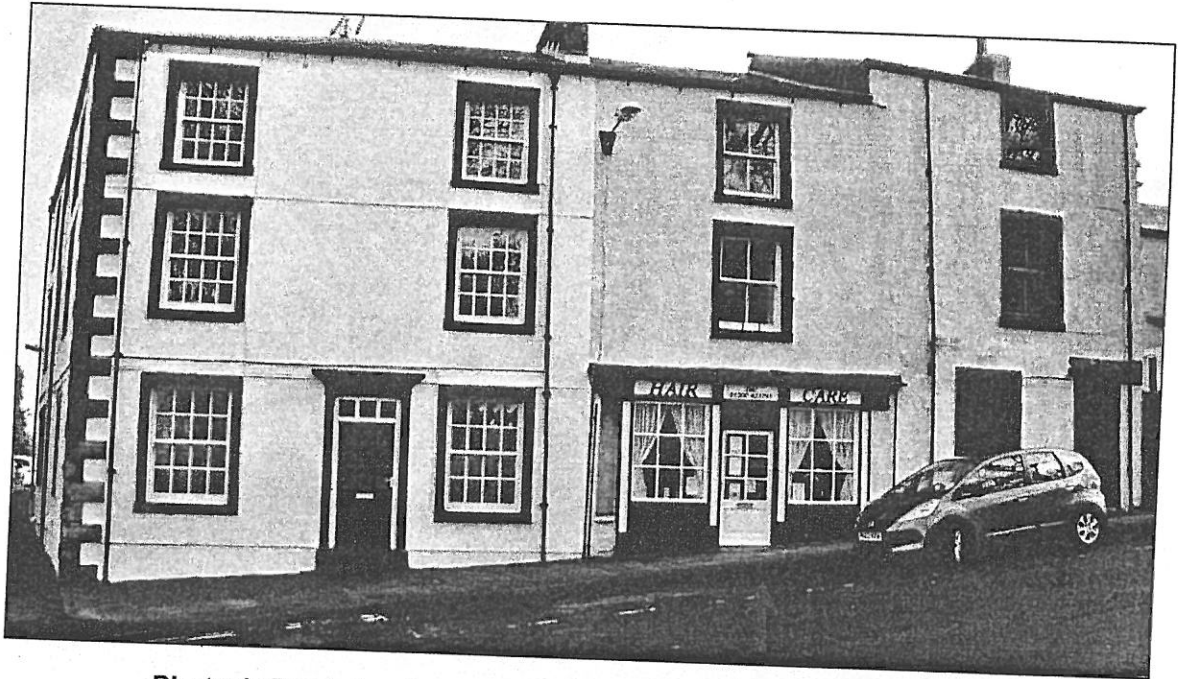
Photo 1: Front elevation to Parson Lane (No 18 is central building)

- 6.2 The front elevation of number 18 is roughcast, believed to conceal stonework beneath, and is one room wide. The shop front occupying almost its full width is essentially traditional and quite possibly original to the building, though some components, including the door and the glazing bars to the windows, are mid or late 20th century. The first and second floors each have a central window with square-faced, painted stone surround, and horned, four pane sashes, probably early 20th century replacements of smaller paned glazing. The roof is blue slate, re-laid within the last 20 years or so, and there is a stone ridge stack at the west.

- 7.2 Externally, the front elevation makes a very important contribution to the setting of the listed building and the conservation area, through the traditional shop front, and the original openings to the two upper floors, and although none of the window frames here are original, they are of traditional form. The plain and modest, yet aesthetically pleasing arrangement of openings is important here.

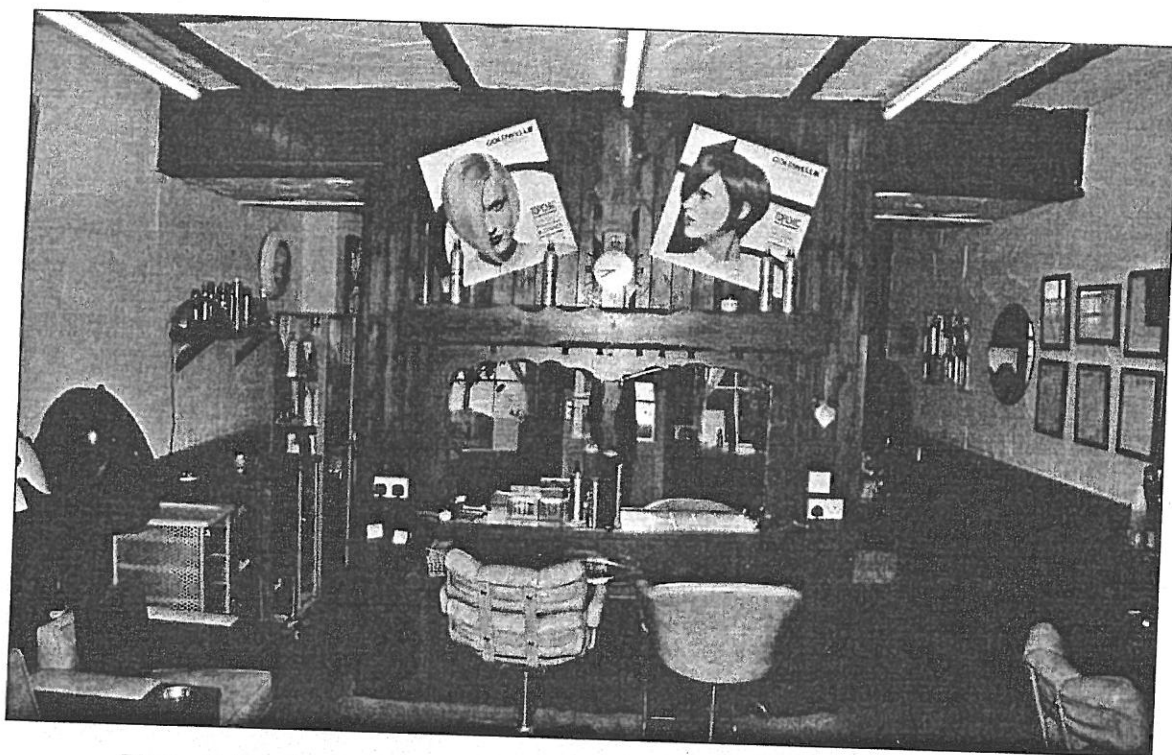
**Photo 3:** Front room on ground floor, with staircase within central portion

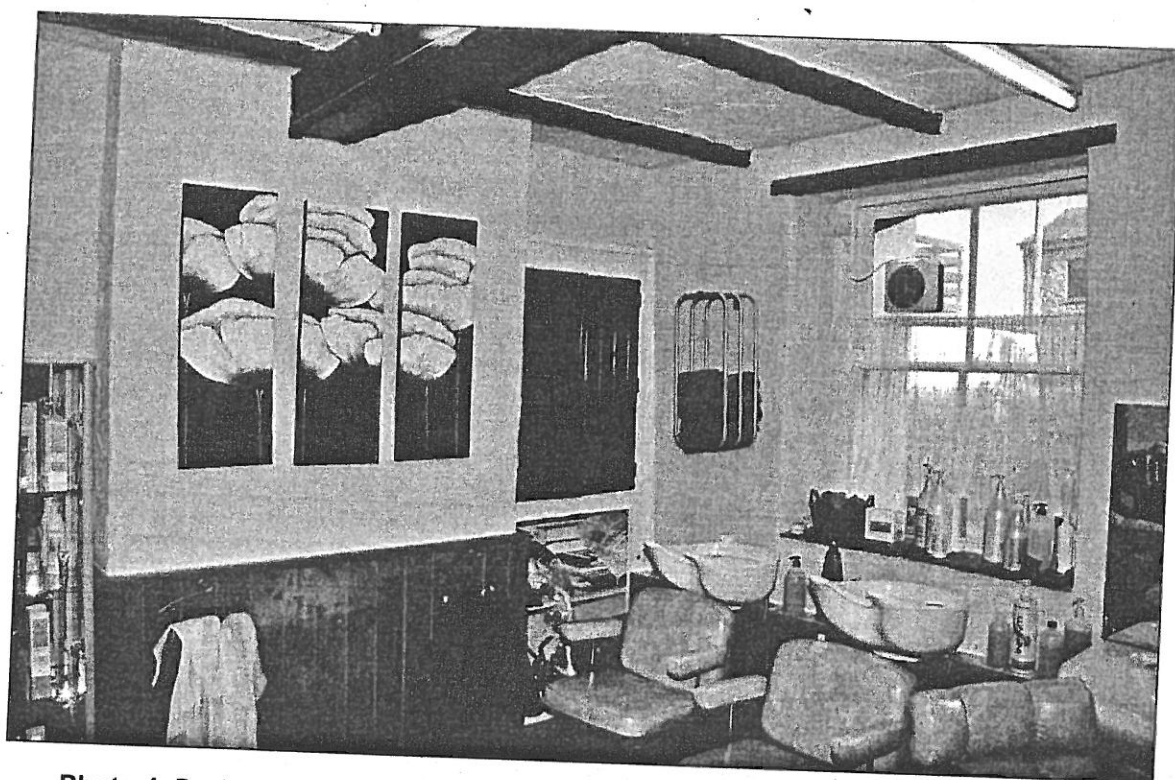
**Photo 4:** Back room on ground floor, towards chimney breast and alcove cupboard
