## BAT, BARN OWL & NESTING BIRD SURVEY AT

CUNLIFFE MOSS FARM,  
MELLOR

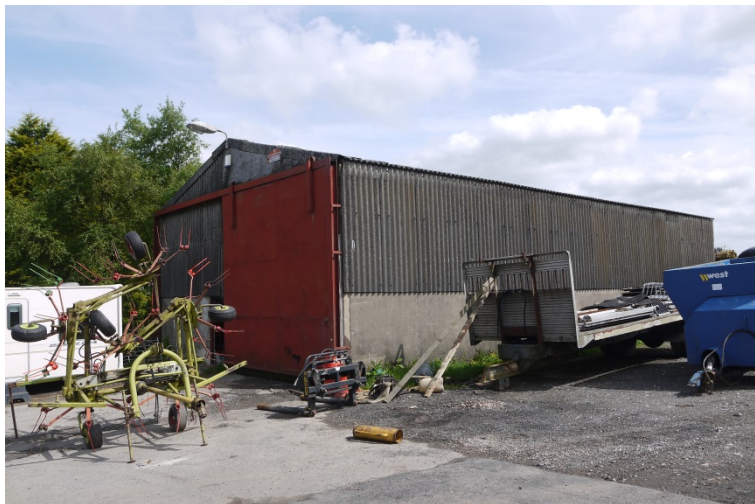
The lower parts of the walls of the building are made from concrete block and are in excellent condition. The blockwork is pointed flush and offers no potential for bats.

| BUILDING 1 | |
|---|---|
| | <p>Building 1 is a large portal framed barn constructed of concrete block and cement fibre corrugate.</p> <p>The blockwork is well pointed and the corrugate sheeting on the wall is a single skin, with no cavities which could be used by bats.</p> |

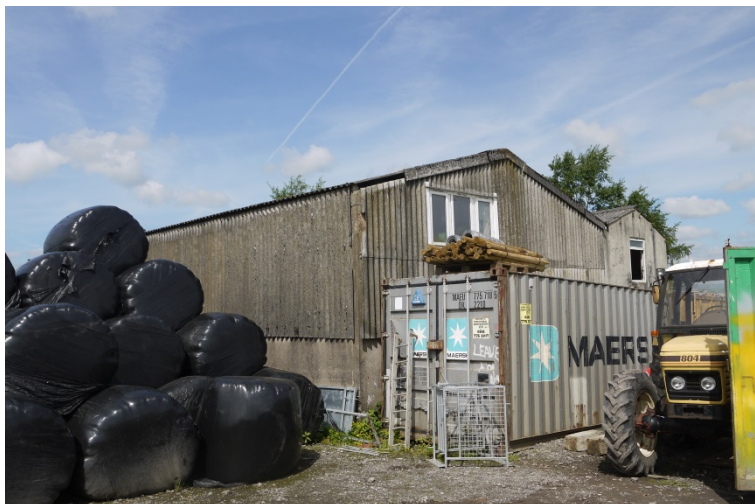
| BUILDING 1 | |
|---|---|
| | <p>The roof also is a single skin of corrugate sheeting and offers negligible opportunities.</p> |

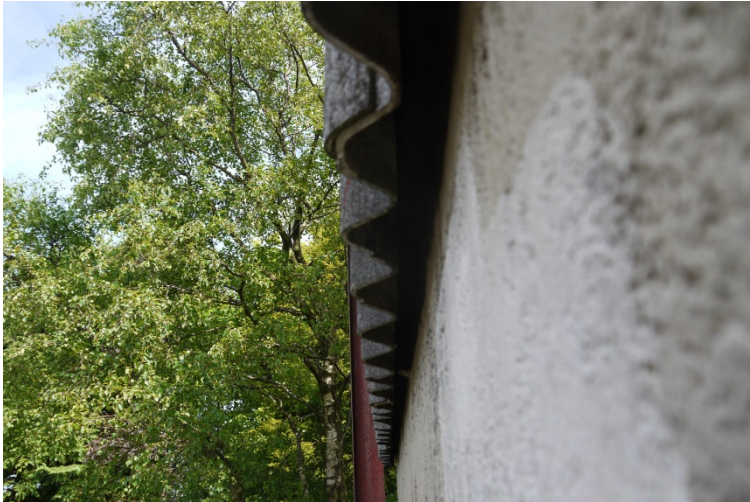
The upper parts of the walls are a single skin of cement fibre corrugate sheeting. Where these overlap the block walls, small vertical tubes are created. These are mostly sealed at the bottom with expanding foam but some were found to be accessible. The resulting spaces are open and exposed and would not offer high quality roost sites. Torch inspection found no evidence of use by bats.

Small vertical crevices created where the corrugate extends over the block base are short and highly exposed.

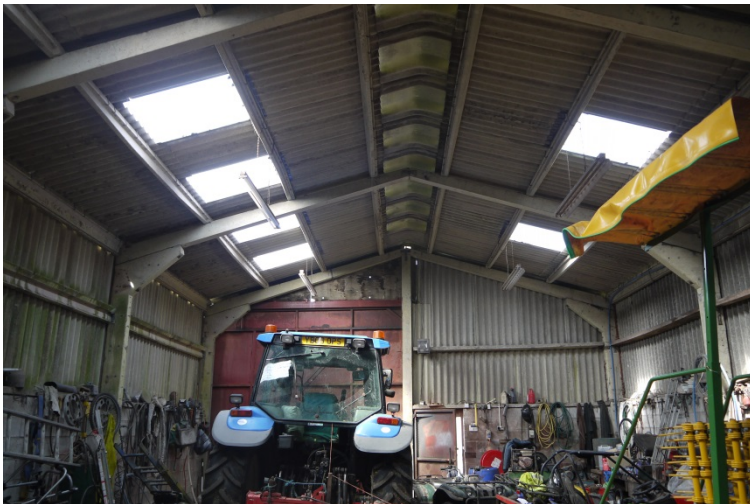
The internal space is cavernous and well illuminated by skylights. There are no enclosed voids and there was no evidence of use by bats.

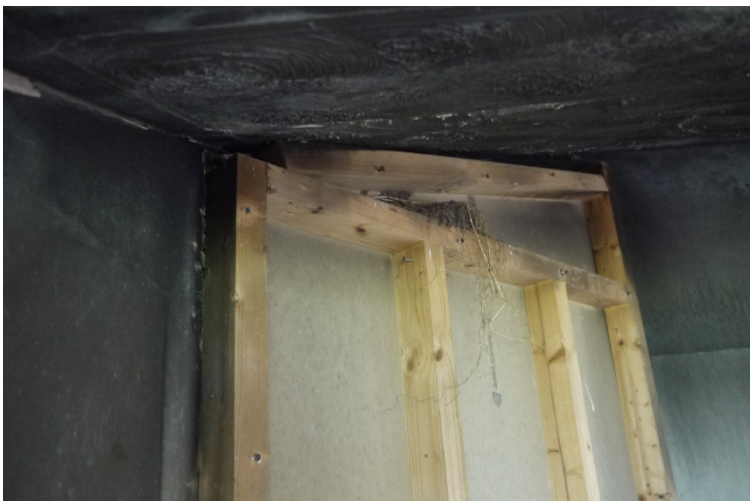
An old swallow (*Hirundo rustica*) nest was found on the first floor of Building 1. The nest was found to be vacant at the time of the survey.

An old swallow nest was noted in one of the first floor rooms. The window was missing to allow access.

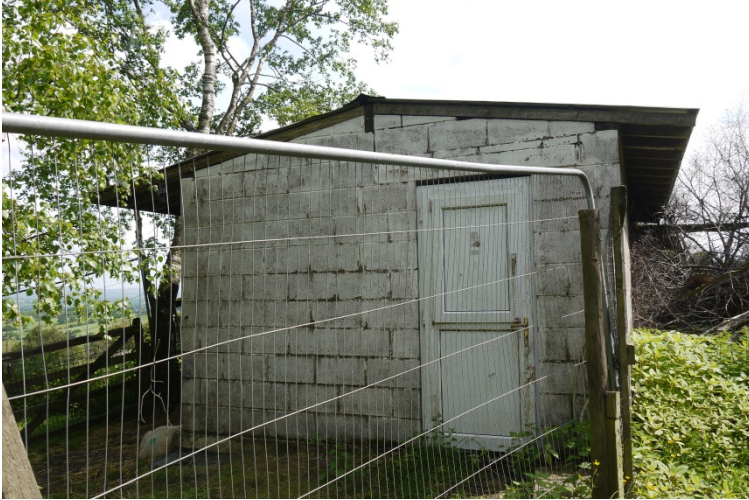
A small block built outbuilding currently used to house sheep.

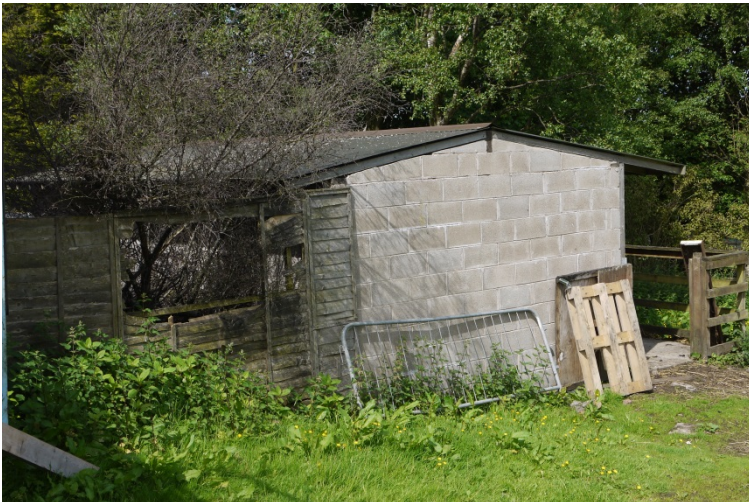
The block walls are well pointed and the single skin corrugate roof does not offer any opportunities for roosting bats.
