**BAT SURVEY AT -
WALLACE HOUSE
GRINDLETON**

**DATE AND TIME OF VISIT
6th July 2017 10.00am**

REFERENCE NO. 5362

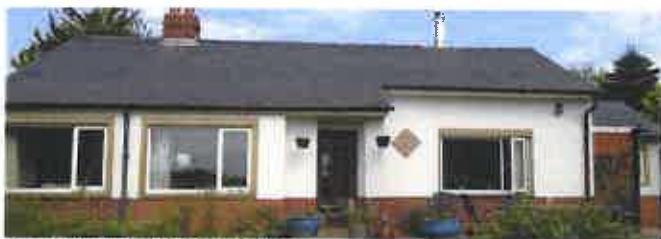
Front South east elevation

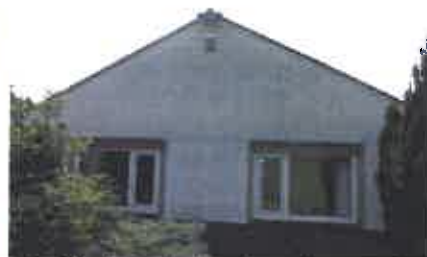
Part North east elevation of rear outrigger

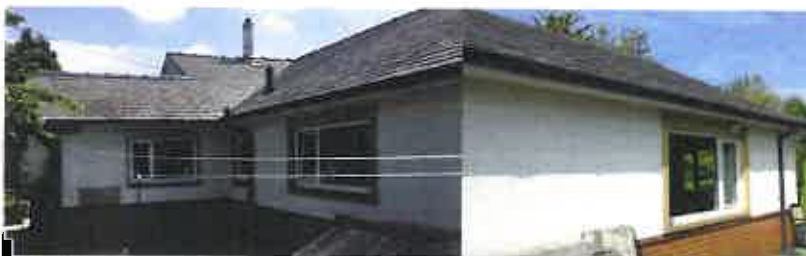
Side North east elevation

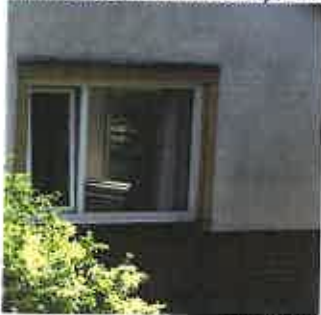
The walls are brick cavity, a brick plinth with white painted render finish above.

The render and brick walls are in good condition with no cracks, crevices or access points.

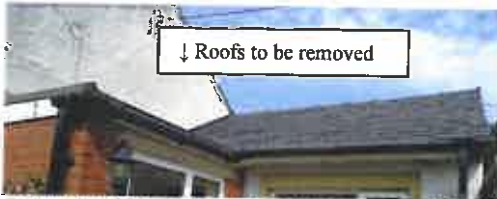
The side porch with pitched slate roof and felt flat

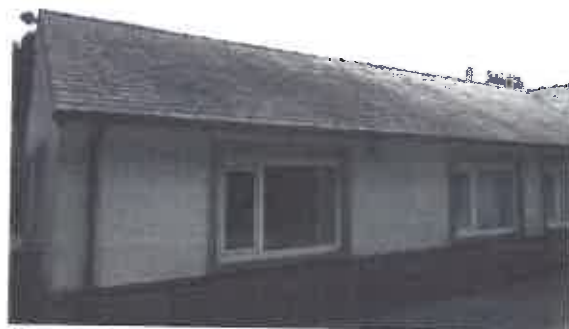
Rear outrigger roof pitch

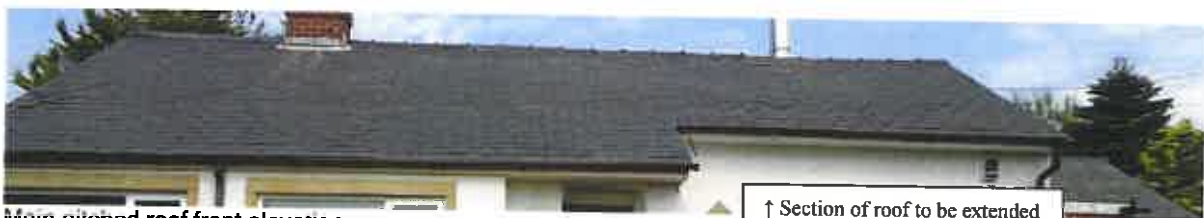
Main pitched roof front elevation

↑ Section of roof to be extended

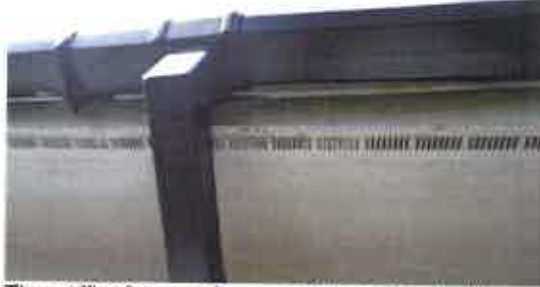
The slates are in reasonable condition with some slight gaps but nothing significant or suitable for bat access. The soffits are all in reasonable condition and tight fitting the ventilation grille does not provide access

The soffit of the roof section being extended has no ventilation grille but has two holes. The endoscope was used to examine the void the result was negative.

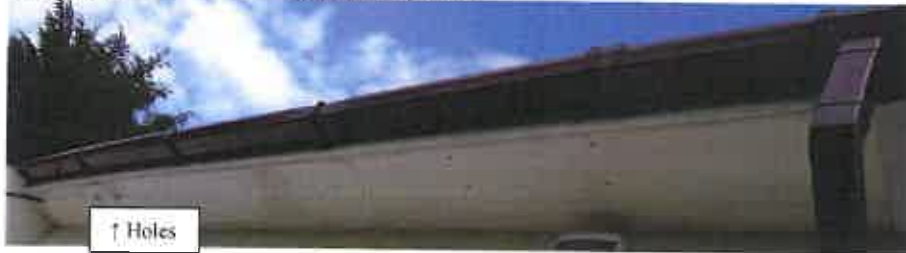
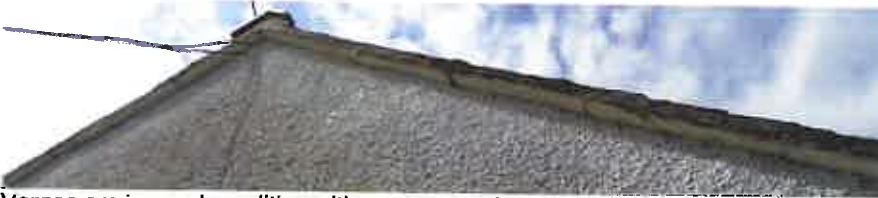
Verges are in good condition with no gaps at abutment of wall with the roof slates. The felt flat surface and the eaves were in good condition with no gaps or access points.

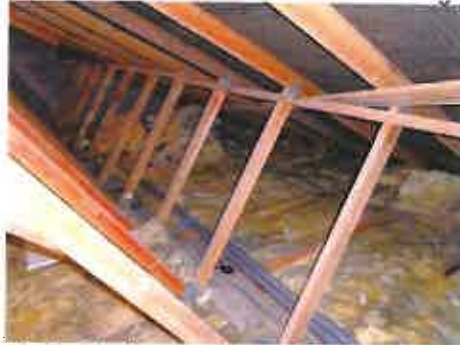
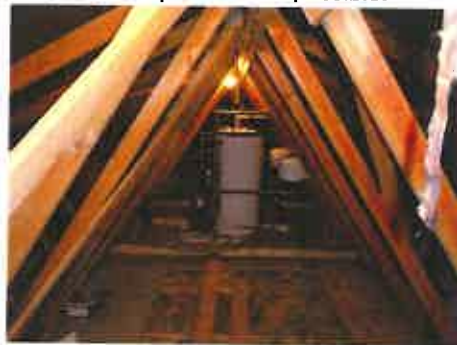
Roof void of rear outrigger: Timber truss rafters with felt and quilt insulation between joists. All timbers and felt in excellent condition.

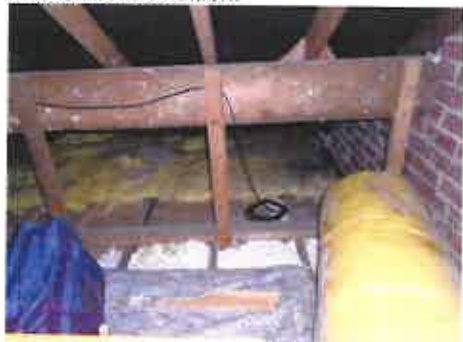
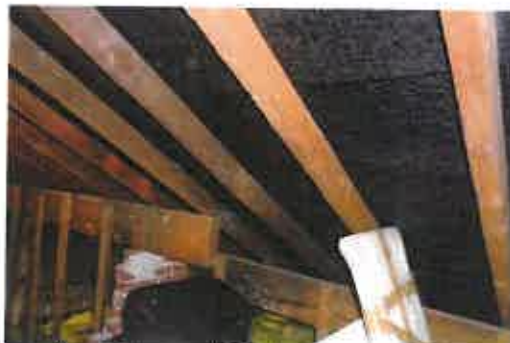
The roof void of the original bungalow: timber purlins, rafters and felt. Insulation quilt between joists. Both voids are dry and clean with no droppings or significant insect remains.
