BARN AT WHEATLEY FARM, THORNLEY-WITH-WHEATLEY, LANCASHIRE:

HERITAGE ASSESSMENT

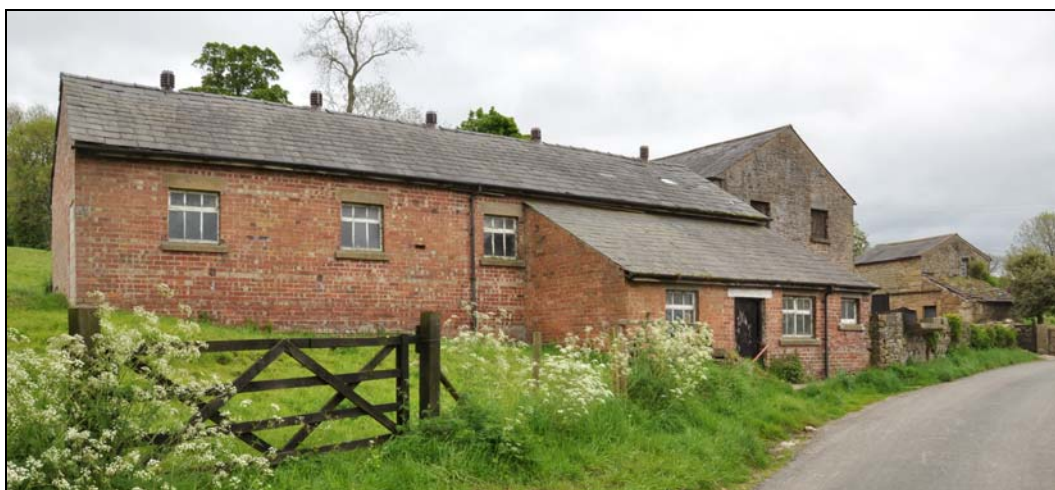
- 5.1 Wheatley Farm is set on slightly undulating land at the foot of Longridge Fell, with the farm buildings forming a discrete group, clearly separated from the farmhouse by the public road. This separation of house and farm raises the status of the former, though it was probably still considered to be the home of a yeoman farmer rather than of a gentleman. The clustering of barn, trap-house and mid 20th century shippon creates a coherent group of farm buildings of various ages, enclosed on the roadside by a good stone wall, which have been little altered by more recent intervention, with the exception of a modern shed to the rear of the barn. The focus of present farming is in a group of much larger sheds to the south of the farmhouse, separated by the historic group by open space beyond the trap-house, formerly gardens or orchards.

Photo 1: Farm buildings group, from the north

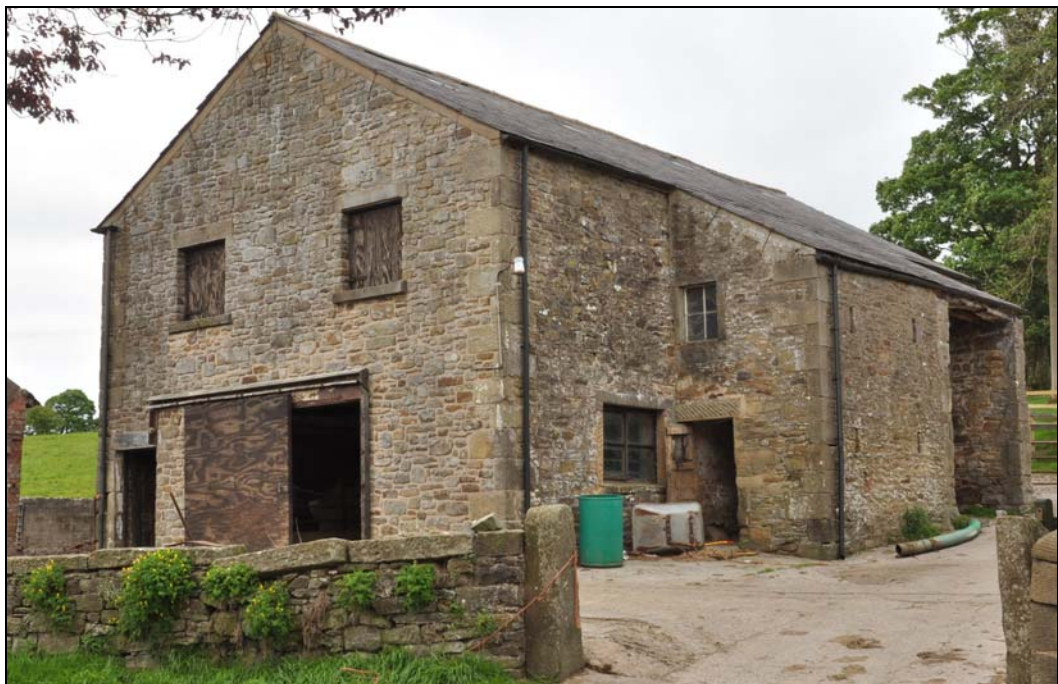
- 5.2 The barn at Wheatley is likely to be late 18th century and therefore of similar date to the farmhouse. It is a four bay, two storey structure which is fairly typical of the combination barns found throughout this part of Lancashire, and it is built down the slope in the manner of a bank barn. The walls are mostly of random sandstone rubble, though the north-west gable has been rebuilt in recent years with a concrete block inner leaf, and the roof is blue slate with roof lights, no doubt attributable to a 20th century re-roofing.

Photo 2: Front of barn and rebuilt gable

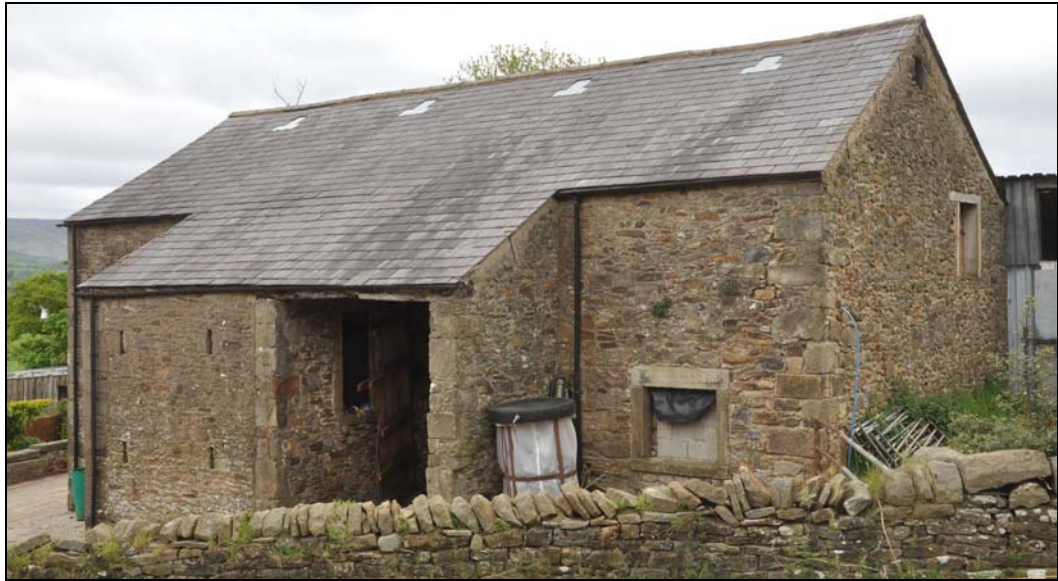
Photo 3: Front of barn

Photo 4: Rear elevation

- 5.4 Some original features are present within the south-west porch, including the cobbled floor, loft beams, and harr-hung oak door frames (ie. stile and rails), though the doors have been much repaired. The original rear doorway opposite this is full width and has a stone arch over a timber lintel fashioned from a re-used cruck blade, but as noted above could not be used due to the later lean-to added to the rear elevation.

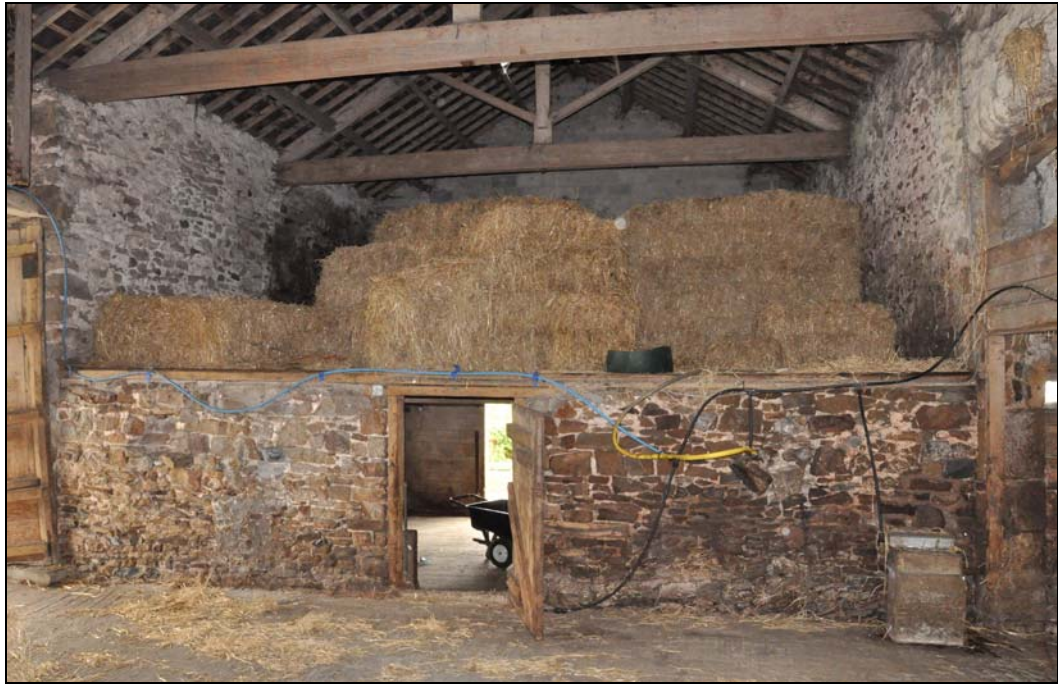
- 5.5 The barn interior is divided on the ground floor by a stone wall, to enclose a shippon in the north-west end, and support the hay loft over it, with the two south-east bays being open to the roof. This is an entirely characteristic arrangement, though the difference in floor level between the two ends is greater than is usually encountered. None of the original shippon fixtures remain in situ, and the loft over this end of the building is partly carried on steel beams, so quite how this area was arranged historically cannot now be determined. The three

king post roof trusses, of square-sawn softwood and with bolted purlin ends, are not original and were probably introduced with the re-slating of the building in the 20th century.

Photo 6: Barn interior with wall enclosing shippon

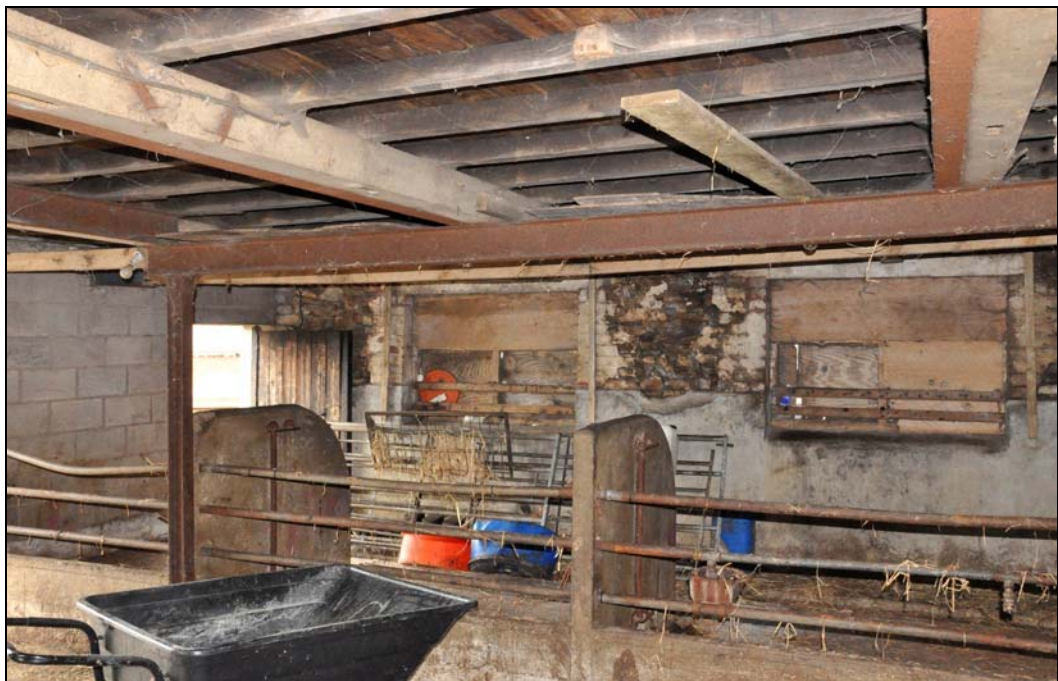
Photo 7: Present shippon

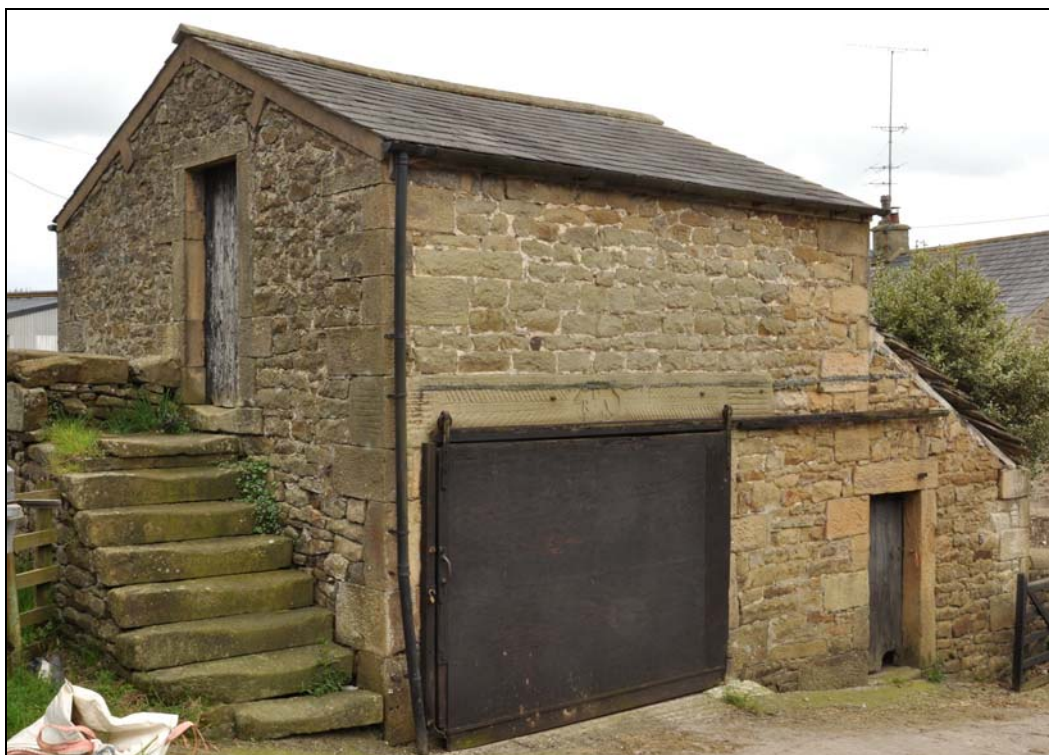
- 5.7 The small trap-house to the south-west of the barn is also of heritage significance as a largely unaltered farm building, in this case bearing the date of 1820 and the initials “D R A”, likely to be those of a relative of the builder of the farmhouse in the 1770s. It is of generally similar materials to those used in the barn, although the lintel inscribed with the date is further decorated by parallel tooling along its length. It too has been re-roofed with blue slate, though a lean-to along the north-west gable retains the original stone slates. Associated with it

is the garden boundary wall with half-round coping, and a flight of stone steps to the south-east gable, beneath which is a cavity perhaps used as a dog kennel at one time. There appear to have been no changes to any of the openings, and the window in the north-west gable retains a small paned frame, perhaps original, though the main doorway now has a 20th century sliding door fitted.

- 5.8 The trap-house is important as a little altered and dated structure of the early 19th century, which was clearly important to the farm as housing its owners means of transport. Its small scale and pleasing aesthetic qualities within the group contribute to its significance.

Photo 8: Trap-house

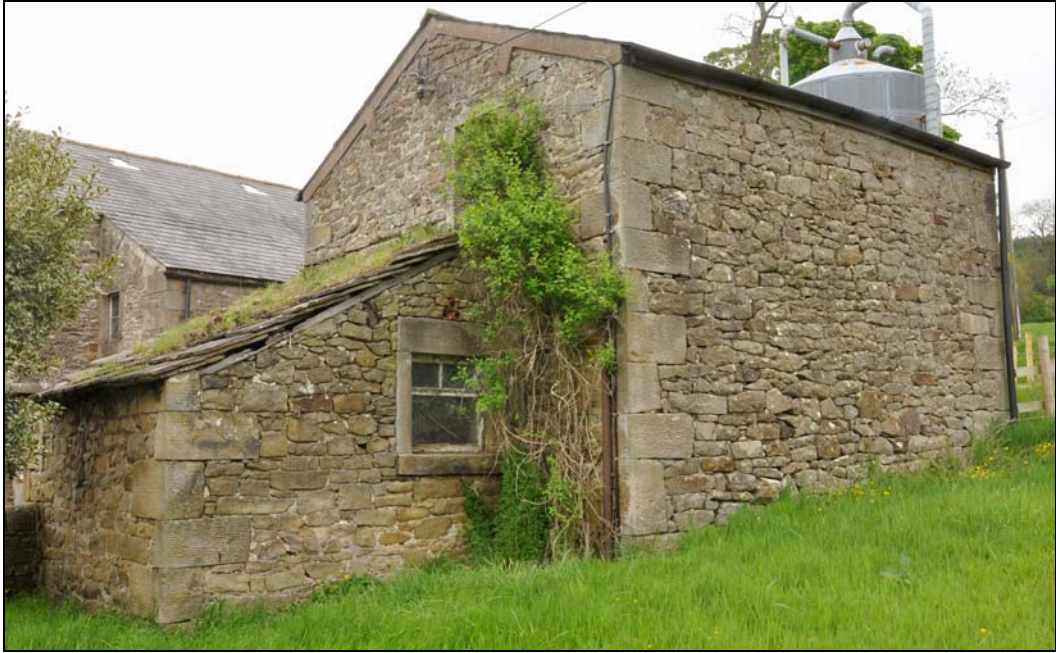
Photo 9: Trap-house

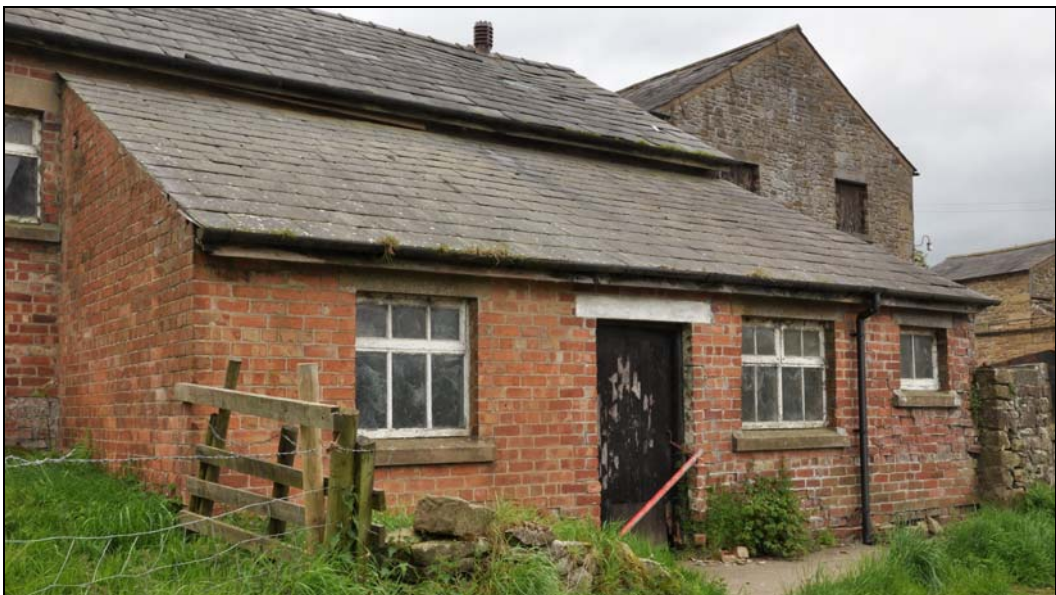
5.10 The shippon is of modest size by today's standards, being five bays long, and has a blue slate roof with salt-glazed ventilation cowls and roof lights; there is a regular pattern of hopper-opening windows to both sides, and a large doorway in the south side (probably enlarged) allows tractor access. Attached to the west side, perhaps as an additional phase, is a lean-to on a lower level and accessible from the roadside, which would have contained machinery and milk storage space. The interior of the main part of the building has modern cubicles, which probably replaced more traditional stalls in which the cows would have been tied.

Photo 10: Brick shippon

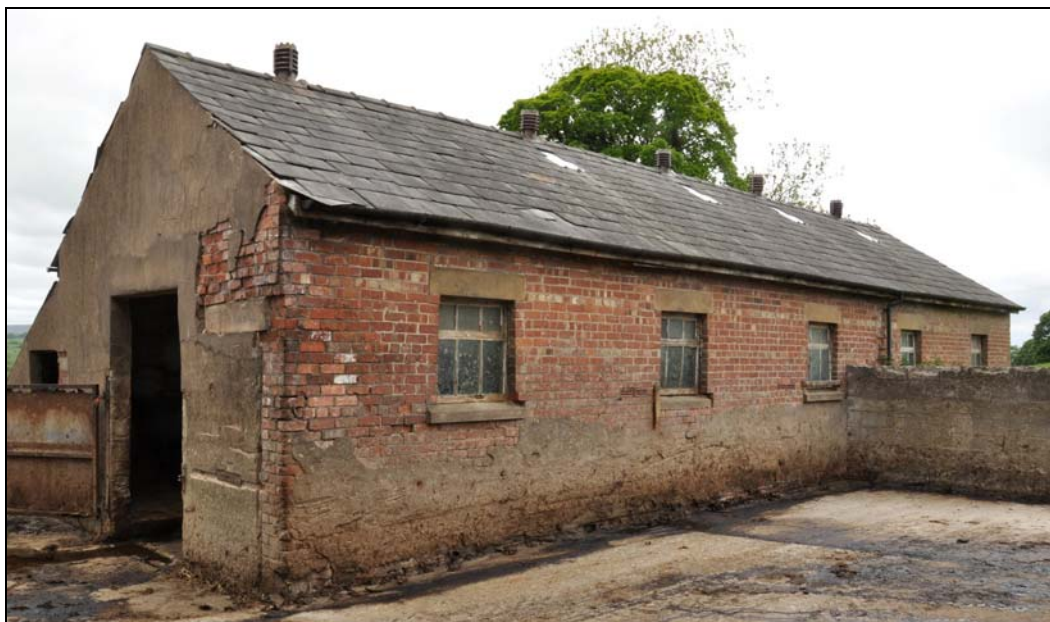
Photo 11: Brick shippon

- 5.11 The shippon also has heritage value as a member of the group of farm buildings and as a relatively recent agricultural structure, of a type which is however now generally redundant. Such buildings are no less subject to attrition and demolition as older types of farm buildings, and this is an externally well-preserved example, which stands discrete from but alongside other members of the group.
