**BAT SURVEY AT -  
14 BEVERLEY DRIVE  
WHALLEY**

**DATE AND TIME OF VISIT  
13th July 2017 3.30pm**

**REFERENCE. Mr Byrne**

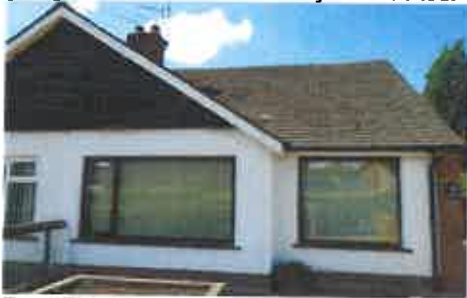
Front Elevation

The house is a semi detached bungalow probably dating from 1950's with a more recent attached flat roofed garage to the side. It is currently uninhabited.

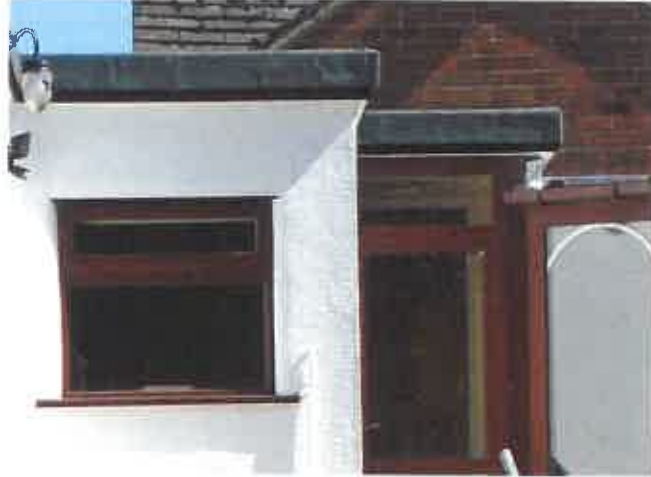
The walls are Brick with a smooth render finish to the front elevation of the house and garage, The gable and rear walls are brick.

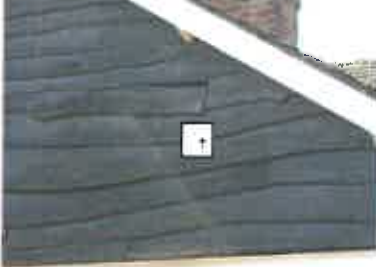
The brickwork and render walls are in good condition with no access points or cracks and crevices. The timber boarded gable on the front elevation has one board which has slipped ( see photo below) , close inspection with the aid of an endoscope indicated that it is not currently used nor are there signs that it has previously been used by bats. However future use could not be discounted so to avoid any potential future disturbance to bats it is recommended that the gap be blocked to prevent any entry prior to the work commencing.

No mitigation is essential however as mentioned before it is recommended that the gap in the timber boarding be mended or blocked and the slipped tile be repositioned to prevent any entry prior to the work commencing. Particular care should be taken anyway when removing the roof tiles and the timber boarding.

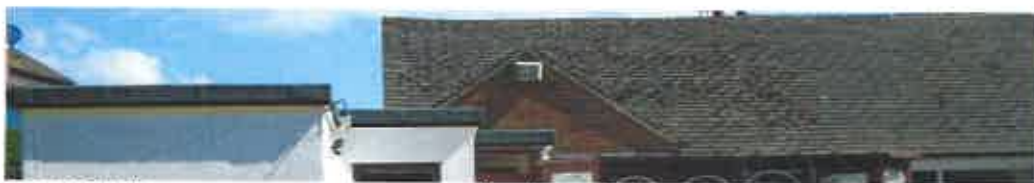
The roof is a tiled pitch with a shared gable to the front elevation and a smaller gable to the rear. The gable roof abutment is pointed and to the front elevation the eaves have gutters on brackets. The conservatory has a plastic flat roof with lead flashings at the abutment with the house wall. The garage has a felt flat roof with a slight over hang at the eaves.

Garage felt flat

Rear house pitch and gable

The garage roof is in perfect condition with no gaps or possible access points in the felt or in the eaves overhang. The conservatory roof is in reasonable condition, it does not provide potential roost habitat for bats. The lead flashing at the abutment with the wall is tight fitting and does not provide any crevices or access points.

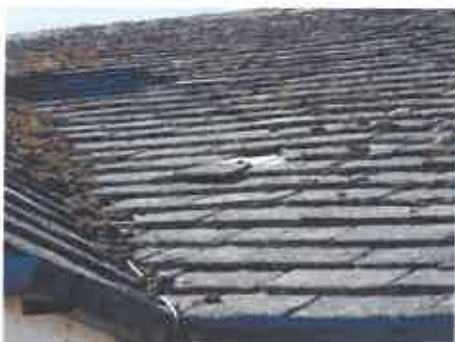
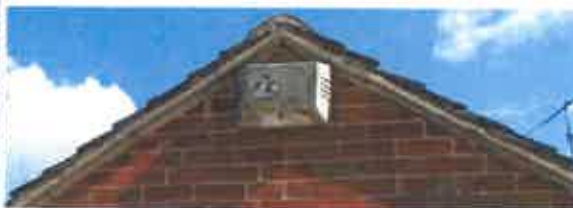
The tiled roof had significant moss coverage particularly at the laps, generally there were no gaps or crevices which could be used by bats. There is however one slipped tile in the front ( south east ) elevation as shown below. Inspection with Binoculars was carried out for signs of grease or scratch marks at the gap entrance, no evidence of use was found. The gable is pointed with no gaps, cracks or crevices. The gutter eaves were inspected for any gaps or access points, none could be found.

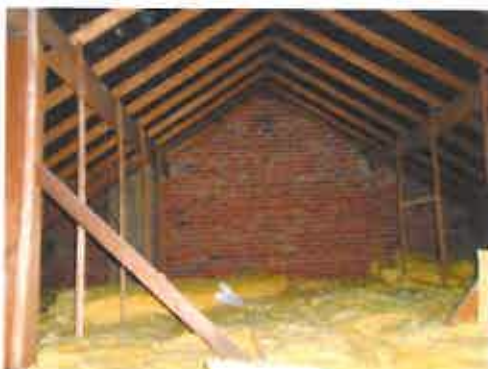
House roof void

The house roof void was accessed via a loft ladder the space was insulated at ceiling/floor level with quilt. The structure was timber purlins, rafters, felt and hangers all in very good condition. The quilt was clean and free from any droppings or insect remains. The space is not currently used by bats and has no evidence to indicate it has ever been used in the past, it provides sub optimal roost and forage potential.

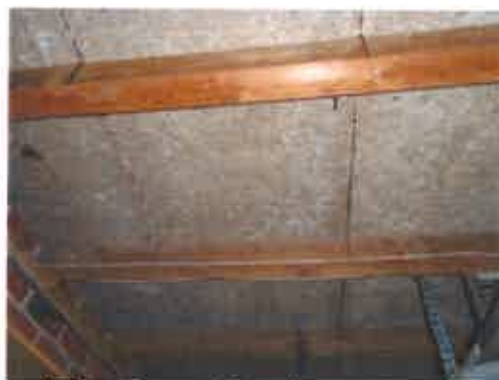
underside of garage flat roof

The garage does not have an enclosed roof space, the timber joists and OSB board were examined from the under side. The space provides sub optimal roost and forage potential, it is inaccessible to bats.
