Protected Species Survey: Stone barn at Eatough's Farm, Fleet Street Lane, Ribchester, PR3 3XE

# EUROPEAN PROTECTED SPECIES (EPS)

Eatough's Farm Barn. Fleet Street Lane, Ribchester, PR3 3XE (NGR: SD 629 358)

**Dusk emergence survey: 30 August 2014: Dawn re-entry and swarming survey 6 September 2014**

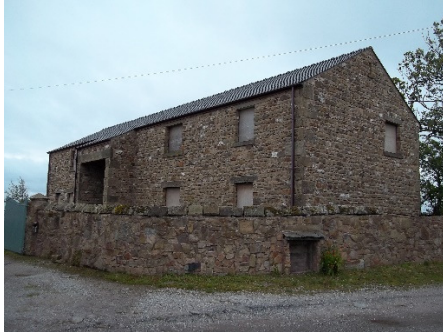
Figure 1: Barn (Building #5)

Building 5: the detached stone barn is a substantial two storey structure with well-pointed external stonework and block-lined cavity wall construction. The barn has been recently re-roofed with a timber trussed duo-pitched slate roof lined with a breathable membrane. There is a large open portal on the front elevation (figure 12), all windows are currently boarded.

Although the ridge tiles and roof verges appears to be relatively well-sealed, there are gaps between the timber fascia boards and stonework. Internally there are gaps between the roofing spars and the blockwork walls at both gable ends and there is evidence of fresh bat droppings on sills, block walls and timber spars throughout the building.

This building has moderate to high potential for attracting bats.

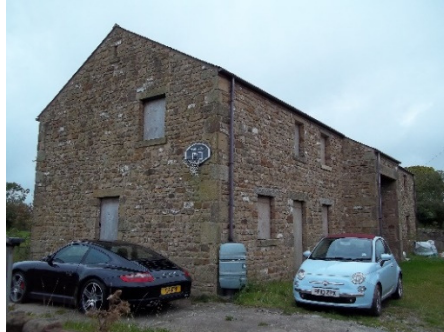
Figure 2:

- (1) Building 1 - small outbuilding (as shown in figure 4)
- (2) Building 2 - sheds / old pens (as shown in figure 9)
- (3) Building 3 - small outbuilding (as shown in figures 5 to 8)
- (4) Building 4 – farmhouse (not included within the development)
- (5) Building 5 - large stone barn (as shown in figures 1 to 3 and 10 to 12)

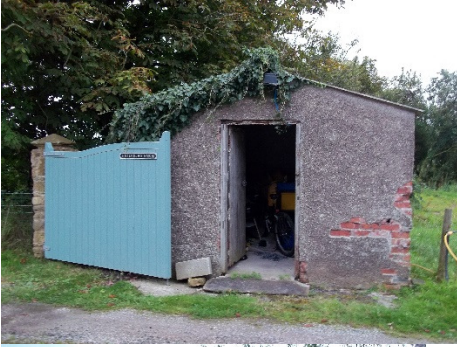
Figure 4: Building #1

Building 1: a small shed with rendered brick construction and duo-pitched cement-asbestos sheet roof and single glazed window; the building is partly clad in ivy and is in poor structural condition (to be demolished), low potential for supporting roosting bats.

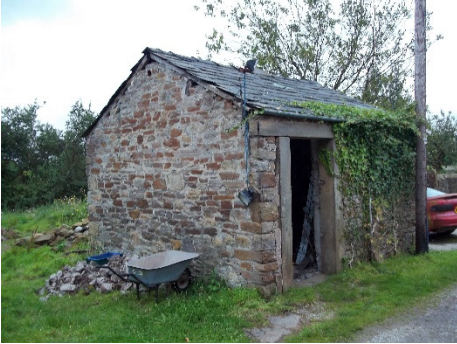
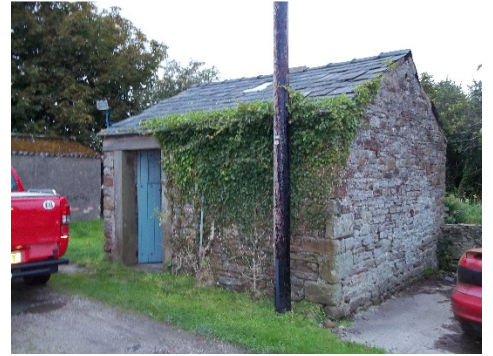
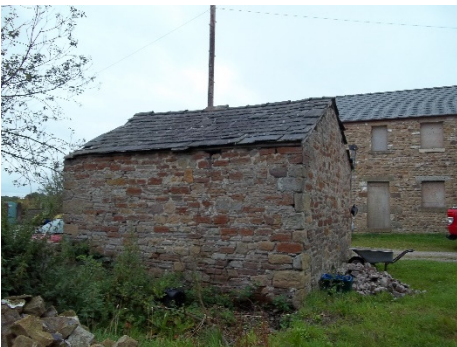
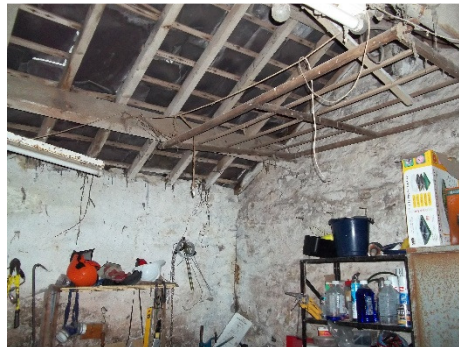
Figure 5: Building #3

Building 3: a stone-built shed with duo-pitched slate roof, the roof is unlined and has one small glass slip skylight. Both gable end are mortar-pointed although there are many gaps in the masonry and along the roof verges. The building is currently used as a tool shed; it is partly covered in ivy and requires renovation. Although the building has very low potential for supporting breeding bats, however there is some (low) potential for attracting solitary roosting / perching bats.

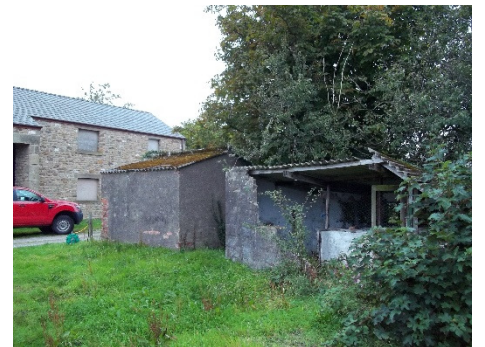
Figure 9: Building #2 on right

Building 2: a small block walled shed / animal pen with concrete floor and mono-pitched cement-asbestos sheet roof now partly collapsed – very low potential for supporting roosting bats.

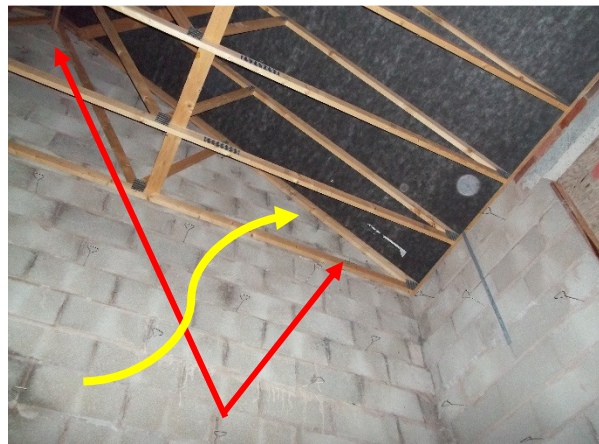
Figure 14: SW gable end

Bat droppings were located on blockwork walls at both gable ends and over surfaces of stored materials; obvious accumulations of droppings were noted on timber roof spars below the both gable apexes and internal roof verges (figures 13 and 14). A small accumulation of fresh droppings was also found on the woodpile in the extreme SW corner of the building.

At least one bat (species unknown) was seen emerging and re-entering a roost behind one of the timber rafters on the SE gable (yellow arrow in figure 14).
