EPS METHOD STATEMENT

European Protected Species – (Bats)

Newton Hall, Newton-in-Bowland, Clitheroe, BB7 3DY

April 2017

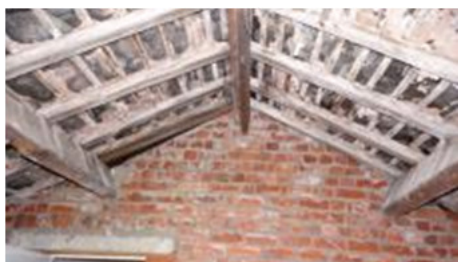
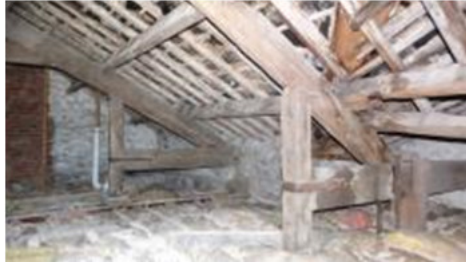
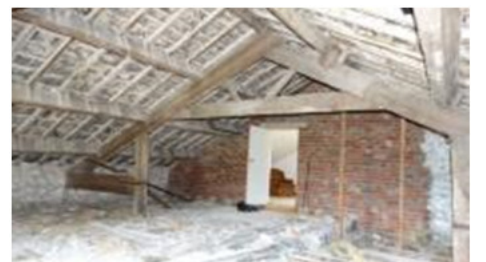
The presence of bat droppings throughout the roof void (figures 5 to 7) indicates relatively low frequency roost activity by whiskered bats (*Myotis mystacinus*) - the species being confirmed by DNA sampling.

The quantity of droppings within the main roof void suggests occasional roosting activity by low numbers of bats or solitary individuals. There is no evidence that area is used as a maternity roost by whiskered bats.

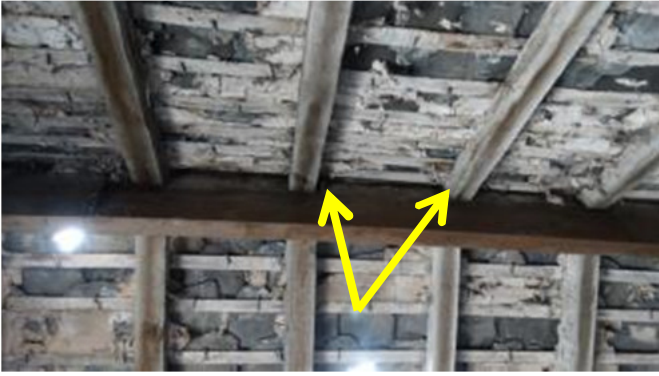
Figure 8: roost points along ridge board in main roof void

- (i) At the intersection of the timber rafters with the main ridge board (figure 8).
- (ii) Within a small cavity above the brick partition wall and door to hallway close to apex roof (figure 9).
- (iii) Within some of the mortice joints (figures 10 and 11)

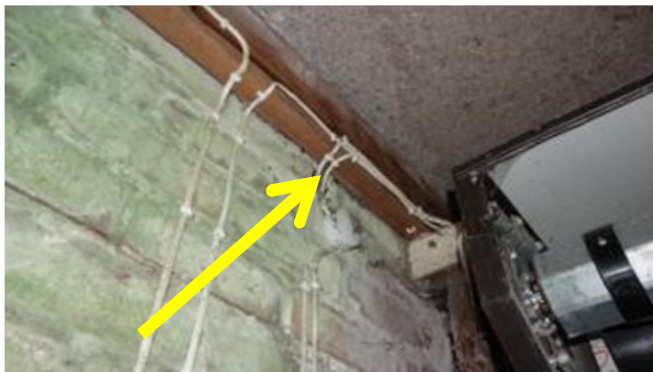
Figure 12: droppings on internal wall in garage.

A small number of bat droppings were also located within the garage on the floor and on a wall in the NW corner close to the door mechanism (figure12) corresponding with a small external gap in boards (figure13).

The droppings located on the wall inside the garage (15/09/16) were relatively fresh, suggesting they were recent in origin and probably indicating roosting activity during the previous season (spring / summer 2016).

3. Replacement roost (garage)	<p>The new build to replace the existing garage will require design modifications to accommodate new roosting opportunities for crevice-dwelling bats (ie. pipistrelles) to compensate for the loss of the roosting area in the garage wall (figs. 12 / 13).</p> <p>Recommended: 1 No. Schwegler Bat Box 1FE 00748/3 wood concrete , 300mm wide x 300mm high x 100mm deep located at eaves level or just below apex as appropriate to final design. Additionally, provide 2 No. apex mortar gaps 18mm x 165mm providing access points between roofing membrane and roof tiles / slates.</p> <p>Avoid the use of Breathable Roofing Membranes (BRM's) in the area where bats are likely to roost (ie. within 2000 mm of the roost entrances). Timber sarking / bitumen roofing felts are preferable to BRB's which can result in fluffing of fine fibres by bats resulting in bats becoming entangled in these fibres.</p> <p><i>(Designing for Biodiversity. A technical guide for new and existing buildings. 2nd Edition p.121 RIBA Publishing. (ISBN 978 1 85946 491 5) 2013. pp. 107 / 115</i></p>

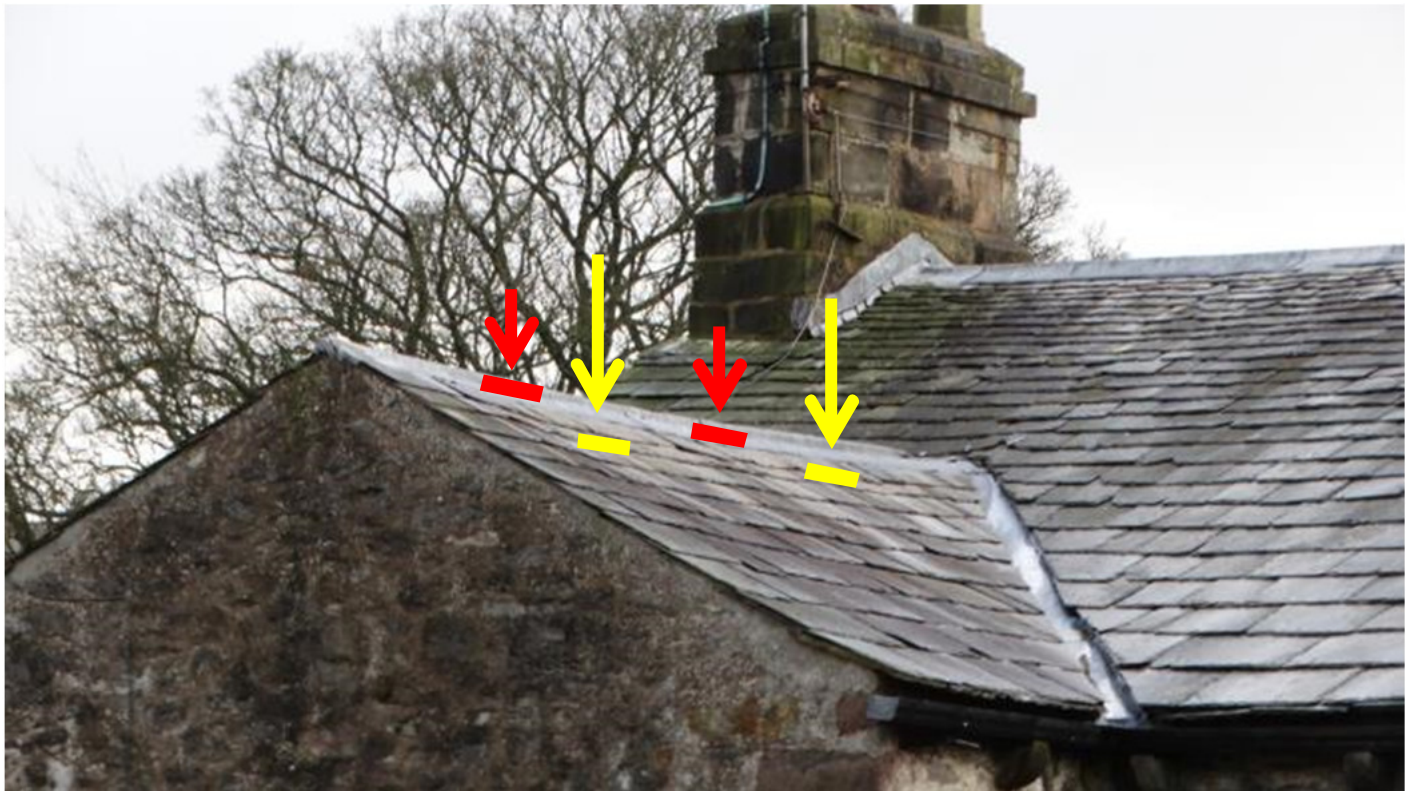
Figure 15: Approximate location of access tiles on roof of dedicated bat loft. RED: Ridge tile access x 2 YELLOW: slate access x4

5. Providing bat access points	<p>(1) Bat access tile / slate set 18mm gap x 165mm long with corresponding gap in underlay. 2 no. required on each roof slope above the dedicated bat loft area (total 4 no. access tiles / slates)</p> <p>(2) 2 No. ridge access tiles required in the roof directly above the dedicated</p>

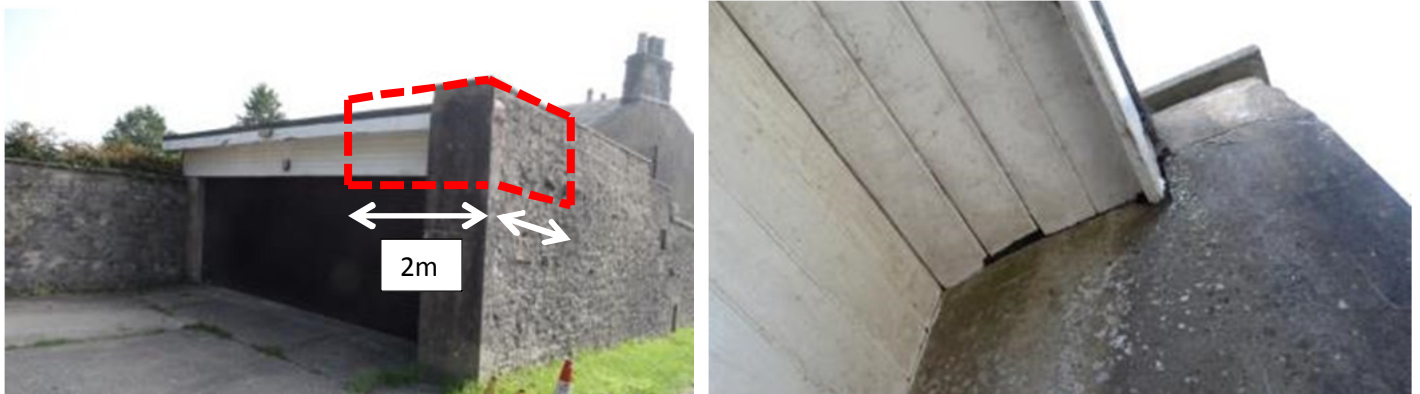
Figure 16: Critical area of garage roof requiring hand removal of materials within 2m of the roost area.

Before any demolition begins, an ecologist / surveyor should inspect the roost site and carry out a supervised removal / demolition of the roof in case any bats are present. Soft demolition will require removal of the roofing felt, fascia and soffit within 2m of the bat roost by hand. Lifting of roof materials must be carried out with care to prevent possible crushing and injury to bats.

The removal of roofing materials prior to demolition of the garage must be supervised by an ecologist to ensure that in the unlikely event of bats being exposed / disturbed, the bats are safely handled and removed from site.
