**BAT SURVEY AT -
11 VICTORIA COURT
CHATBURN**

DATE AND TIME OF VISIT
20th June 2017 5.45 pm

REFERENCE. Mr & Mrs B Hardman

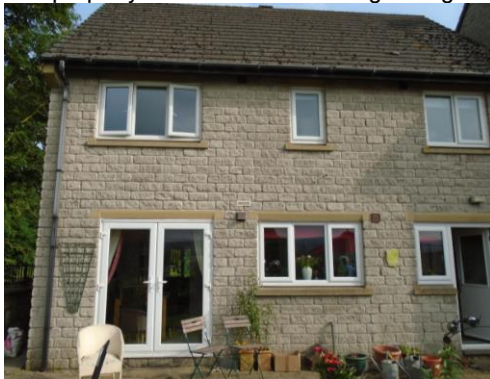
The property is a detached dwelling dating from 1990's

Rear north west elevation

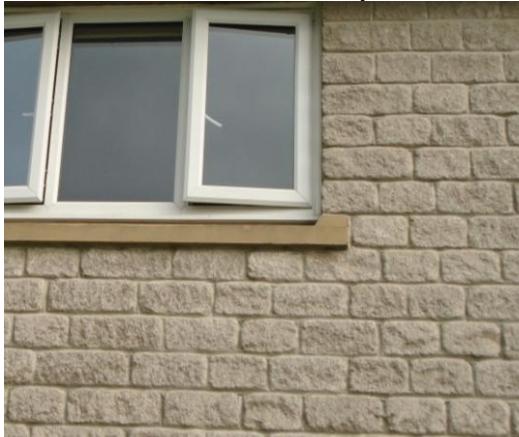
The walls are coursed stone cavity construction.

The stone walls are in perfect condition with no possible access points.

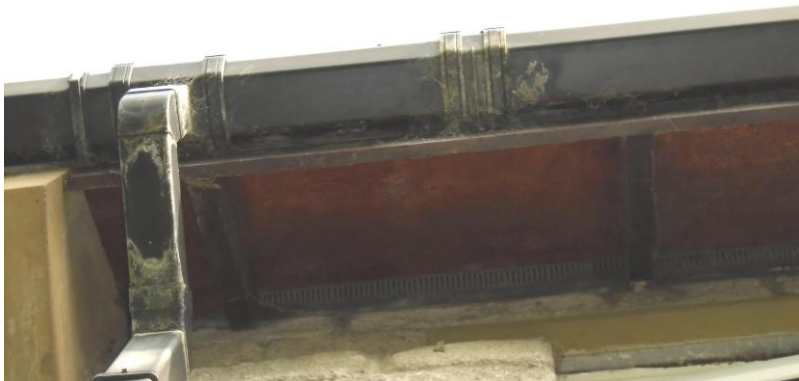
The house has a pitched roof with a tile finish. There is an overhang at the eaves, the fascias and soffits are timber, a upvc ventilation grille is in the soffit at the abutment with the wall. The gable has a upvc verge trim

Soffit where the bay window will be positioned

The soffits and verge are also tight fitting with no access points or gaps which bats could use. The roof structure is in accessible to bats.

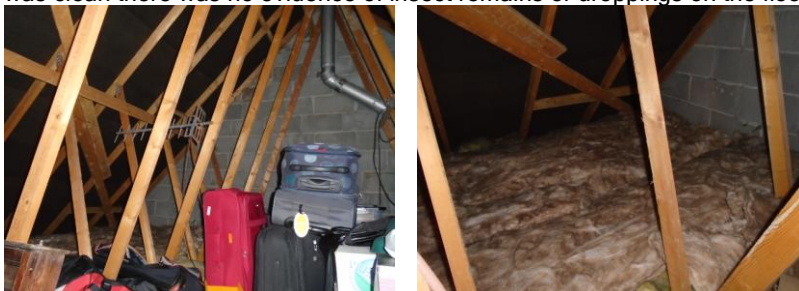
The roof void was accessible via a ceiling hatch, It was a timber truss rafter construction with felt over all in very good condition. The centre of the floor was boarded for storage use with insulation quilt to either side. The space was clean there was no evidence of insect remains or droppings on the floor surfaces.

The roof space had no evidence of bat access, none of the above evidence was found
