**BAT SURVEY AT -**

WARDS FOLD FARM  
ABBOTTS BROW  
MELLOR

DATE AND TIME OF VISIT  
9<sup>th</sup> June 2017 10.00 pm

REFERENCE NO. 5325

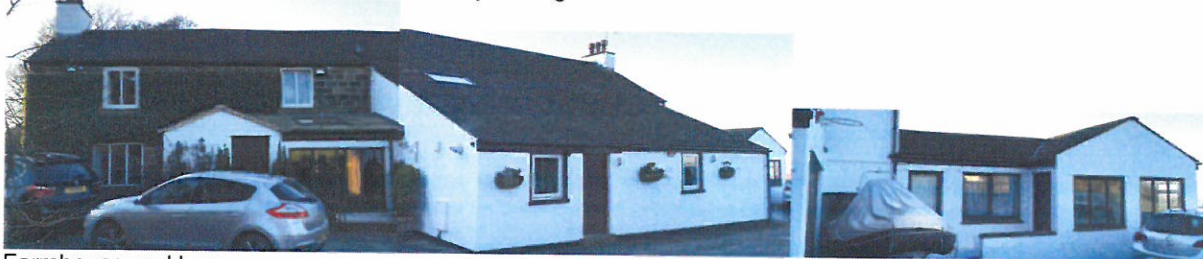
The property is a detached farmhouse and barn which has been converted to form one dwelling with a granny annex, the original conversion took place approx 40 years ago. The annex at the northern end of the building is single storey and was constructed about 15 years ago.

Farmhouse and barn

granny flat annex East elevation

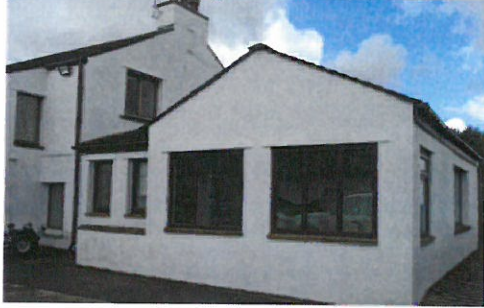
The annex to be demolished is constructed in cavity blockwork with a smooth white painted render finish the gable wall of the adjacent house wall also has a render finish.

The walls provide no access points, cracks or crevices which have the potential to be used by bats.

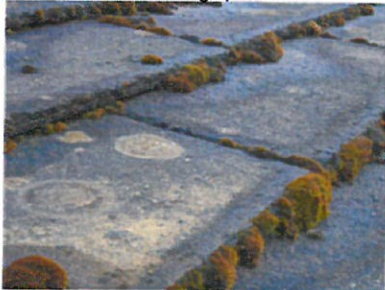
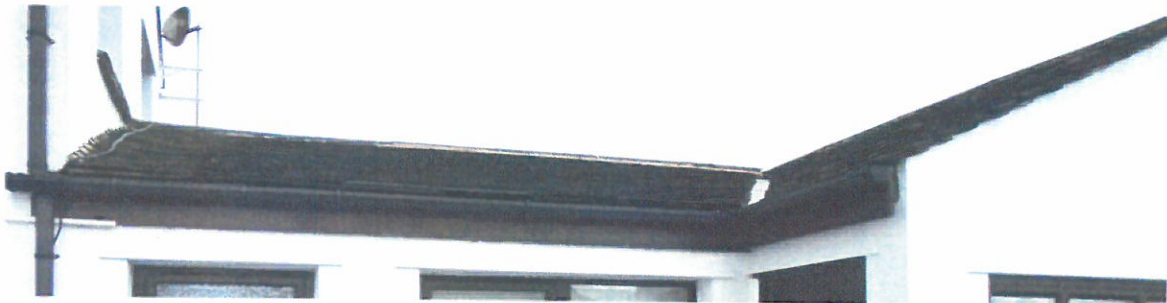
The roof is pitched with valleys at the abutment of roofs. The finish is tile and the fascias are fixed to the rafter ends with a small gap behind.

Potential access points ↑

All the tiles are tight fitting with areas having moss growth at the joints. The ridge tiles and the lead flashing are in reasonable order and do not provide any access points for bats.

The fascias however do provide a void behind, the void was possible to inspect closely, over the door there are some gaps at the abutment of the wall with the roof providing a crevice which has the potential as a roost opportunity.

Any gaps at the eaves level need to be blocked as soon as possible particularly above the door opening. It is also recommended that bat habitat be included in the scheme see next page.

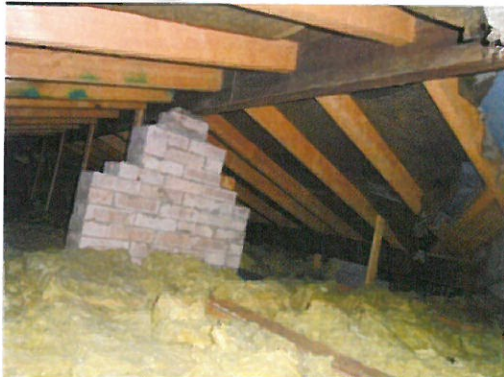
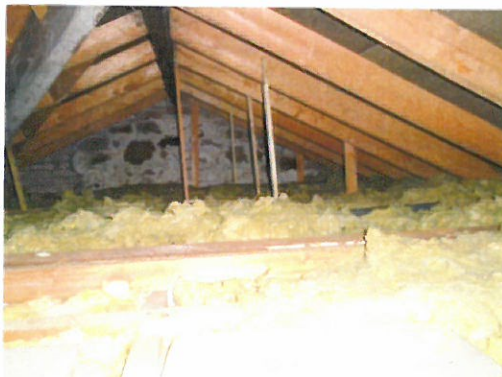
The roof void is accessed via a hatch, the felt and rafters are in good condition with no rot, cracks or crevices. The space is clean and dry with no dropping or insect remain evidence on the quilt insulation between the joists.

The roof space did not have any evidence of current or past bat presence.

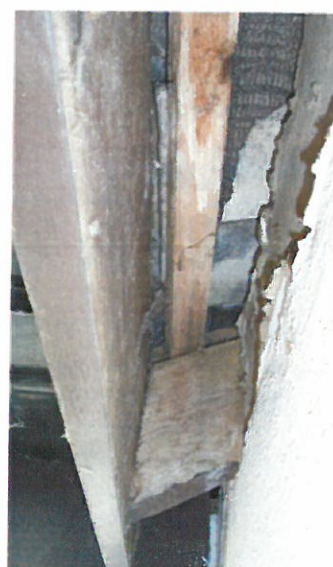
The focus of the survey was on the annex being affected by the application. The exterior was examined closely for dropping, staining or grease marks at potential access points. The fascia void was mainly covered by old cobwebs and there were no signs of grease marks or staining indicating entry by bats, however close examination of the section above the door did reveal a single dropping and urine stain on the wall below. The void behind the fascia was further examined for any indication of entry to the gap between roof covering and the wall. No grease marks or any further dropping evidence( the dropping found was old ) was found indicating frequent or current use. Based on the evidence found it appears that a single bat has used the building in the past but currently there are no signs to indicate presence.

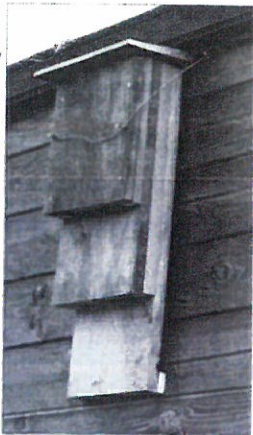
Kent bat box

Simple to construct, self-cleaning and low maintenance.

The only critical measurement is the width of the crevices—these should be no larger than suggested. Other measurements are approximate.

Box to be made from untreated rough-sawn timbers  
Timber should be c.20mm thick  
The box should be rainproof and draught-free  
Crevices can be between 15 and 25 mm wide  
Fixing may be by use of brackets, durable bands or wires
