**LAND TO THE REAR OF  
ST PAUL'S TERRACE  
CLITHEROE**

**PHASE 1 PRELIMINARY  
RISK ASSESSMENT**

Date: 18<sup>th</sup> March 2015  
Ref: LKC 15 1072

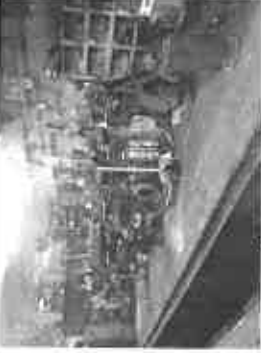
- The eastern garage is currently being used for domestic spraying and repair of vehicles.
- Many oil containers were noted within the garage and significant oil spillages / leakages were noted on the hardstood concrete flooring.

Multiple garages used for the maintenance, repair and domestic paint spraying of vehicles were noted onsite, containing an inspection pit, oil containers, spray paint tins and oil barrels. Evidence of fuel/oil spillages / leakages was present on the site surface within the garages.

| <p>Photograph 1 (P1)<br/>View of the two garages present onsite used for wagon maintenance</p> | <p>Photograph 2 (P2)<br/>Inspection pit and many oil spillages / leakages noted on the concrete</p> | <p>Photograph 3 (P3)<br/>Spraying and repair of vehicles within the eastern garage</p> | <p>Photograph 4 (P4)<br/>Storage of parts and large diesel tank within the eastern garage</p> | <p>Photograph 5 (P5)<br/>Western open area to the garage with a possible corrugated ACM roof</p> | <p>Photograph 6 (P6)<br/>Used oil barrels to the west of the garages</p> | <p>Photograph 7 (P7)<br/>Above ground diesel tank and grid cover to below ground waste oil tank</p> | <p>Photograph 8 (P8)<br/>Above ground diesel tank to the south east of the garages on a brick bund</p> | <p>Photograph 9 (P9)<br/>Fuel pump noted east of the garages - fuel staining noted up the building</p> | <p>Photograph 10 (P10)<br/>View of allotment area to the west of the site with sheds and raised planters</p> | <p>Photograph 11 (P11)<br/>Domestic garage to the far west corner of the site</p> | <p>Photograph 12 (P12)<br/>Evidence of drains and services present across the site</p> |

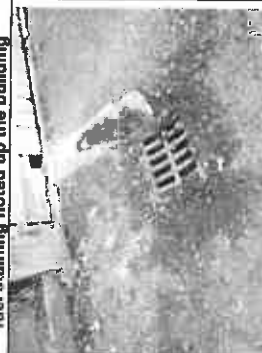
- Underground services, including manhole covers were noted onsite.
- The remainder of the site was noted as a hardstood tarmacadam access road.
