**BAT SURVEY AT -
22 SHIREBURN AVENUE
CLITHEROE**

DATE AND TIME OF VISIT
26th Oct 2017 5.30pm

REFERENCE. Mr Bone

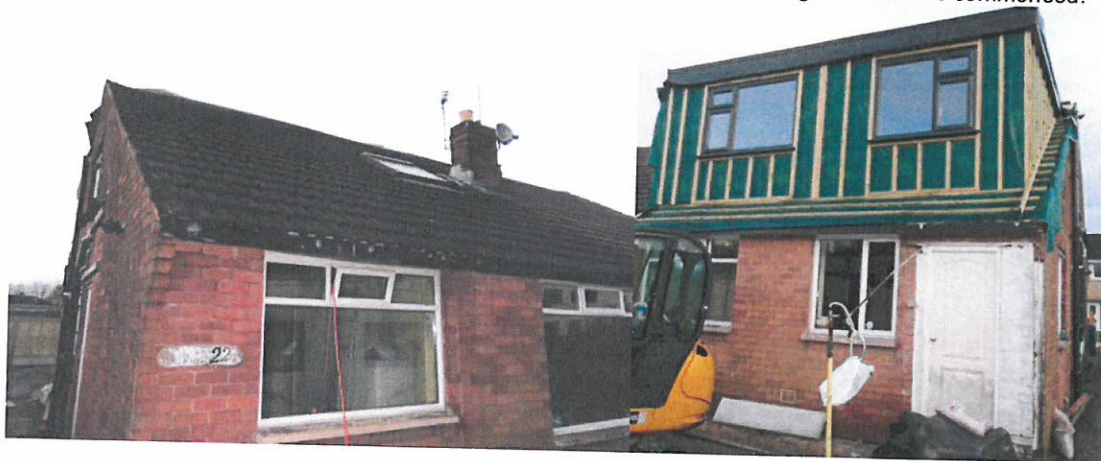
TYPE OF BUILDING

The property is a semi detached dormer bungalow. The dormers are on the rear elevation and are currently being refurbished due to water ingress. It is currently uninhabited and some clearing out work has commenced.

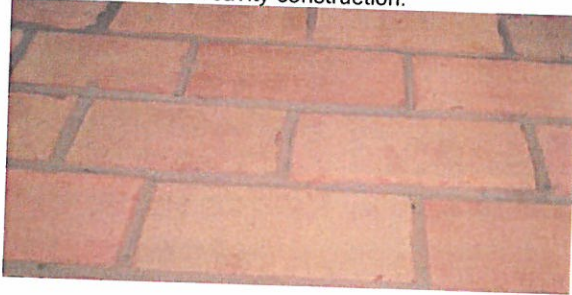
WALL CONSTRUCTION

The walls are brick cavity construction.

BAT ACCESS POINTS IN WALLS

No access points, cracks or crevices, the walls are in reasonable condition.

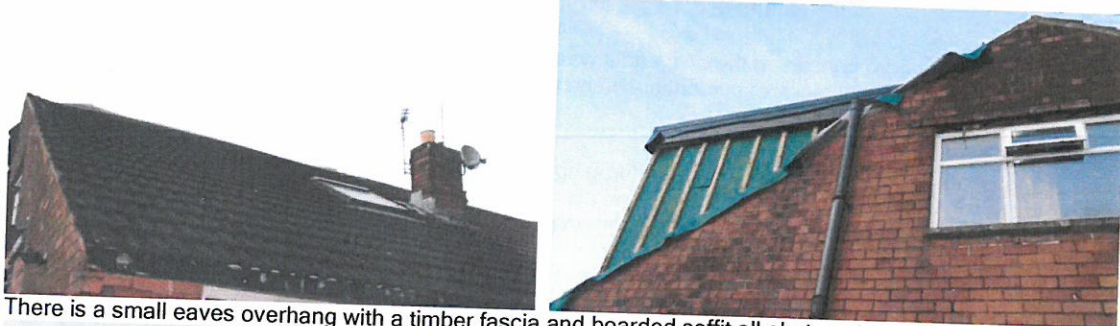
ROOF CONSTRUCTION

The roof is pitched with a profile tile finish there is a roof window in the front south east elevation. There is a large dormer window in the rear north west elevation which is currently being refurbished.

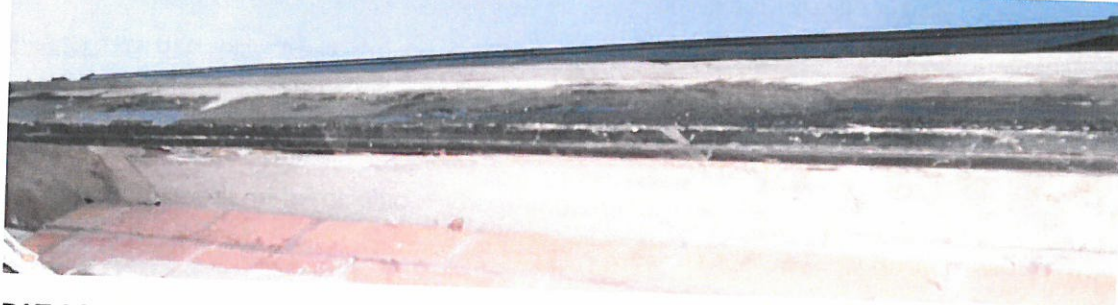
There is a small eaves overhang with a timber fascia and boarded soffit all abutments are tight fitting

BAT ACCESS POINTS IN ROOF

The front pitch is in good condition with all the tiles tight fitting and the verge being pointed. The rear elevation has been stripped to repair the dormer, no bats were found during this work.

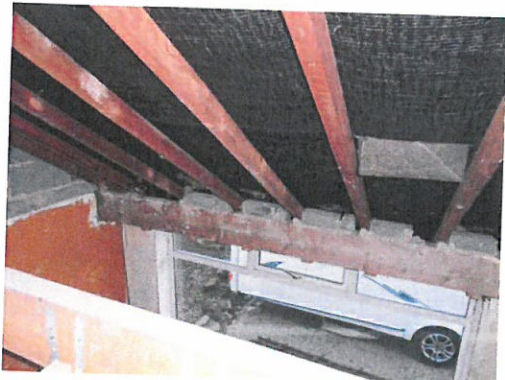
ROOF SPACE

The roof was timber rafters , purlins and felt with battens . There is no enclosed roof void as some ceilings have been removed all the structure was examined closely there were no signs of any current or past use by bats .
