DRAFT DESIGN AND ACCESS STATEMENT

Stanworth House,
York Street, Clitheroe

Proposed internal alterations and external additions
Job No: 2317 - October 2016

STANWORTH HOUSE, YORK STREET, CLITHEROE, LANCASHIRE:**HERITAGE STATEMENT****1 Introduction**

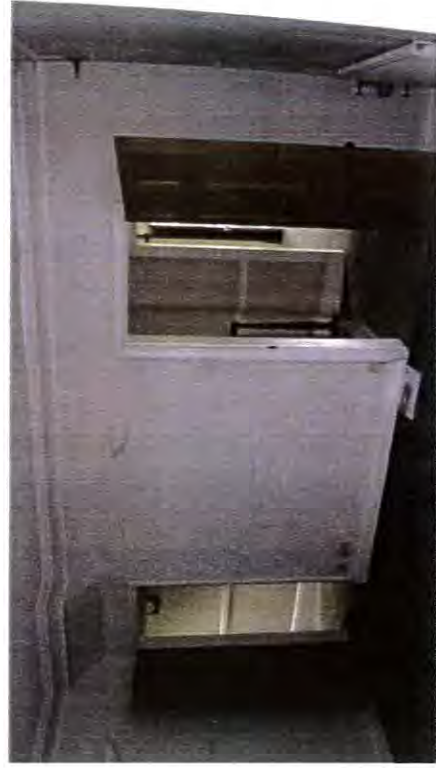
Existing front Lounge (left hand door is proposed to be infilled).

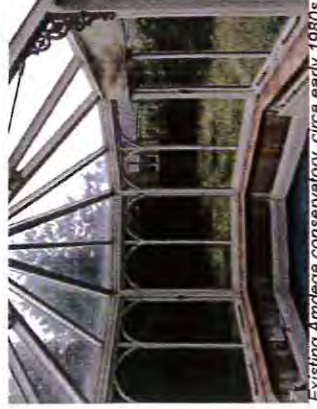
Existing Ardega conservatory, circa early 1980s.

- 6.4 The present conservatory is entirely an addition of *circa* 1992, and did not replace any historic structure, though it is not certain whether there was formerly an access into the present kitchen here, or if the present one was enlarged from a window at that time.

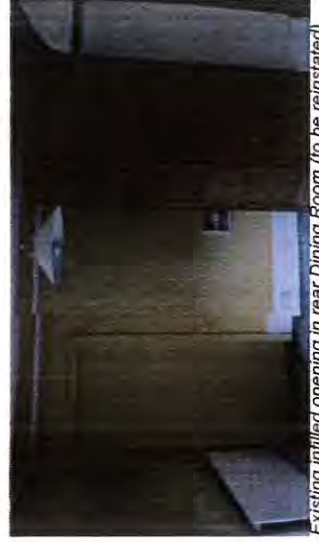
Existing infilled opening in rear Dining Room (to be reinstated)

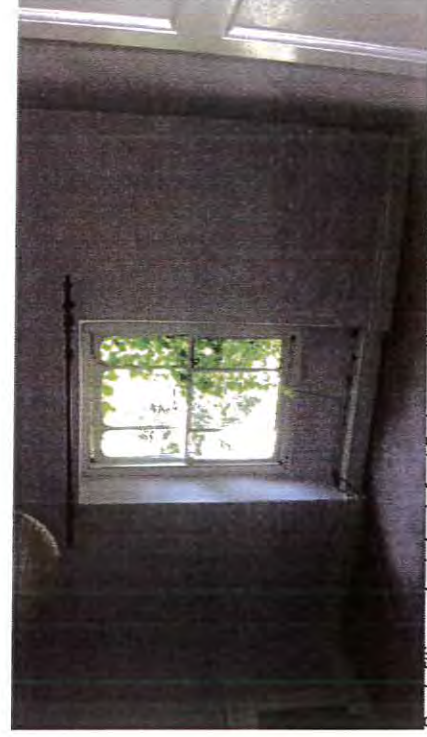
Poorly fitting sash window in front Bedroom, with vegetation ingress.

The property has suffered from being empty and therefore needs various areas of attention to repair roofs, guttering, downpipes, stone detailing, windows (the existing sash windows are ill-fitting and rotten in places), internal finishes, etc., to prevent further deterioration. The external landscape proposals will include essential cutting back and tidying of overgrown areas. The existing tarmac hardstanding / turning head, in front of the detached double garage, will become part of the garden, laid as lawn, with a new turning head formed further back along the driveway. The existing garage will be replaced with a freestanding Summer House on the same footprint. A new block paved path is proposed from the driveway, up to the front Porch and a patio terrace is to be laid adjacent to the new Garden Room extension.

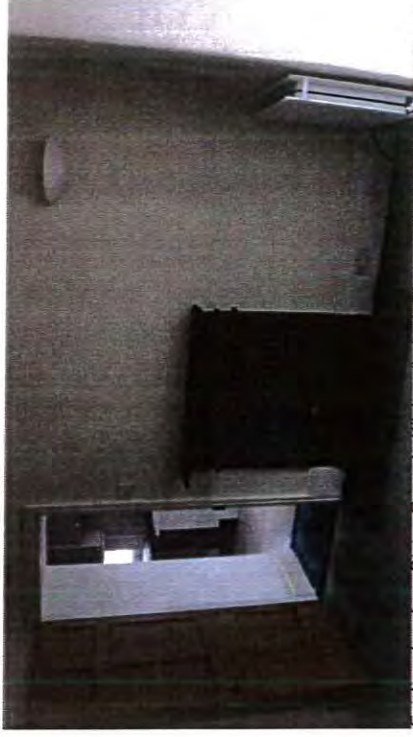
Existing door from Dining Room to Kitchen (to be milled on Kitchen side, with recess or cupboard retained on Dining Room side.

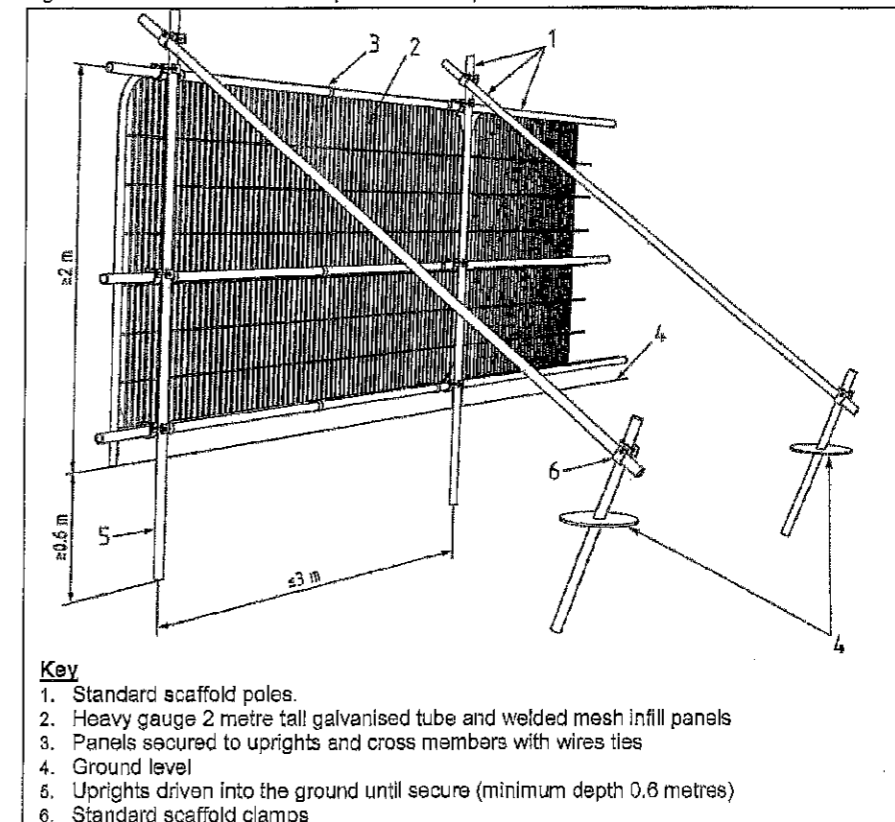
Figure 2: BS5837:2012 Default specification for protective barrier

Type 1 (i.e. 'Default') Temporary Protective Fencing Construction (see Figure 2, below)

1. Temporary protective fencing panels shall be weldmesh "Heras" panels of at least 2.0 metres in height.
2. The panels shall butt together and be securely fixed to a scaffold framework, as per points 3 to 5 of Figure 2, overleaf.

6. No fixing shall be made to any tree and all possible precautions shall be taken to prevent damage to tree roots when locating posts.
7. A 600mm x 300mm warning sign reading "TREE PROTECTION AREA KEEP OUT" (see Figure 1) shall be fixed to every 10.0 metre length of protective fencing.

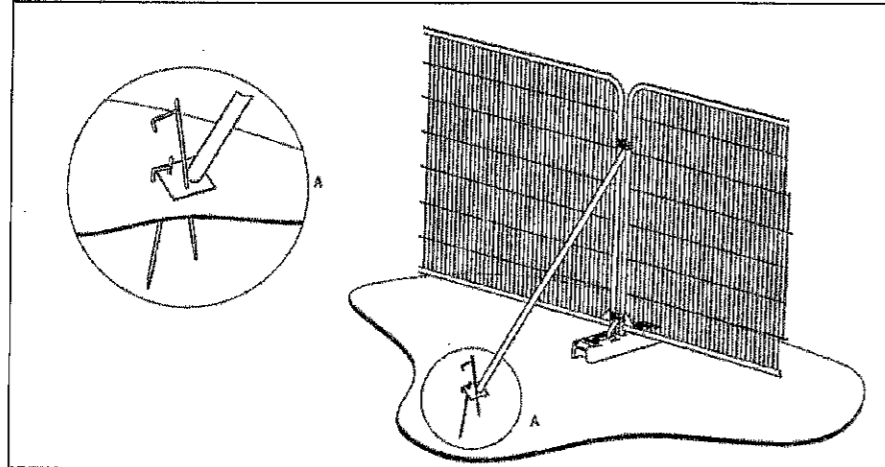
Figure 3(a): Type 2 Fencing (BS5837:2012 above-ground strut stabilising system with ground pins)

Type 2 Temporary Protective Fencing Construction (see Figure 3(a), below)

1. Temporary protective fencing panels shall be weldmesh "Heras" panels of at least 2.0 metres in height.
2. The panels shall stand on rubber or concrete feet.

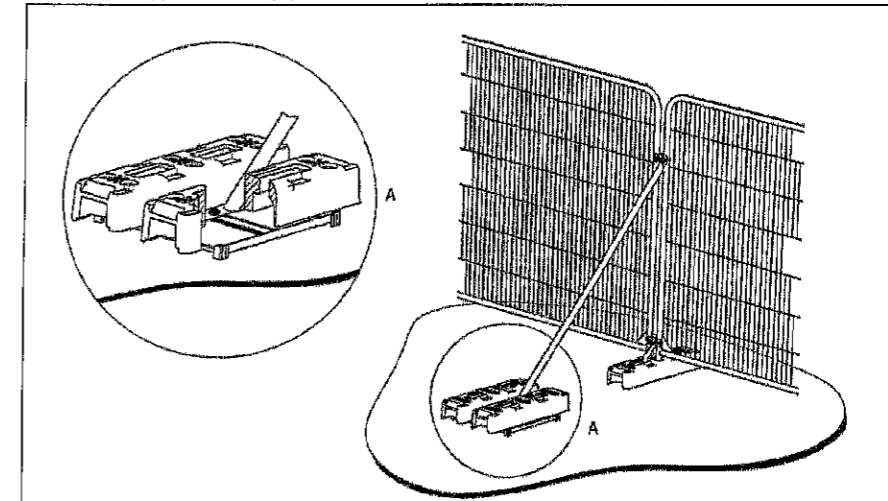
Figure 3(b): Type 3 Fencing (BS5837:2012 above-ground stabilising system with strut on block tray)

Type 3 Temporary Protective Fencing Construction (see Figure 3(b), overleaf)

1. Temporary protective fencing panels shall be weldmesh "Heras" panels of at least 2.0 metres in height.
2. The panels shall stand on rubber or concrete feet.

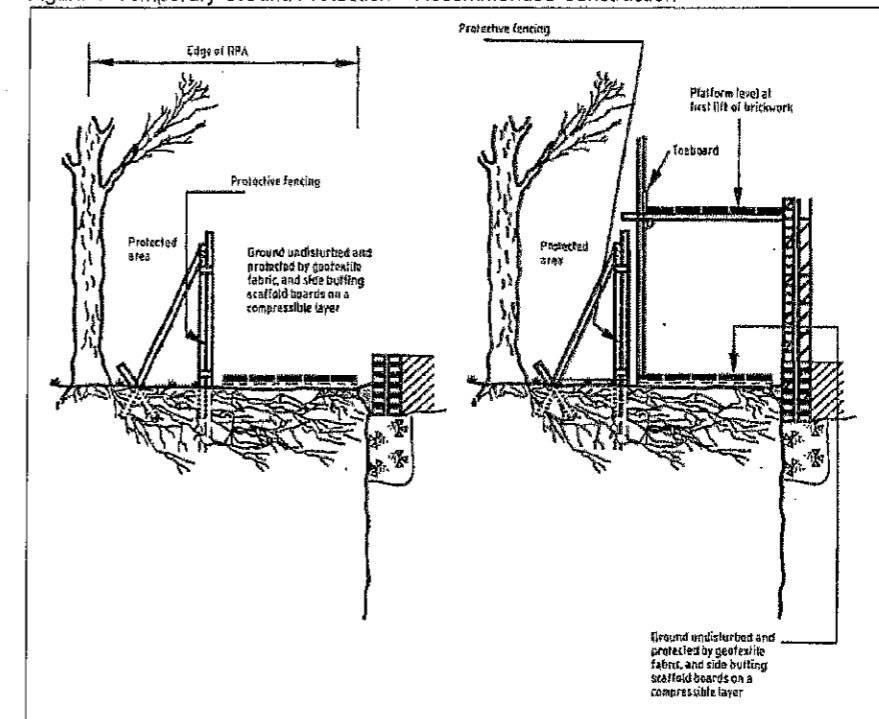
Figure 4: Temporary Ground Protection – Recommended Construction

Temporary Ground Protection

2. Any necessary Temporary Ground Protection areas shall conform to Figure 4, below, unless otherwise agreed with the LPA.
3. The Ground Protection Area shall be left undisturbed and covered by a semi-permeable geotextile membrane which shall, in turn, be covered by a compressible layer consisting of a material such as woodchip.
4. Side-butting scaffold boards shall then be fitted to cover the Ground Protection Area.
5. On completion of installation, and prior to any demolition or construction works, site preparation, excavation or delivery of plant and materials, the Consulting Arboriculturist or the LPA Tree Officer, as agreed, shall inspect the Temporary Ground Protection.
6. The Temporary Ground Protection shall remain in place until completion of the project and only removed following receipt of written permission from the LPA.

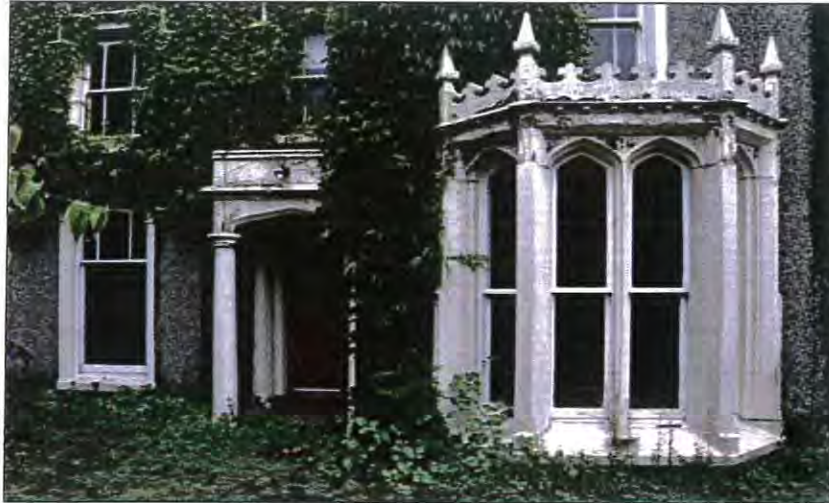
Front elevation

- 6.2 The house faces east and has a strongly Gothic theme, though to some extent this is thought to reflect changes in the second half of the nineteenth century, and it may have been established earlier in that century as a more modest house in a more restrained, possibly classical idiom. It has a three-bay plan: the south bay was originally only a single room deep (the present lounge), with the central entrance hall with modest staircase situated next to it. The adjacent bay to the north breaks forward and appears always to have been two rooms deep (presently a pair of dining rooms), but the northern end of the historic house has a less coherent form and is suggestive of having undergone substantial change. The external form of the present kitchen is unusual and this single storey gabled unit, set back from the front elevation and provided with a parapet, may have been an addition to the original building, or much altered (perhaps reduced in size) during the nineteenth century. At the rear of the house the present "sitting room" is a ground floor extension under a blue slate roof perpendicular to the main house, dating from around the turn of the twentieth century, and appears to have been built in conjunction with the insertion of the stained glass rear window.

- 6.3 A number of external aspects point to historic work at the house having been carried out with salvaged masonry and without a wholly coherent or competent scheme of design, so might perhaps be attributed to the Hargreaves family whose stone mason members would have had a good knowledge of construction methods as well as ready access to stone, whether new or discarded, but perhaps no formal training in design. Work at the house which might be attributed to such origins include the mis-matched dressings for the canted bay window, and the front wall and parapet of the kitchen wing, the window of which incorporates an octagonal capital (such as might have come from a church) over the mullion, visible internally.

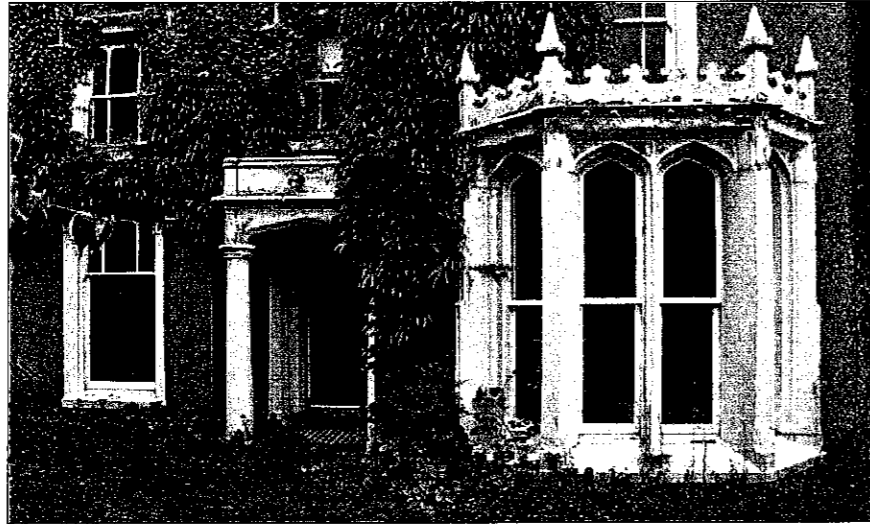
Front elevation

- 6.5 A number of external aspects point to historic work at the house having been carried out with salvaged masonry and without a wholly coherent or competent scheme of design, so might perhaps be attributed to the Hargreaves family whose stone-mason members would have had a good knowledge of construction methods as well as ready access to stone, whether new or discarded, but perhaps no formal training in design. Work at the house which might be attributed to such origins include the mis-matched dressings for the canted bay window, and the front wall and parapet of the kitchen wing, the window of which incorporates an octagonal capital (such as might have come from a church) over the mullion, visible internally.
