**BAT SURVEY AT -  
69 WHALLEY ROAD  
LANGHO**

DATE AND TIME OF VISIT  
9 th Nov 2017 1.30pm

REFERENCE NO. 5463

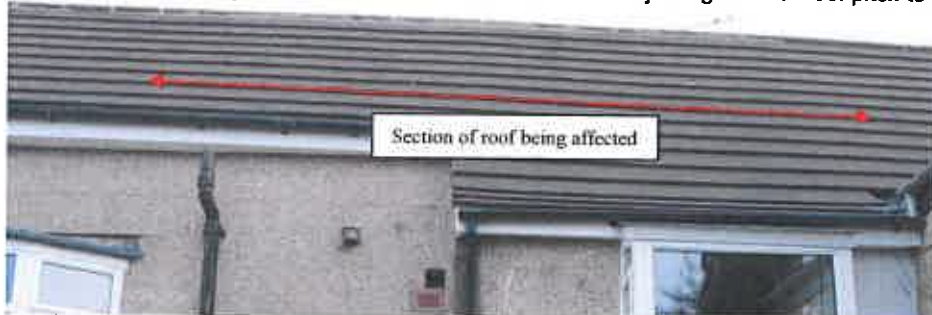
Proposed single storey extension to the rear which involves adjusting the rear roof pitch to extend over new room

Impact of development in relation to potential bat habitat:-  
Roof being disturbed.

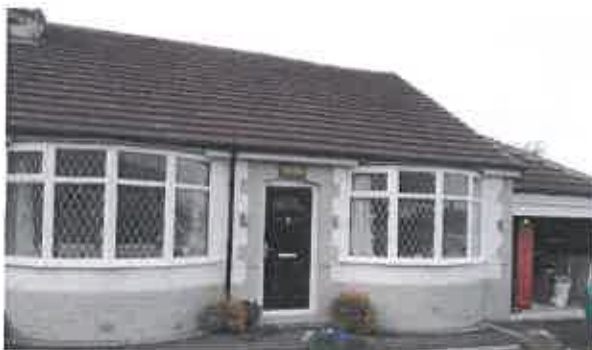
Front elevation to Whalley road

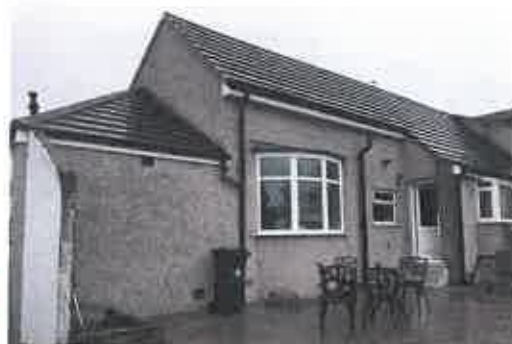
Rear elevation

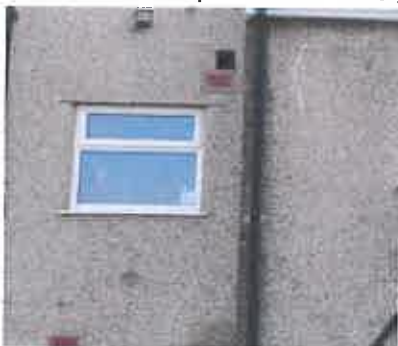
The rear walls are pebble dash render, the front walls are a combination of painted render and painted brick.

Rear elevation

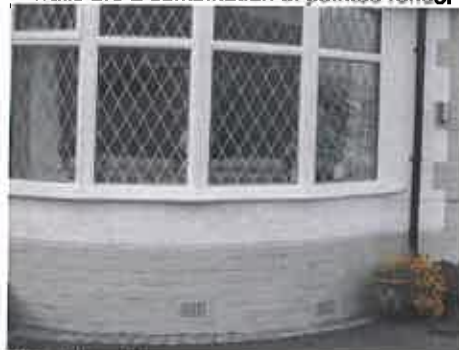
Front elevation

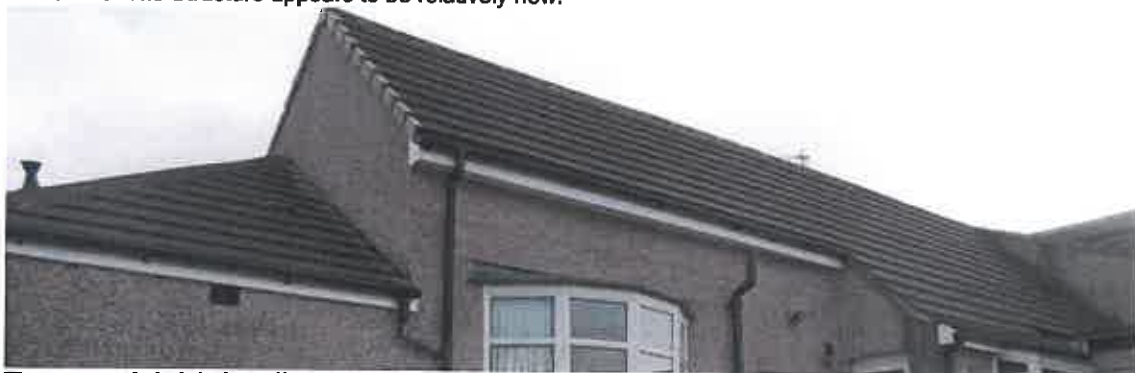
The roof is a conventional pitch over the house section with a small lean to section. The garage is a hipped construction separate from the main roof structure. The roof finish is tile with a upvc verge detail and upvc fascias and soffits. The Structure appears to be relatively new.

The rear roof pitch being affected by the development .

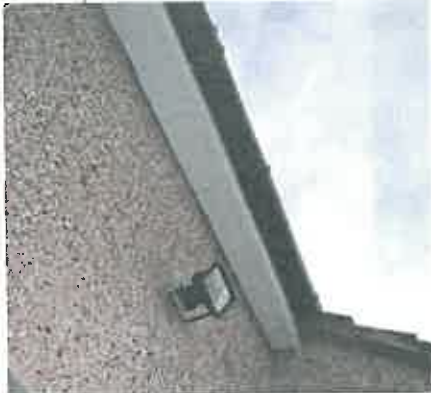
The tiles are tight fitting and in perfect condition. The upvc soffits are very tight fitting, there are no possible access points or crevices for bats to enter this building.

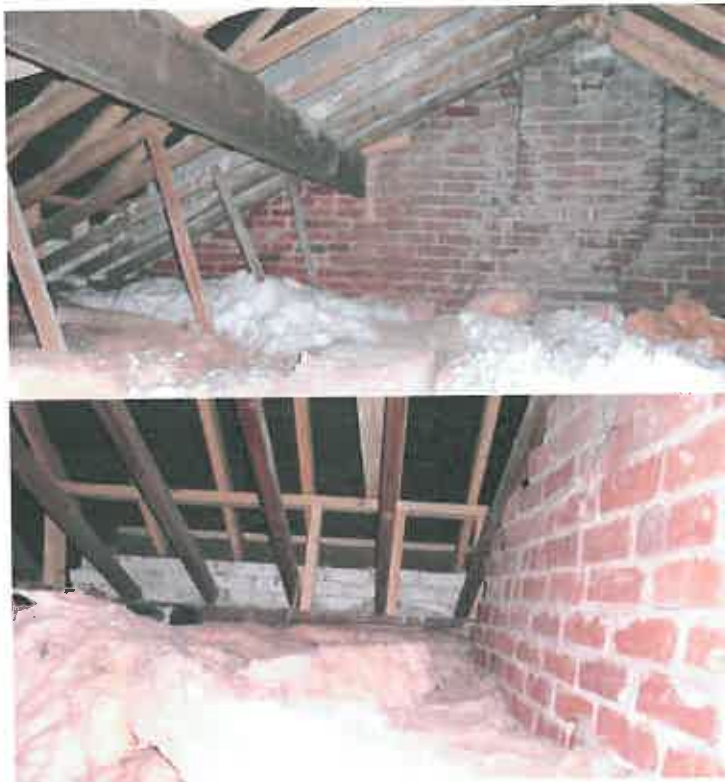
The roof space was accessible via a loft ladder, the original roof structure was timber purlins and rafters but the rear pitch has been altered and the new structure is constructed over the original, see below. The insulation is clean with no signs of dropping or insect remains. The space provides a sub optimal habitat for bats due to its inaccessibility.
