BAT SURVEY AT -

**CIBOLA
PENDLETON**

REFERENCE NO. 4358

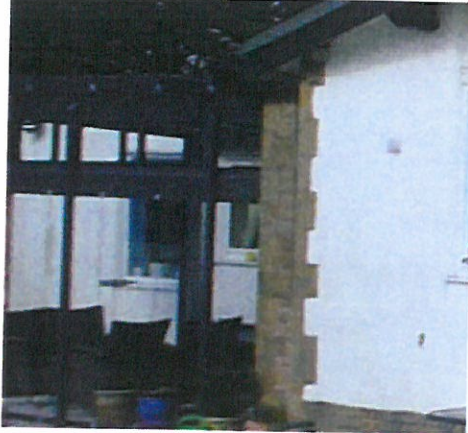
The walls are white painted render with a stone plinth and stone corner details.

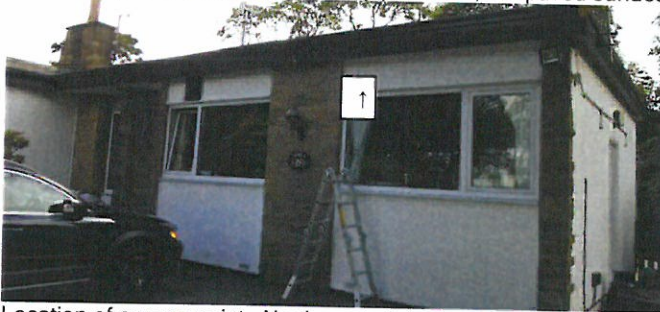
Location of access point North west elevation

The walls are in perfect condition with no cracks or crevices, the stone pointing is in good condition. The walls generally do not provide any potential for roosting bats, however there is a small hole at the abutment of the stone pier, rendered wall and soffit (see below). The opening had grease marks near the opening however internal inspection did not reveal any presence, the paved surface under has no sign of droppings.

A thorough inspection was carried out to determine if bats were currently roosting in the building the result was negative. This roof is not being used for roosting nor does it appear that it is used for hibernation. The grease marks adjacent to the small hole in the n.e elevation could be an indication that bats have used the crevice in the past although currently no bats are present. The replacement of this roof with a more traditional roof structure will not displace any bats nor will the scale of the alterations impact on the commute route over the site. The new roof could potentially provide a more suitable habitat for bats than the existing structure and it is recommended that the provisions outlined below be included in the new structure. I would also recommend that the two potential access points be sealed to prevent any bat access prior to commencement of works.

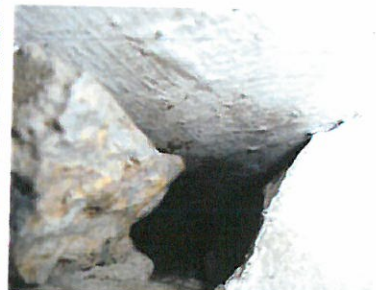
Void at abutment with wall and soffit

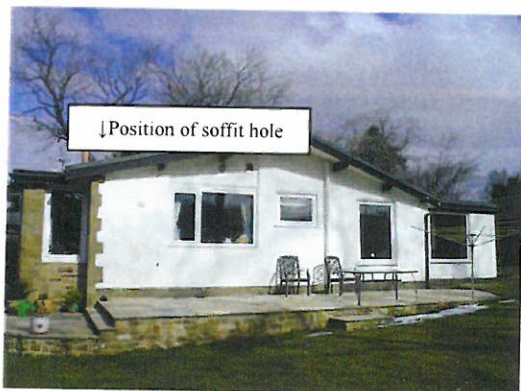
South east elevation

The felt covering is in perfect condition with no access points to the roof void. However the felt at the eaves drip in the north east corner at the abutment with the pitched and flat roof has hardened forming a crevice behind. It was possible to closely inspect and no grease marking or staining or bat presence was detected. The soffits are generally in good condition with no gaps, with the exception of the point indicated below. The access hole was closely examined both internally and externally. There were no grease marks or staining indicators that bats are entering the roof void via the s.e access point and the internal inspection did not reveal any bat presence.
