BAT SURVEY AT

**Study Cottage
23 Church Street
Clitheroe**

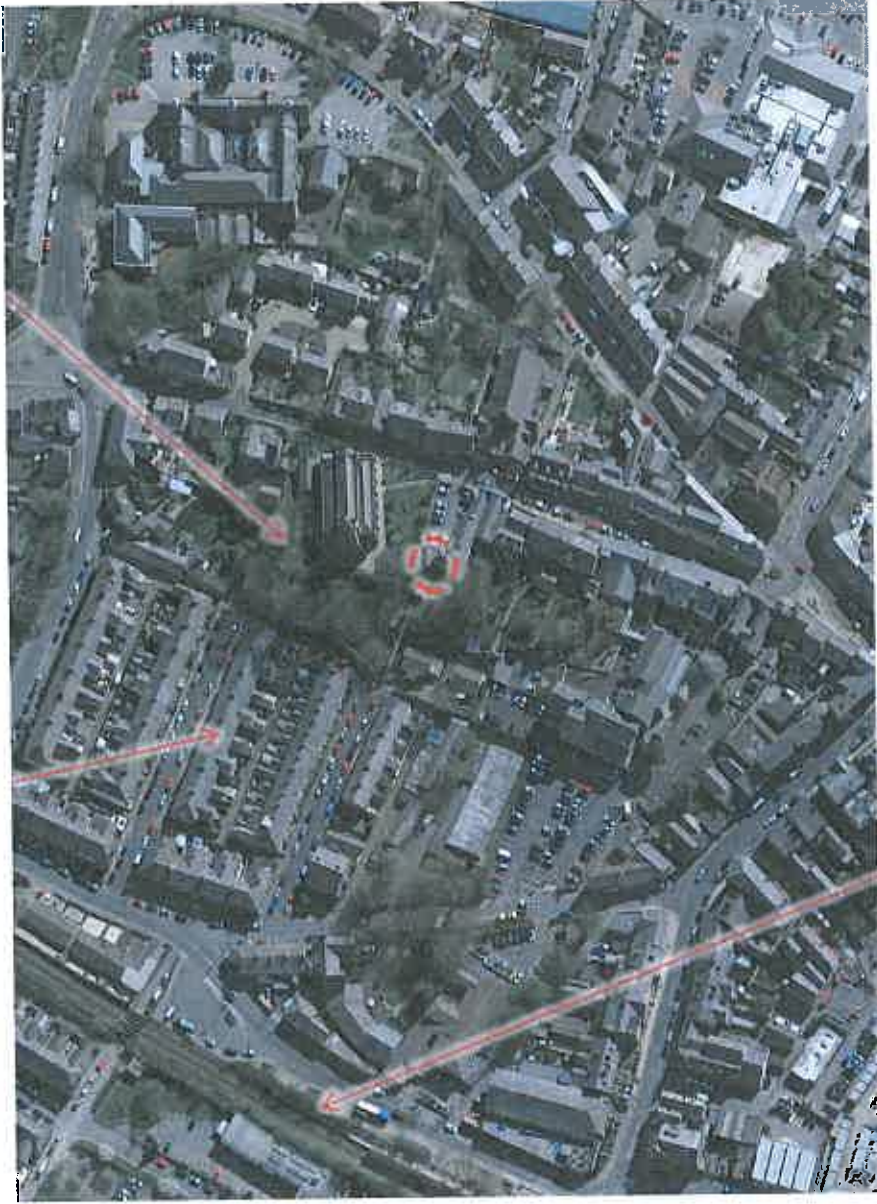
Residential houses are likely to offer negligible foraging potential

A church yard provides low potential for bats to forage adjacent to the site.

A railway line provides a potential bat commuting route locally.

The habitat at and adjacent to the site was assessed from satellite imagery this was then ground truthed, Figure 5.

The habitat on and adjacent to the site identified from satellite images was ground truthed. Details of the habitats found on and adjacent to the site are detailed in Figure 5.

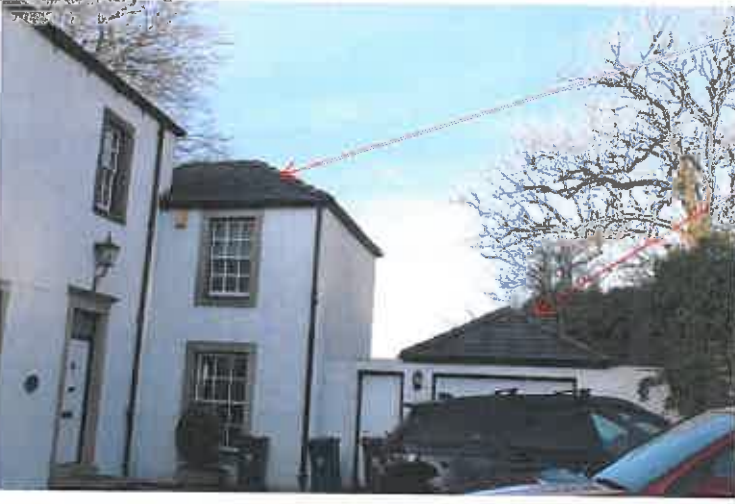
<p>Building 1</p> <p>Building 2</p>

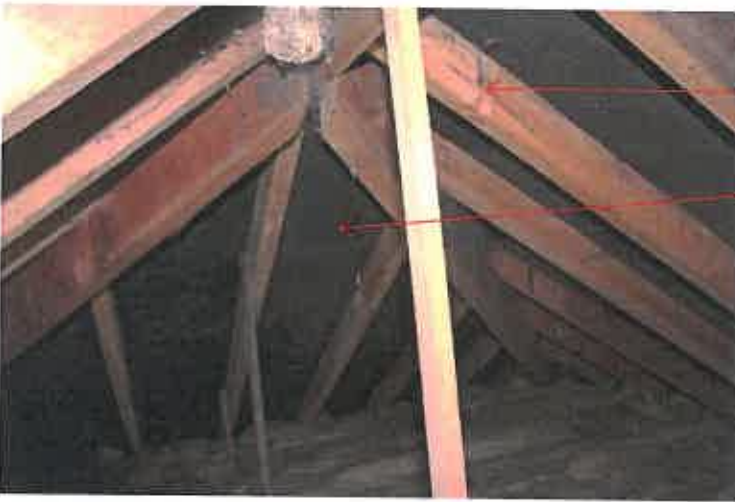
<p>Building 1 - Internal</p> <p>Timber beams in good condition.</p> <p>Felt lining in good condition with no rips or tears.</p>

There are two voids present over the dwelling; only one of these will be altered by the proposals. The structural timbers in the void are in good condition and do not contain any rot or splits suitable for bats to roost or hibernate. The felt lining is also in extremely good condition and does not show any rips or signs of wear which may be associated with use by bats. There is a good covering of insulation in the void. Debris from a small wasp nest was present on this insulation but no evidence of use by bats was found.

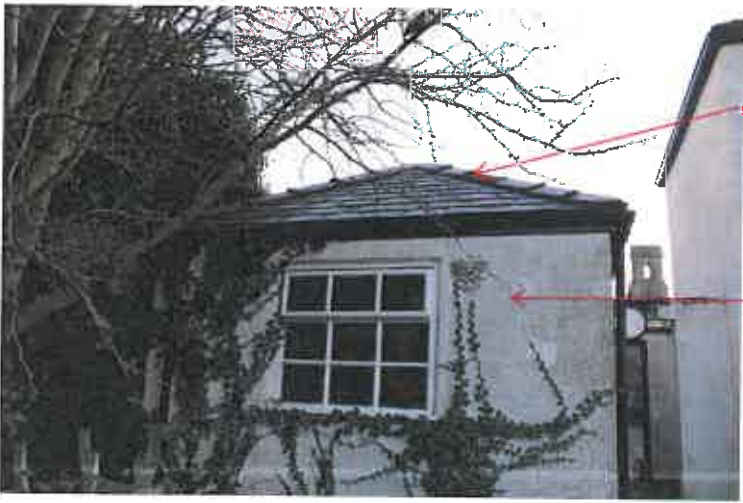
<p>Building 2</p> <p>Gaps present under hip tiles.</p> <p>Render on external walls is in good condition. A window increases the internal light levels.</p>

The garage is roofed with slate and is lined with bitumen felt. Comparative to the dwelling house, the roof of the garage is in poor condition. Gaps are frequent under ridge and hip tiles where mortar is missing, gaps under raised slates are also occasional. Searches of these areas with the use of a high powered torch did not result in any evidence of use by bats being found.

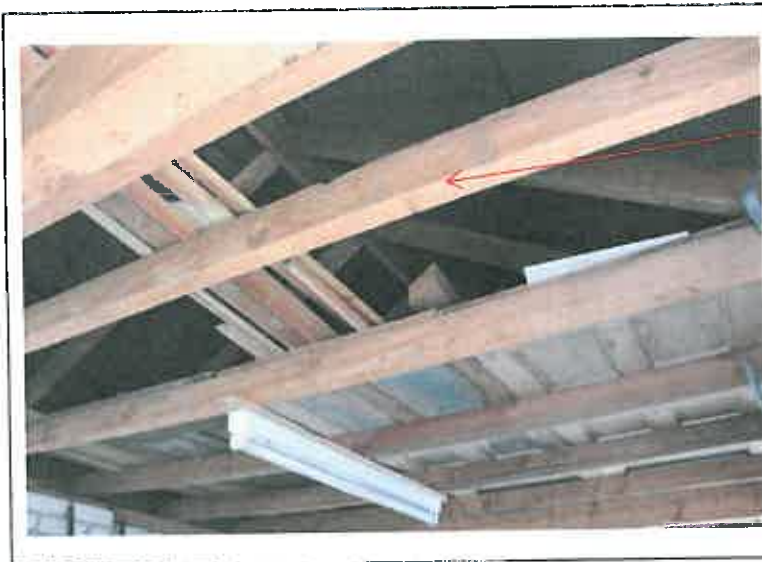
Building 2 - internal

Timber beams in good condition.
