BAT SURVEY AT -
FIELD VIEW
RIBBLESDALE
CLITHEROE

DATE AND TIME OF VISIT
4th Dec 2017 9.30 am

REFERENCE NO. 5308

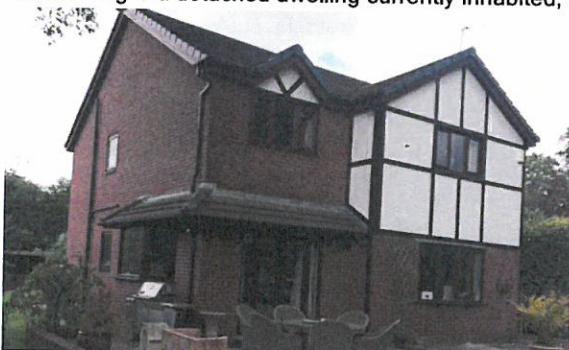
Front S.W elevation

The building is a detached dwelling currently inhabited, it possibly dates from the 1980 's

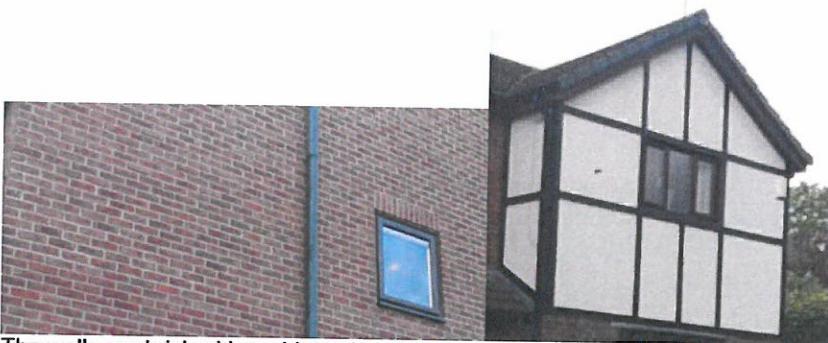
WALL CONSTRUCTION

The walls are brick with a white painted render section on the front gable.

The walls are all in perfect condition with no access points, cracks or crevices.

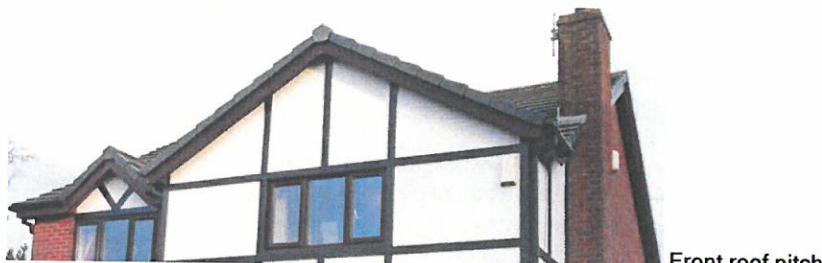
Front roof pitch

The roof is pitched with a gable to a projection on the front elevation and small gable over a window. There is an overhang at the eaves which has upvc boarding soffit and fascias. All verges have a upvc detail. The roof finish is tile.

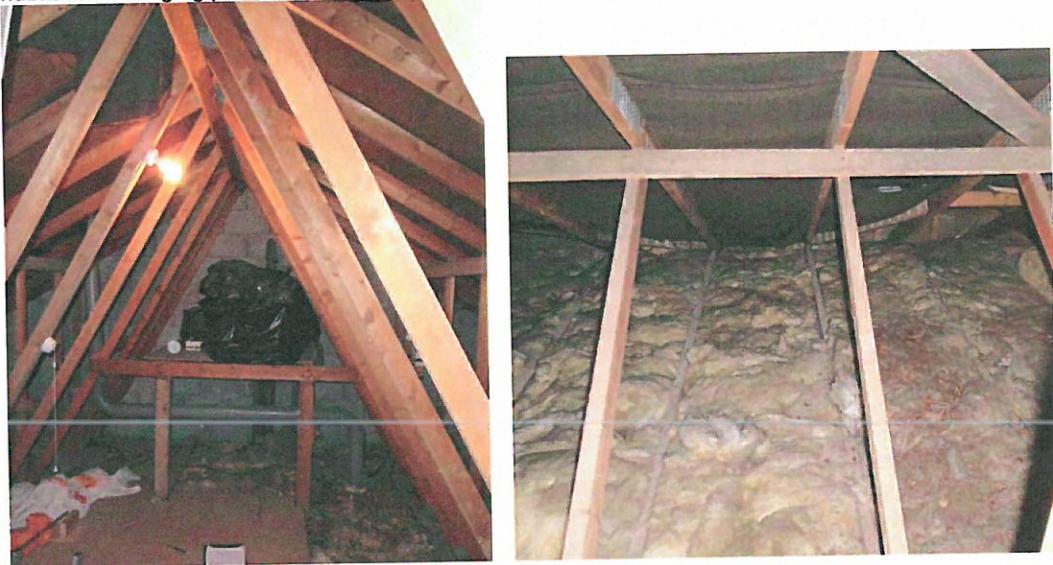
ROOF SPACE

The roof void was accessible via a ceiling hatch, the centre section was boarded over the insulation quilt between joists. The roof is timber truss construction with felt over which was tented over the trusses and in poor condition. The space was draughty, the timbers did not provide any habitat for bats. All the surfaces were clear of dropping and insect evidence the space, access is not possible to the space and it is considered to provide sub optimal habitat and foraging potential for bats.

The roof space was thoroughly examined for all the above listed signs. The quilt was inspected for dropping or feeding evidence, the space is not accessible to bats. No evidence was recorded
