Protected Species Survey: 36, Eastfield Drive, West Bradford, Clitheroe BB7 4TQ

22nd October 2015

Undertaken by Joyce Gillies

Follow Up Survey: 20th April 2017

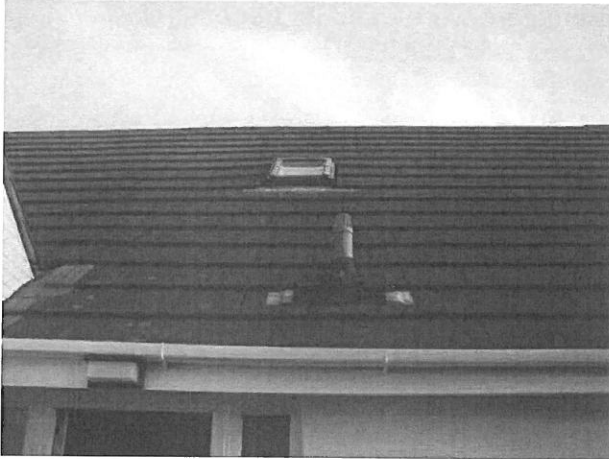
Figure 2 – Side view of roof above front door.

The pitched, tile roof (fig. 2) currently has a small, flat window where the proposed dormer window will be.

Above the front door to the left is a strip of lead at the join with the garage and a little further up is a vent pipe.

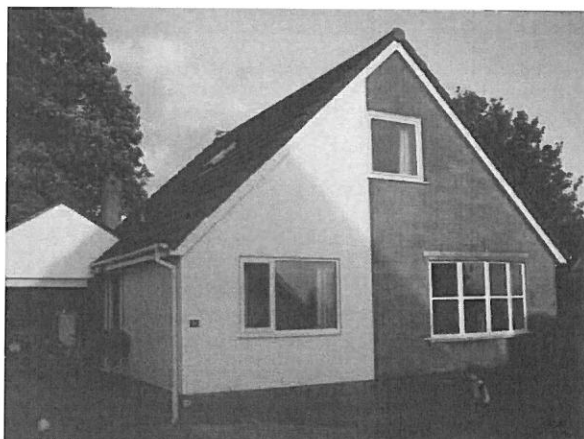
Figure 1 – Front view of the property.

The home is on the edge of a quiet estate of detached bungalows, built on a slope. The property stands within the established garden, front and rear, with an old line of trees running behind all of the gardens.

No bats were seen leaving the property at the gable end or at the back of the property.

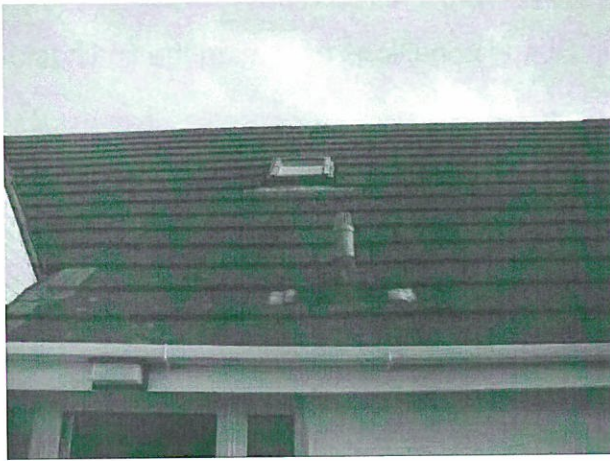
Figure 2 – View of the 'roof light' window.

No bats were seen around the lead flashing of the roof window or other roof structures.

When removing the tiles, roofing felt and timbers along the gutter line etc, care must be taken to go slowly, looking for a bat as work takes place.

Also take care when removing the ridge tiles as these areas may well house a bat.

Lift, don't drag, when removing the ridge tiles and other wood and brick work.
