**Outbuildings off Hammond Drive  
Read Hall  
Read  
Lancashire  
NGR: SD 757 349**

**A  
Heritage Impact Assessment  
on  
Proposed Conversion**

December 2017  
**Mercian Heritage Series 1185**

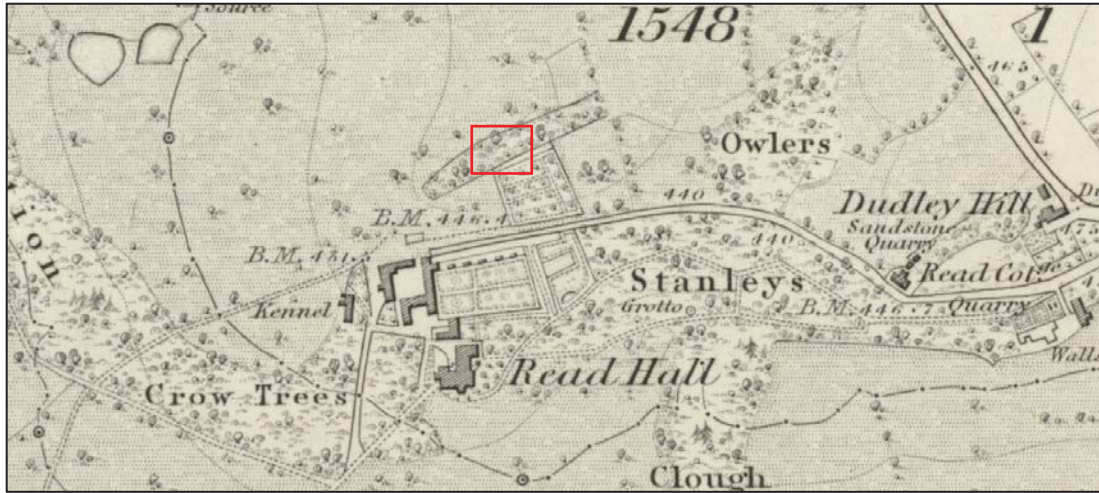
The study area is on the northern edge of a large walled inclosure, shown on the Ordnance Survey map surveyed in the mid-1840's. This was presumably associated with the Hall in some way but its date is not known. On early mapping it seems to be shown as an orchard, accessed from the lane to the south – Hammond Drive; immediately to the east is an ice house. Later maps show it denuded of trees.

Fig.2: Extract from the 1<sup>st</sup> edition 6" Ordnance Survey map, surveyed 1844-6.

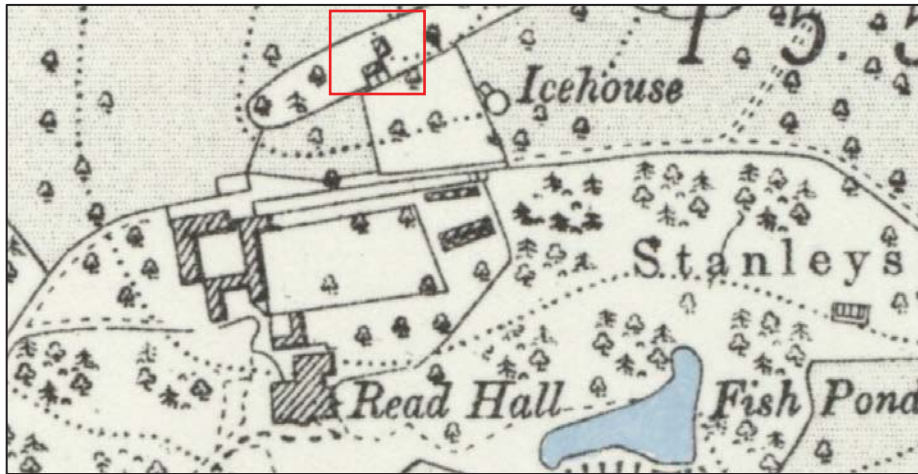
The buildings studied in this report are built on flattened ground to the north of the walled enclosure but are not shown on mapping until the early-1890's – but there is a large gap in the available mapping from the 1840's until that date. The site is within an elongated woodland that was shown on the 1840's mapping and appears to have been a deliberately designed copse on the edge of the slope.

Fig.3: Extract from the 2<sup>nd</sup> edition of the 6" Ordnance Survey map, surveyed 1890-2.

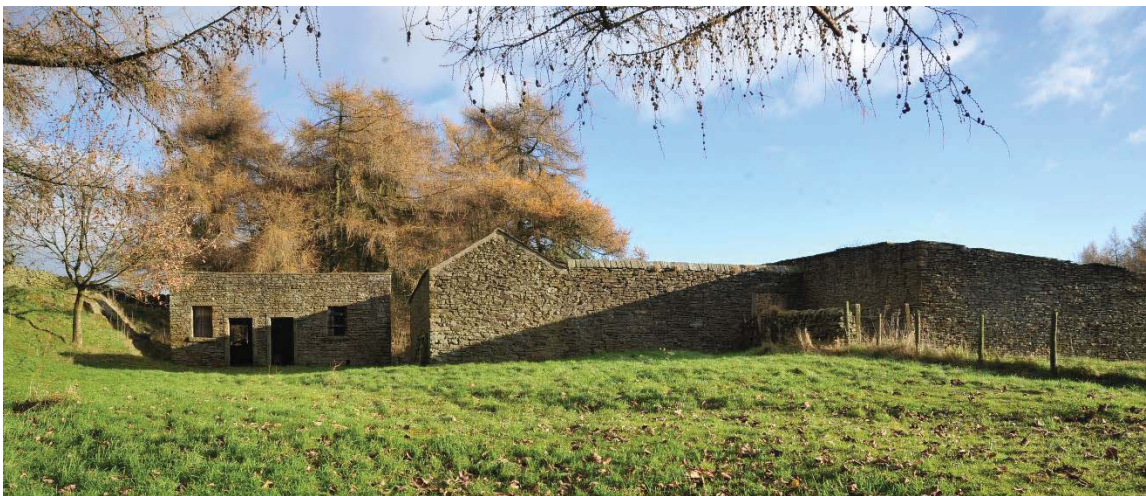
Pl.1: The buildings from the west, North Range to left.

The two ranges are built at right-angles to each other on deliberately levelled ground in the former woodland just to the north of the walled inclosure; the two form an 'L-shape' plan with the 'heel' removed; there is just a very small gap in between the two structures, which are of slightly different date and detailing.

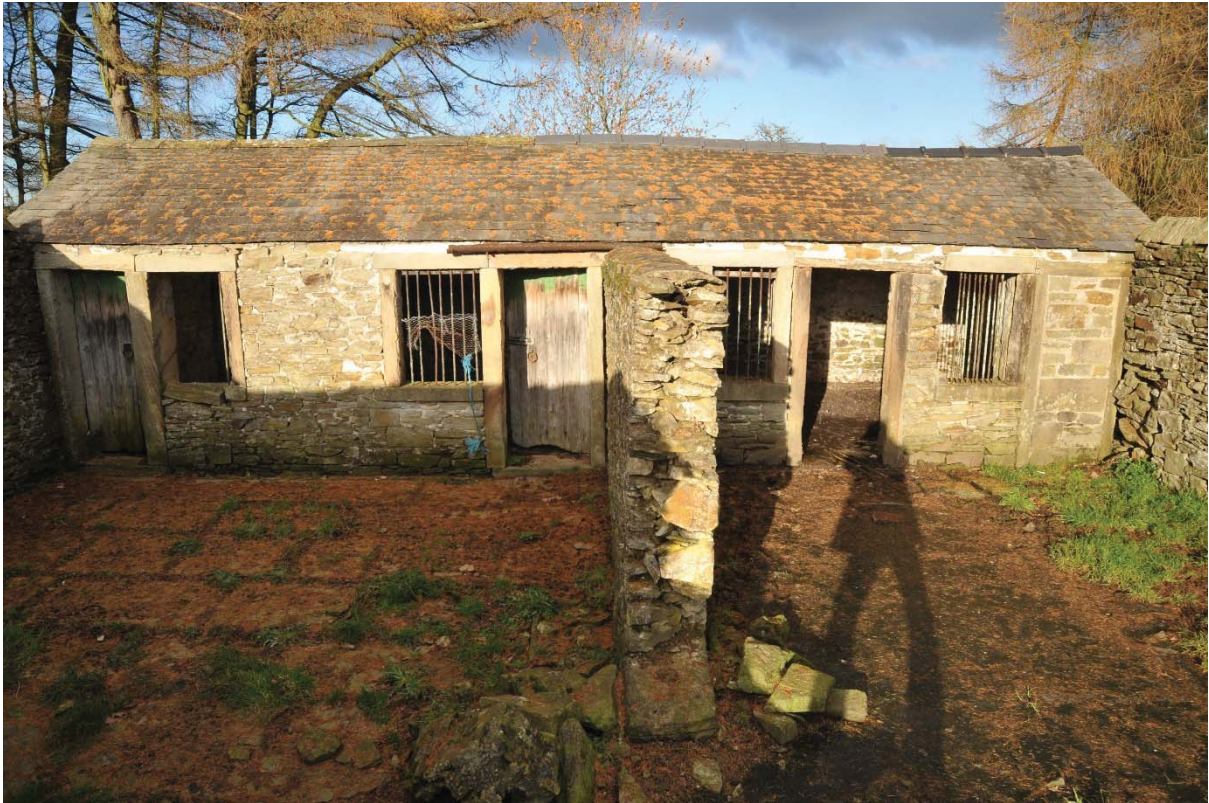
The long rectangular single-storey range is aligned west-east and is built of crude rubblestone gritstone. There are pairs of openings on the front, or south, elevation – each consisting of a doorway and a window.

These have jambs formed of square sectioned worked single gritstone stones – with a central shared stone jamb between the openings. These support individual lintels of the same material. The doorways have stone thresholds and the windows, stone sills.

The elevation is not quite symmetrical, though the paired openings are evenly spaced. The three eastern pairs of openings each have the doorway to the right, or east, and the window to the left. The westernmost pair is reversed.

The doors are, or were, ledged plank doors hung on strap hinges hung on iron hooks fixed into the inner faces of the jambs; the easternmost doorway is blocked in rubblestone. The windows are iron barred; the bars in the westernmost window are missing. There are no openings in the rear or gable walls.

Pl.2: The south, or front, side of the South Range.

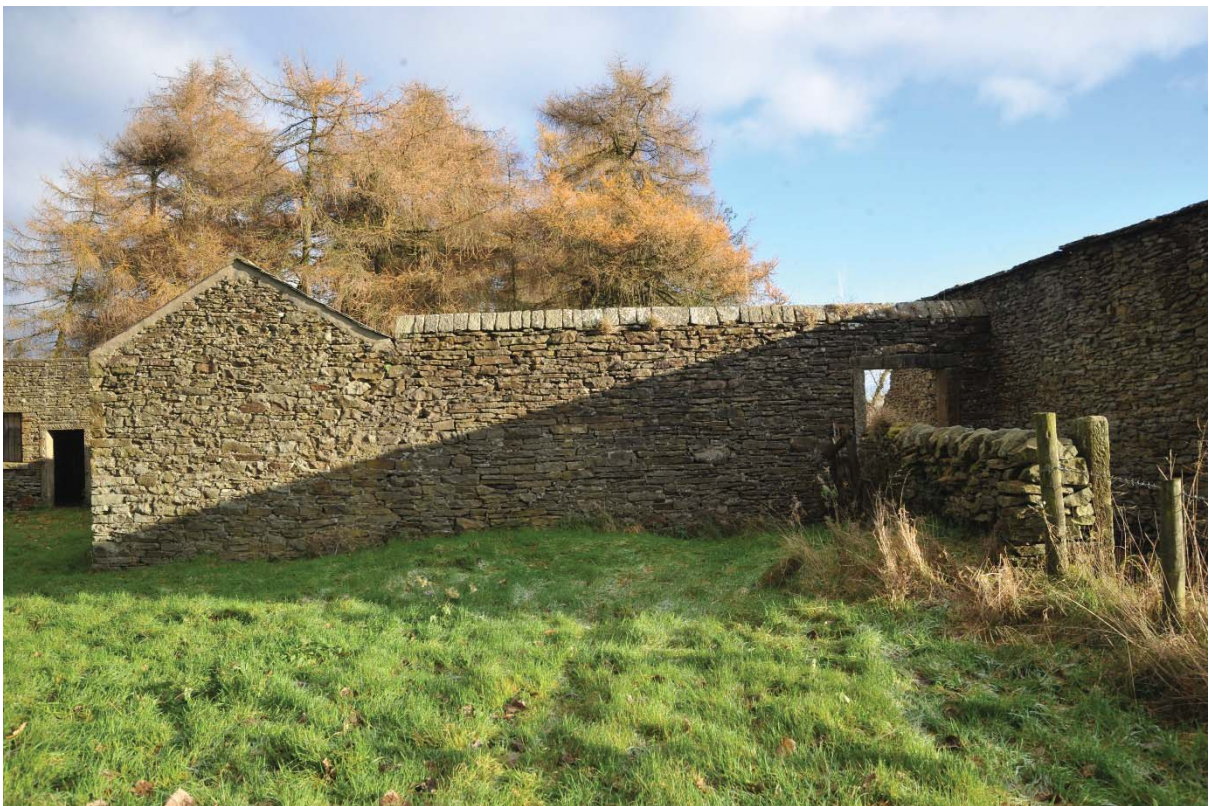
Pl.3: The west side of the South Range and the adjacent front yard.

The gable ends of the South Range are bonded into tall rubblestone yard walls forming the outer western and eastern boundaries of a pair of open yards between the front elevation of the range and the wall of the inclosure to the south. These walls are topped by worked triangular copers and butt against the earlier wall of the inclosure.

Close to the southern end of the western yard wall is a well crafted door or gateway with worked stone jambs and lintel identical to those in the front wall of the range. This doorway is accessed from the west by a narrow open paved passageway between the wall of the inclosure and a low stone wall parallel to it. In the yard, or east, side of the southern jamb is an iron pintle for a strap hung door.

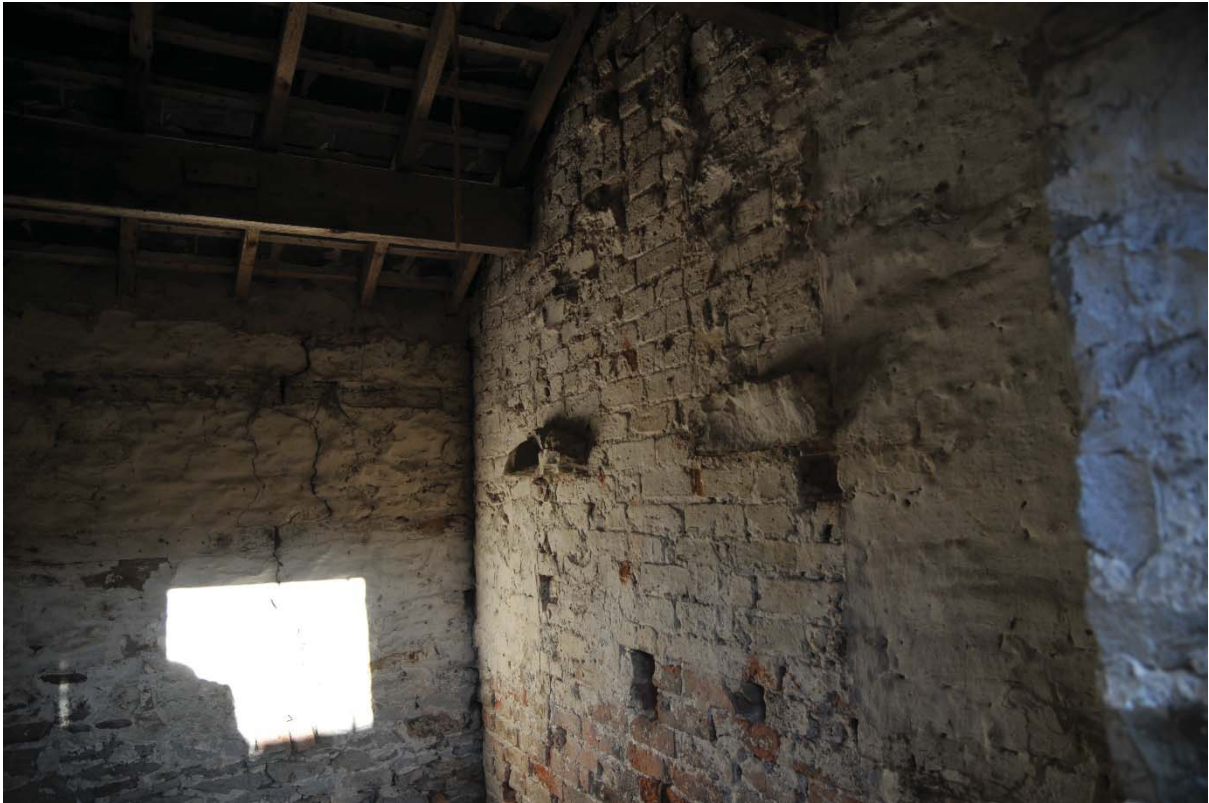
The original surviving central cross-wall is of rubblestone and is bonded into the side walls. The other cross-wall to the west is mainly of brick. On its western side there is clear evidence that this formed the back of a shouldered brick stack that has been demolished; this had a ridge chimney.

Pl.4: The west side of the western cross-wall, showing traces of the lost stack.

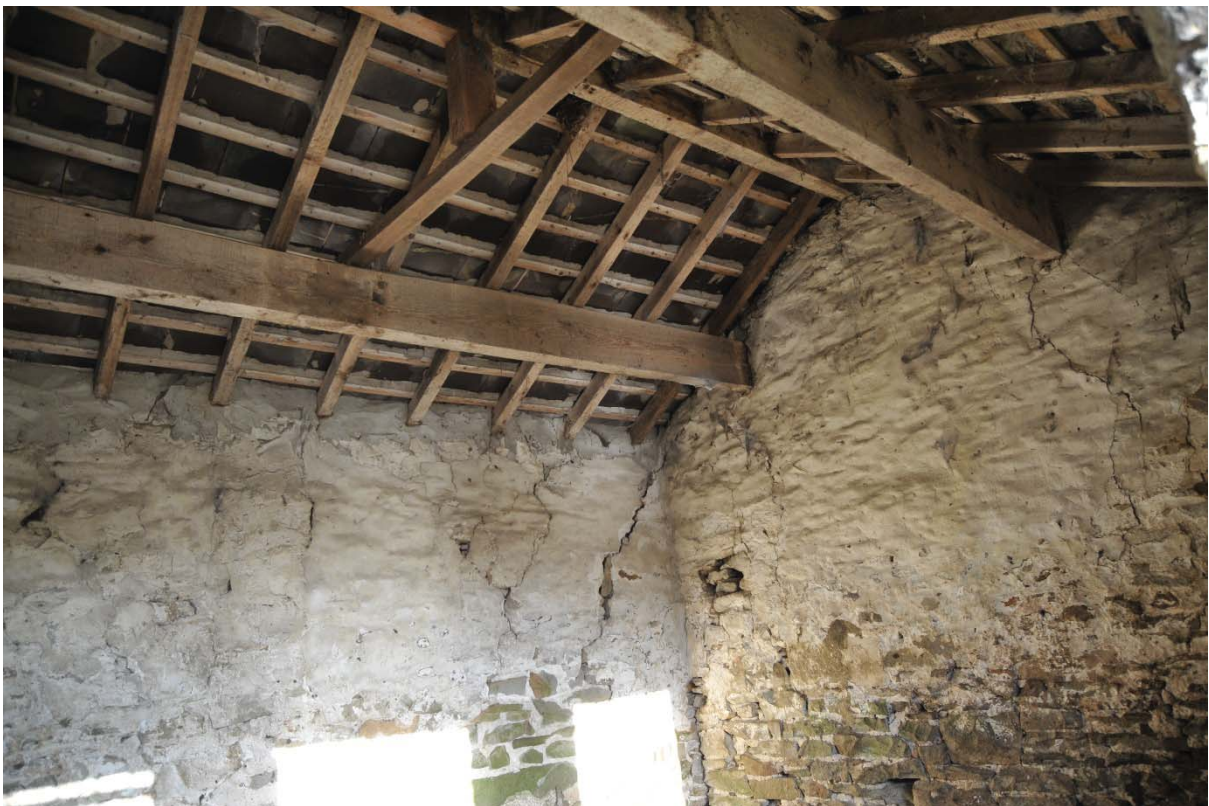
It is unclear how much the roof was rebuilt when the chimney stack towards the western end. When the cross-wall in the eastern half was removed, additional support to the ridge was given by a timber stud supported on a cross-piece resting on the tops of the purlins (*see below*).

It is evident that the longer space was originally divided into two by a cross-wall – the scars of which are just visible on either side despite later limewash. Given the lack of bonding in evident in these scars it seems that this missing cross-wall was of brick.

Pl.5: The longer eastern space, showing scar of removed cross-wall and added roof support.

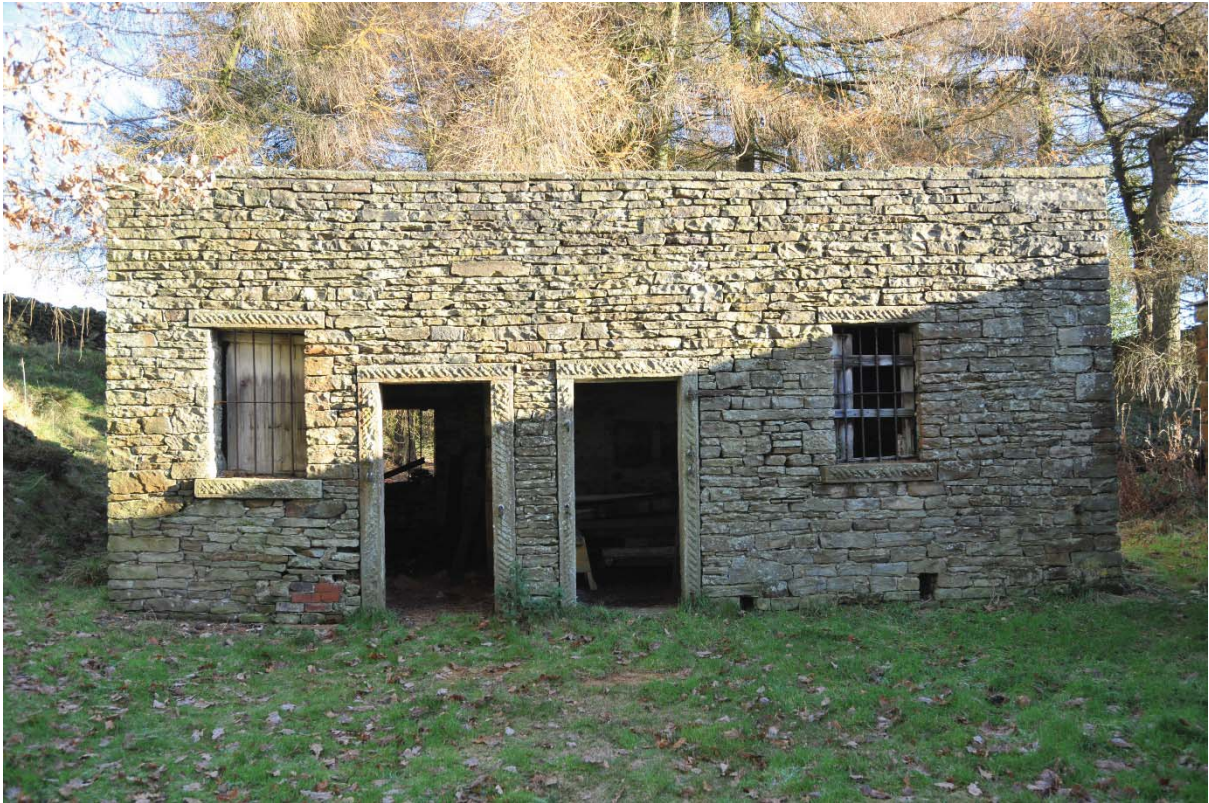
The paired doorways are set to the left of centre. Both have rusticated gritstone surrounds of single stone jambs and flat lintels. There are no surviving doors but the pattern of iron pintles hammered into the outere faces of the openings shows that, at one time at least, they had two leaf, or 'stable', strap-hung doors.

The window openings are tall and rectangular, with plain jambs but rusticated single stone flat lintels and sills. The openings have vertical iron bars. At the base of the wall towards the southern, or right-hand, end, is a small square-headed opening, possibly for a drain.

Pl.6: The front, or west, elevation of the North Range.

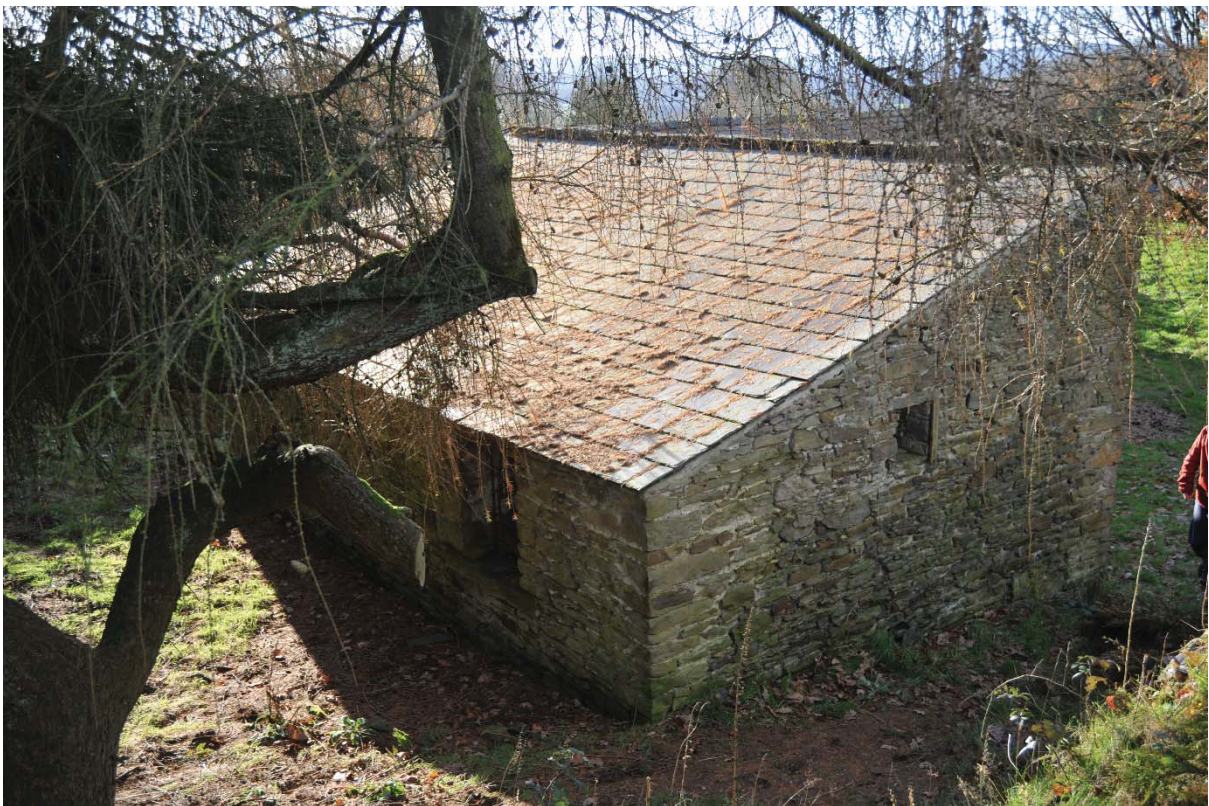
Pl.7: The North Range from the north-east.

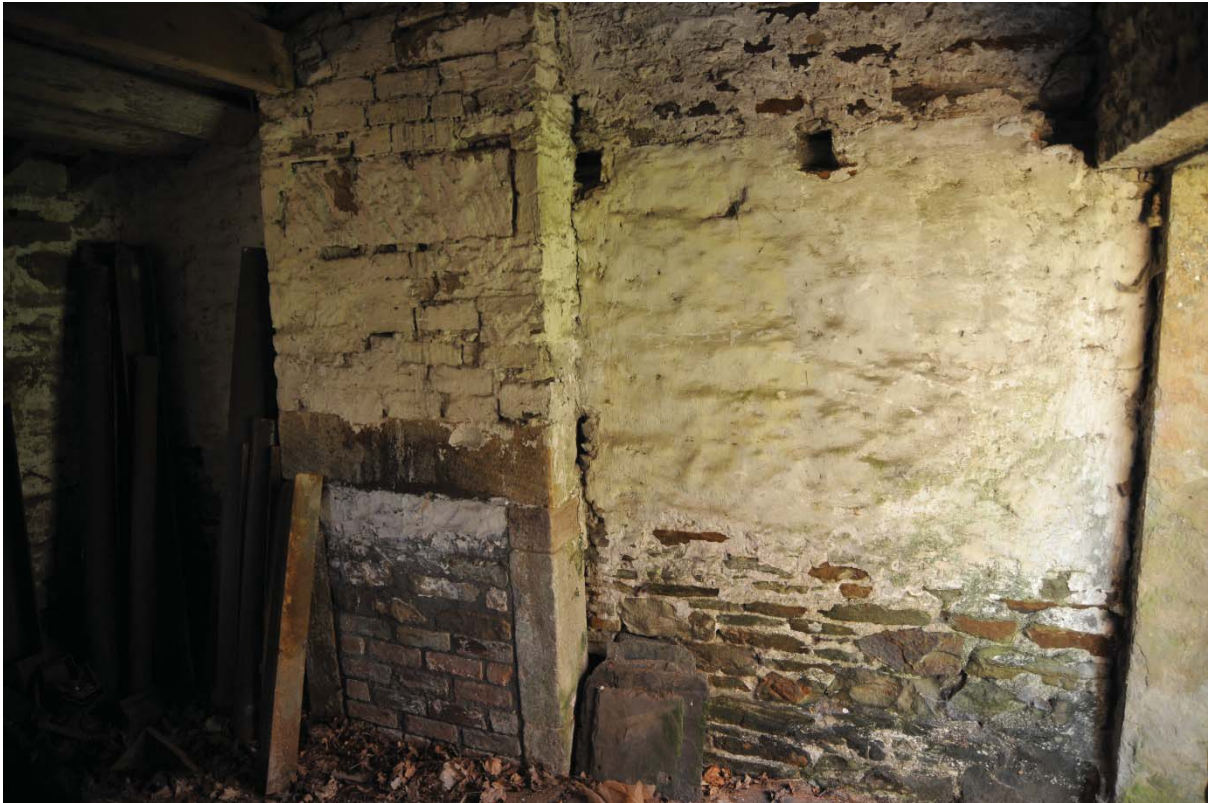
The smaller northern room has a projecting shallow stack on the cross-wall. The stack is a mix of rubblestone and brick and was clearly once topped by a chimney, now demolished. The fireplace has a worked stone surround and is now blocked in brick.

The northern space seems to have been for human use. It is well lit and has a domestic scale fireplace; this was clearly not a fireplace for the preparation of animal feed. The evidence for a small loft is possibly significant as well; it could have been a small sleeping loft – lit by the loop in the gable. It is quite possible that this part of the building was used as a bothy for short-term accommodation of a farm worker or keeper.

Pl.8: The stack and fireplace, and attic joist sockets, in the north room of the North Range.

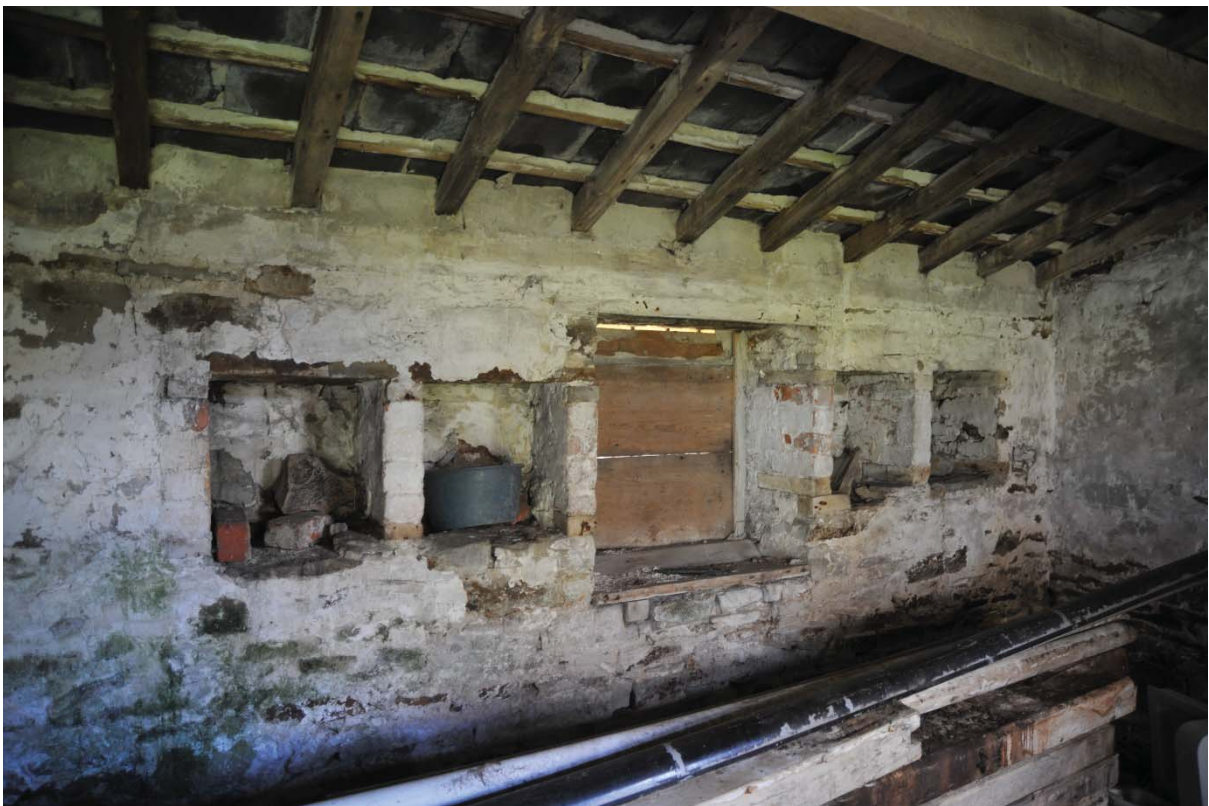
The larger southern space was probably for animal accommodation and had no direct access through the cross-wall to the smaller space. The series of recesses in the rear wall are intriguing and could have been used for a variety of purposes – from storage, to cage stands, positioning of lamps or lights, etc.

Pl.9: The inner face of the rear wall in the southern room of the North Range.

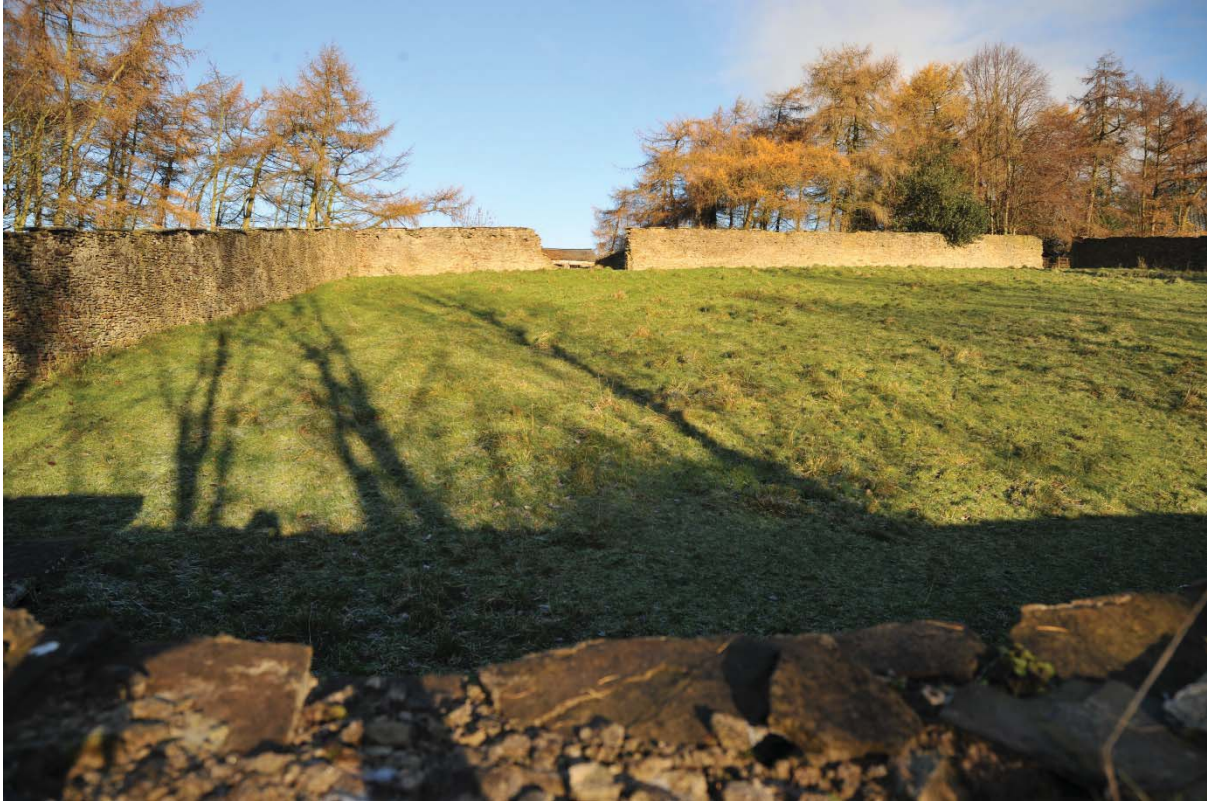
Pl.10: View north from Hammond Drive through the walled inclosure to the study area.

The early mapping of the 1840's shows it to be full of trees laid out in a formal manner so possibly suggesting an orchard, necessarily sheltered by the high walls from the Pennine weather. Another possible role as an animal inclosure – perhaps for deer, given the height of the walls, cannot be ruled out entirely.

As the walled inclosure clearly predates the buildings now attached to its northern side, the relationship between it and them is unclear – but was presumably once significant. The northern wall of the inclosure was pierced by an inserted doorway to provide access from it into the eastern yard of the South Range.

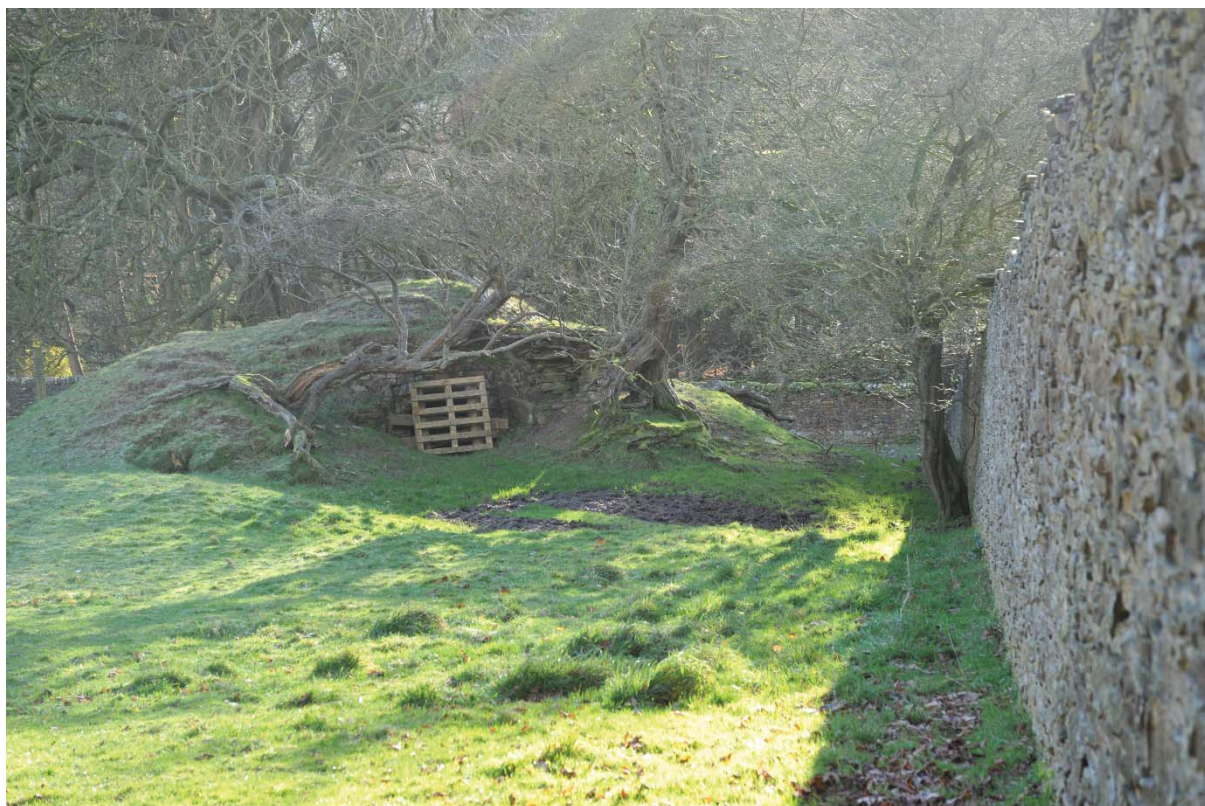
Pl.12: The listed ice house, with the east wall of the walled inclosure to the right.
