**BAT SURVEY AT -
CHANNY TOFT
GRINDLETON VIEW
CHATBURN**

DATE AND TIME OF VISIT
8th Jan 2018 9.00am

REFERENCE NO. 5520

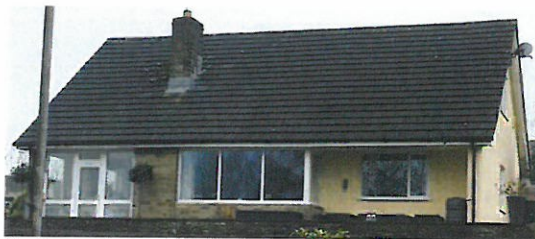
North west elevation

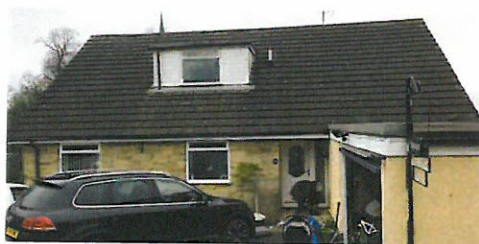
South east elevation

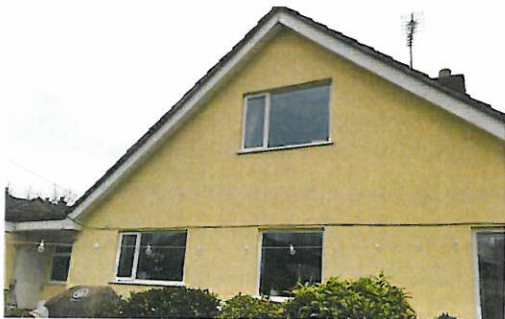
North east elevation

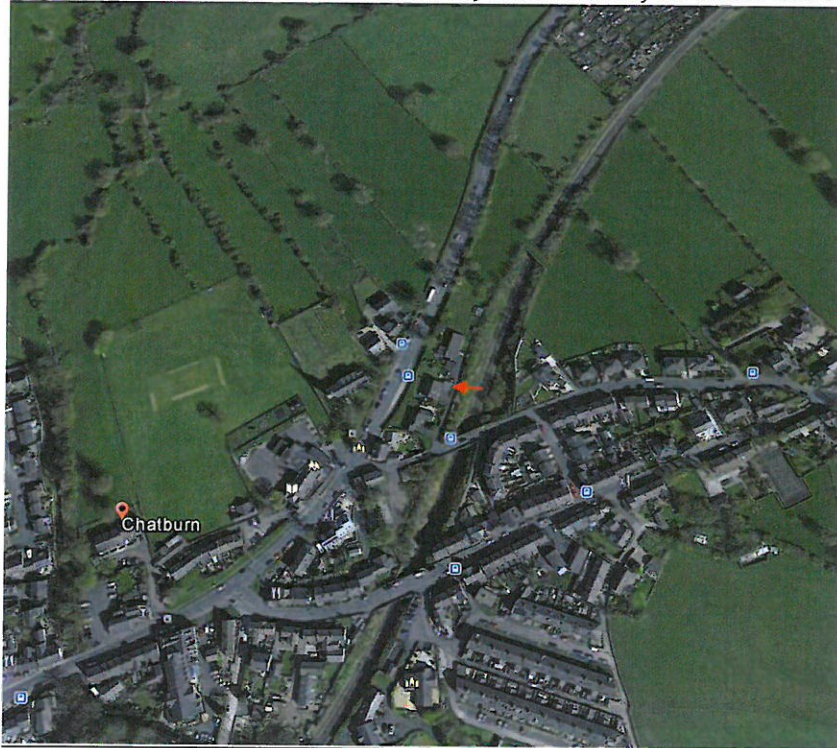
The house is located on the north east outskirts of the village, between the railway line and Sawley road (the main thoroughfare from the A59 into the village). The front garden boundary is directly adjacent to the road and the rear boundary is separated from the railway embankment by the access road off Ribblesdale view.

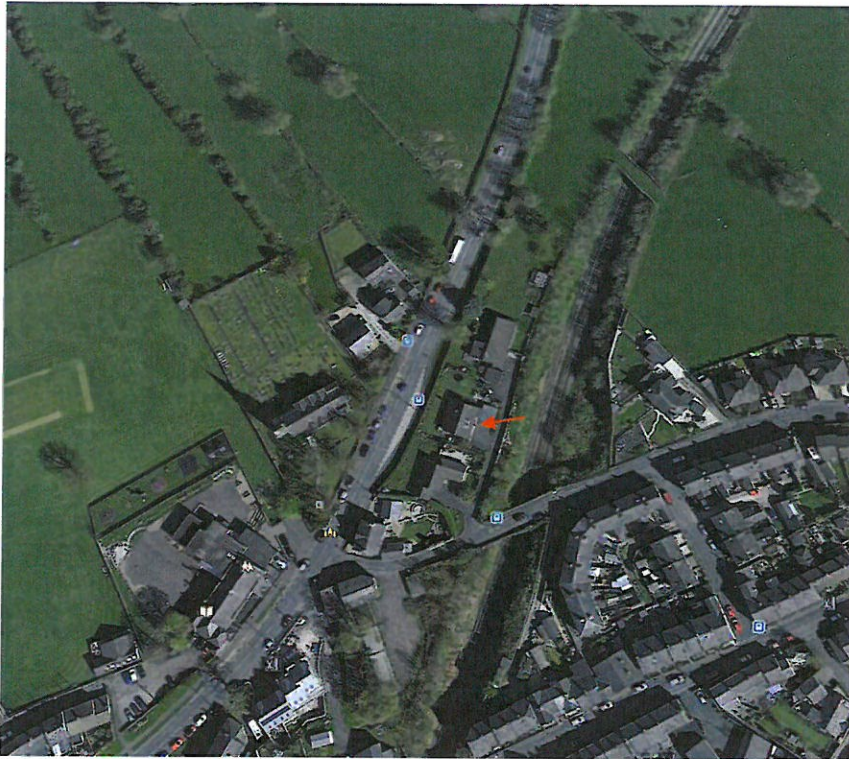
The property is the middle house in a line of three similar age and type of properties opposite the church. The railway line which runs North to south immediately behind the properties is 21m from the house. The rail track is quite densely lined to both sides with vegetation and trees which forms a good potential foraging / commute route, the bridge is 37m to the south with Downham road bridge a further 90m to the south, this habitat is considered high value for bats.

The church located opposite is 40m from the house, there are mature broad leaf trees to the front adjacent to the road the rear grave yard is devoid of trees but is adjacent to pastureland bound by hedgerow and small trees. The greater locality has a good level of habitat potential.

There are no areas of open water within 0.6 km , the nearest water course is Heys brook at 225m to the south .

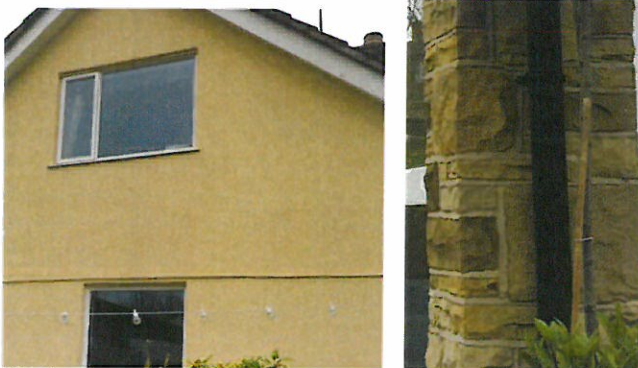
The house walls are mainly brick with smooth render finish. The rear wall is natural stone as is the front bay window and porch area.

There are no access points in the walls all are in perfect condition.

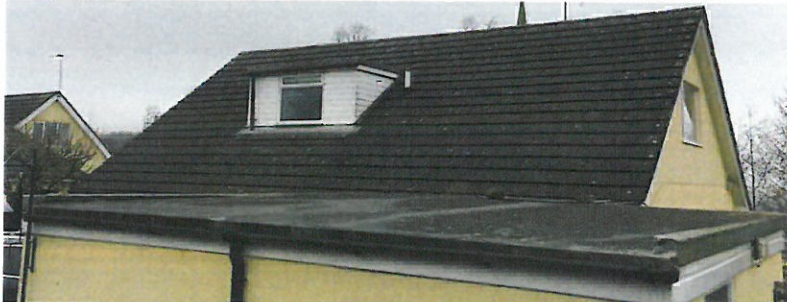
The main roof is pitched with a dormer window with boarded sides in the south east elevation, there is an overhang to the eaves and gables with a upvc boarded soffit to fascias and barge boards, the finish is tile. The garage and link has a felt flat roof with upvc fascias flush to the wall.

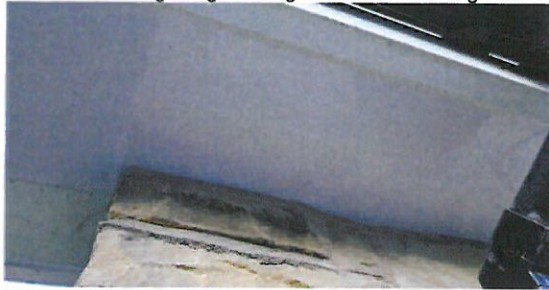
The tile roof is in excellent condition all tiles are tight fitting, the boarded dormer has no gapping in the boards and the flashing is tight fitting. The eaves and gable soffits are very tight fitting with no gaps.

Eaves soffit

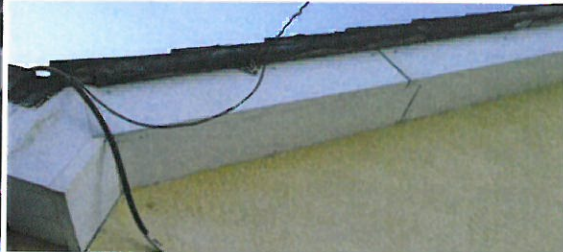
gable soffit

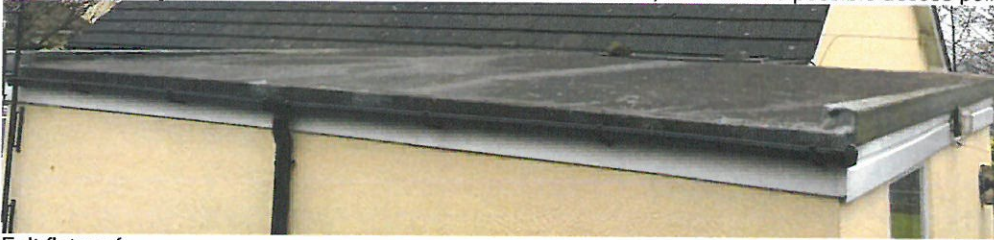
The felted garage roof is in excellent condition as are the fascia's, there are no possible access points.

Felt flat roof

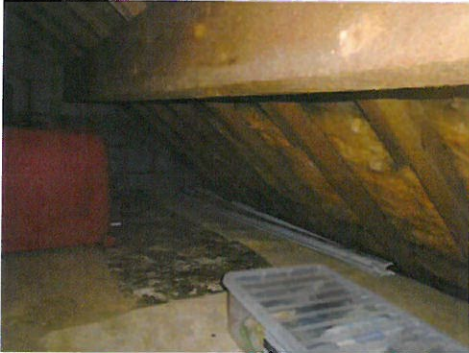
Eaves voids.

The roofs structure was timber purlins and rafters with insulation quilt and sarking felt over the rafters. All timbers are in good condition with no cracks or crevices. The roof voids were clean, the floor surfaces were free of any dropping or feeding evidence. The roof voids provide a sub optimal level of roost and forage habitat.

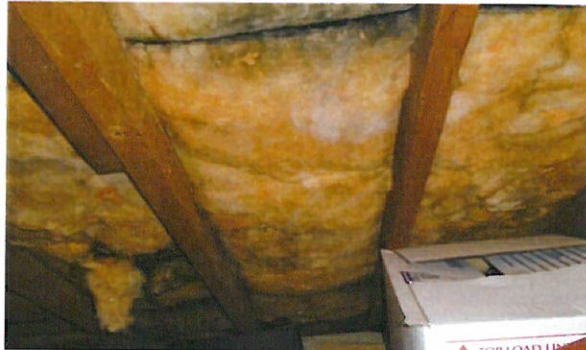
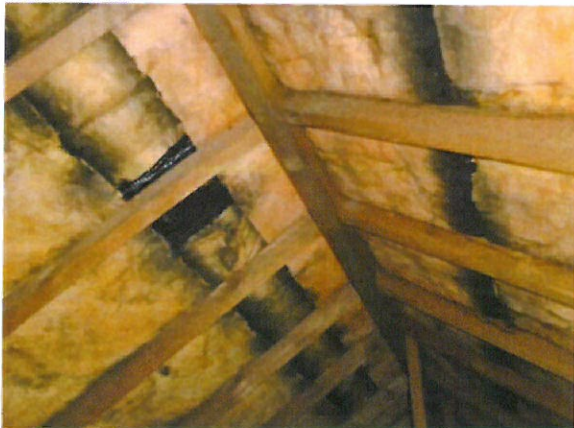
Void under ridge
