**Manor House, Howgill Lane, Rimington,
Clitheroe, BB7 4EF**

Bats: Building Inspection and Activity Survey

Simply Ecology Limited

November 2017

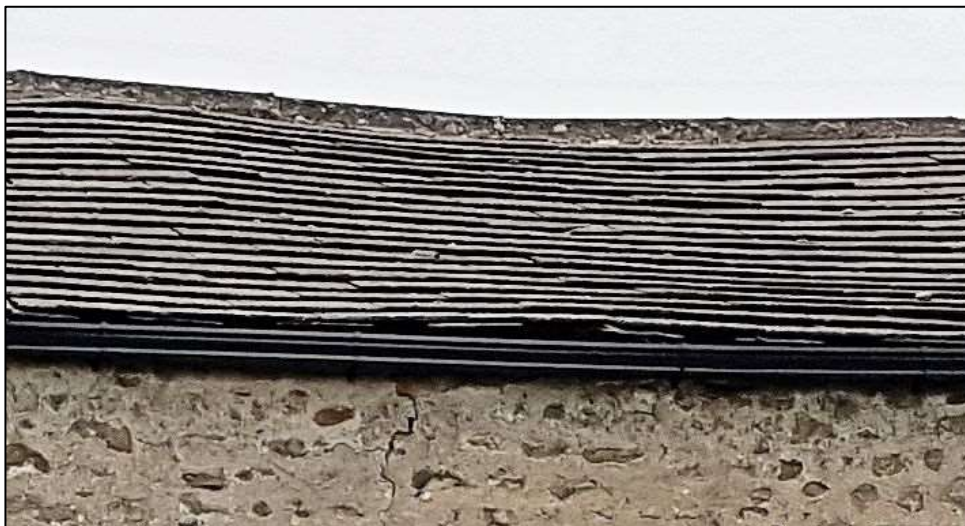
- 3.1.1 The building was a semi-detached stone barn with stone tiles, wooden doors and a mix of wooden and metal window and door frames. The attached house was inhabited although the barn was currently uninhabited and being used as storage space. The survey began by checking the exterior of the building, which was in a reasonable state of repair.
- 3.1.2 A systematic search of the roof was carried out with the aid of binoculars. The roof was of overlapping stone tiles; no slipped or missing tiles were visible, although there were numerous gaps under lifted tiles (see Plate 2).

Plate 2. *The stone tiled roof was intact but with numerous gaps under tiles.*

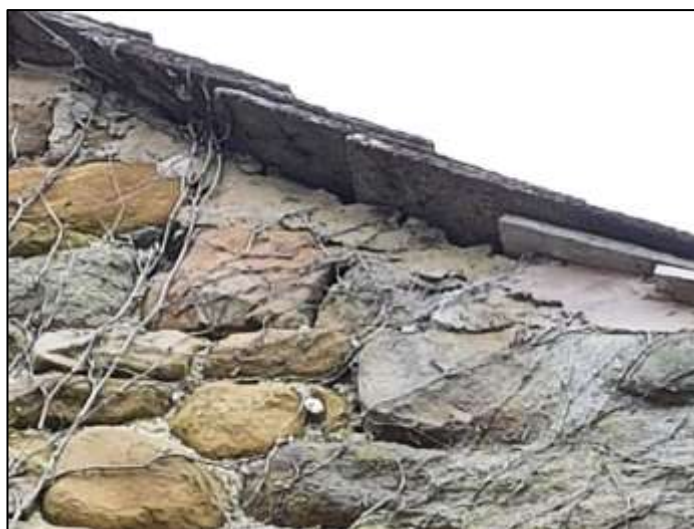
- 3.1.3 Missing mortar on the gable end verges (see Plate 3), gaps along the wall tops (see Plate 4) and absent pointing across the barn (see Plate 5) all provided numerous potential roost access for bats. Holes from historical architectural features were also present (see Plate 6) offering further potential roost access points.

Plate 3. *The roof verges presented numerous possibilities for bats to gain access to potential roosting locations*

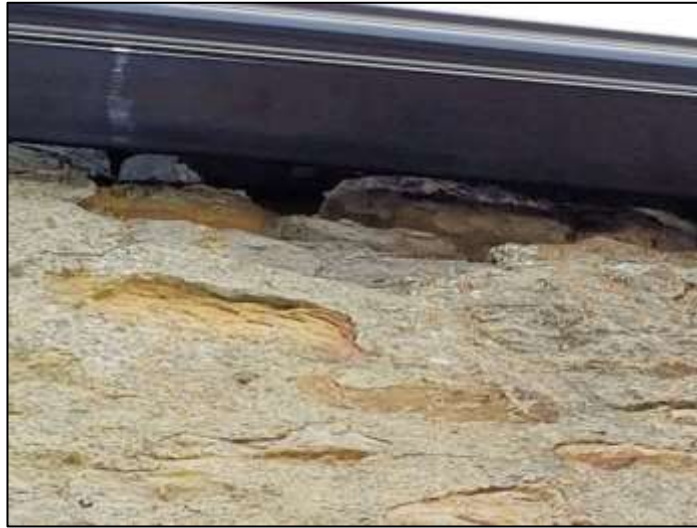
Plate 4. *The wall tops were exposed and offered roost potential and access to the internal spaces.*

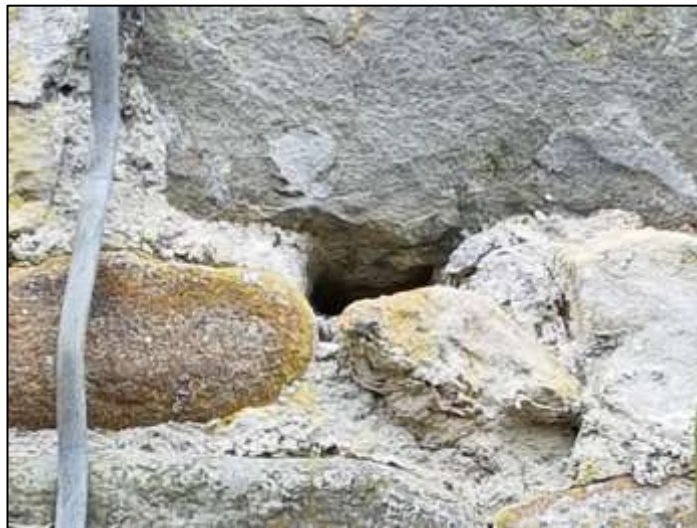
Plate 5. *Other potential roost features included missing pointing.*

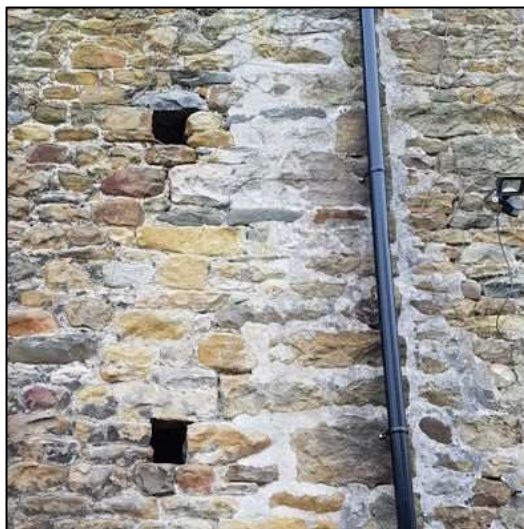
Plate 6. *A number of architectural features offered further roost potential.*

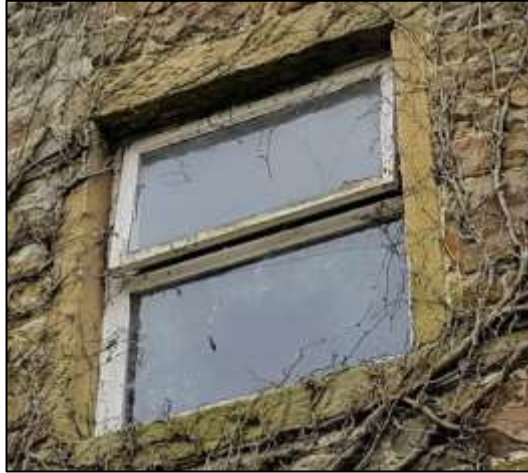
- 3.1.4 The window frames were well sealed (see Plate 7). The door frames were less well sealed, particularly the double wooden doors on south face of the barn (see Plate 8) that offered access to potential internal roosts. Easy access to the internal spaces of the northern barn was also offered via an open archway (see Plate 9).

Plate 7. *The window frames were well sealed and held no roost potential.*

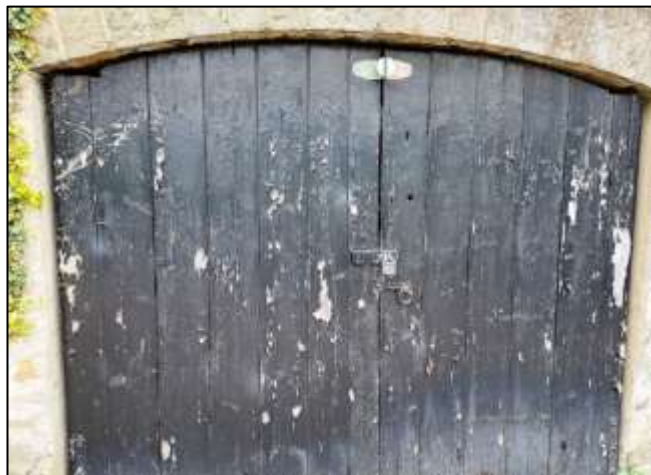
Plate 8. *There were suitable gaps around the double door on the southern barn that provided potential access to the interior of the building.*

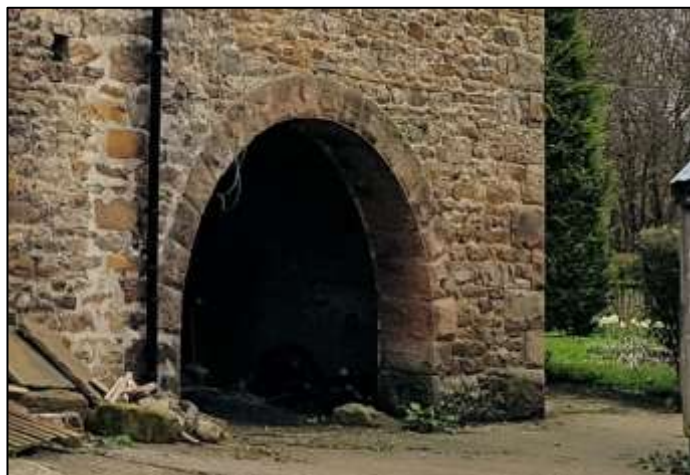
Plate 9. *Permanent access to the internal spaces of the northern barn was available via the open archway on the east gable.*

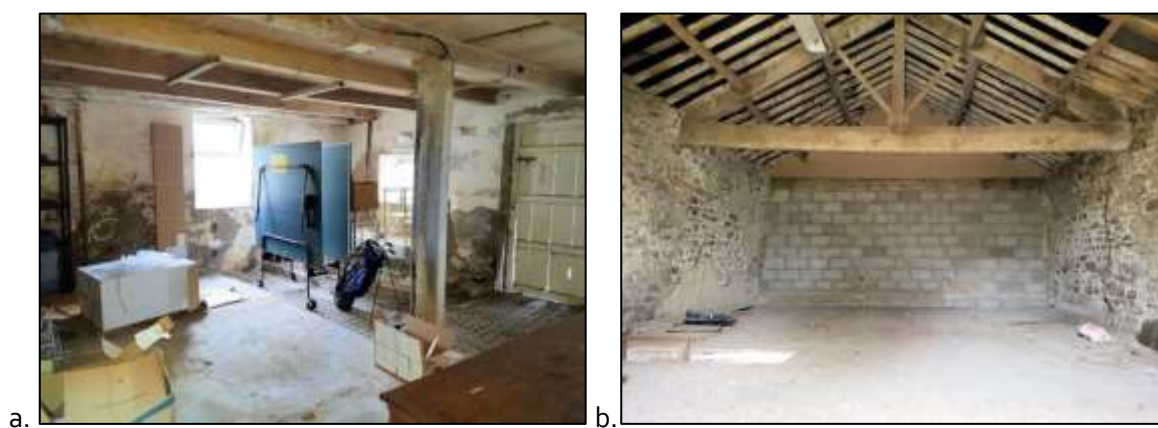
- 3.2.1 The southern barn was divided in two levels; the ground floor was currently in use as storage space and the first floor was empty (see Plate 10). The first floor was accessible via a permanent opening (see Plate 11). The northern barn, an earlier extension, was similarly divided across two levels; the ground level was currently in use as storage space whilst the upper level was in use as an office (see Plate 12).

Plate 10. *Southern barn internal spaces a. Ground floor b. First floor.*

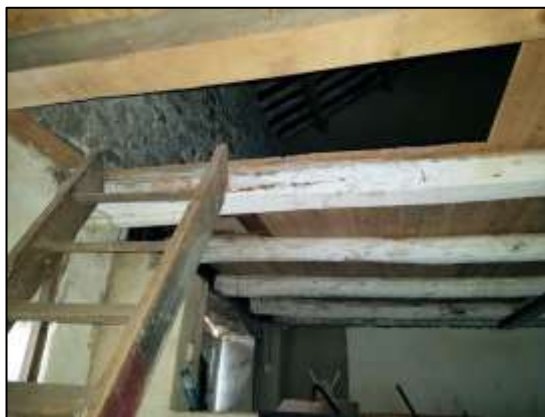
Plate 11. *The ground floor and first floor spaces of the southern barn were continuous spaces.*

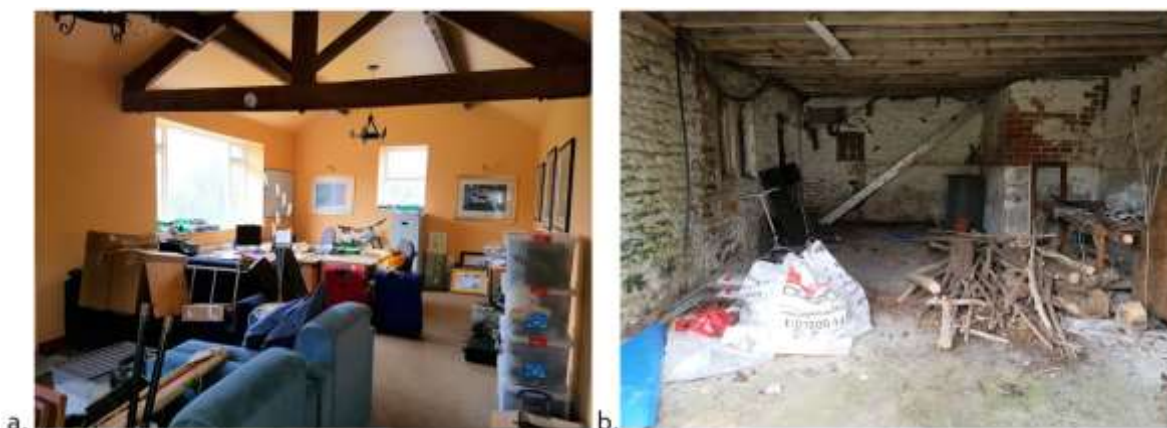
- 3.2.2 The open arched entrance to northern barn, combined with a window between the two ground floors (see Plate 12) and the opening to the first floor, provided an easy access route between all the internal spaces.
- 3.2.3 The walls were variously plastered or pointed stone, block and brick work and plaster board (see Plates 10 and 12), open to membrane lined ceiling on the upper level (see Plate 14).
- 3.2.4 All flat surfaces within both levels (including crossbeams, wall tops, purlins and rafters and underneath key features like the ridge beams etc) were checked for signs of bats. Several bat droppings, as well as possible prey remains, were identified on the ground floor of the northern barn.

Plate 12. *Northern barn internal spaces a. Ground floor b. First floor.*

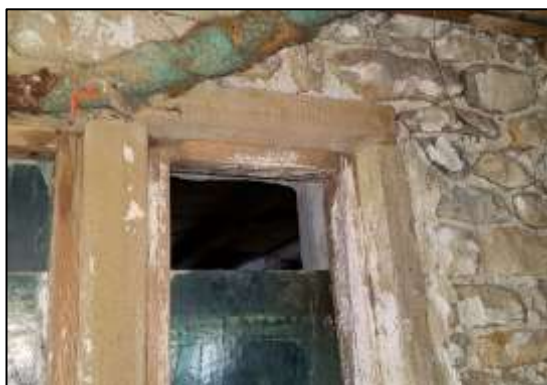
Plate 13. *A window between two ground floor spaces provided a permanent access route.*

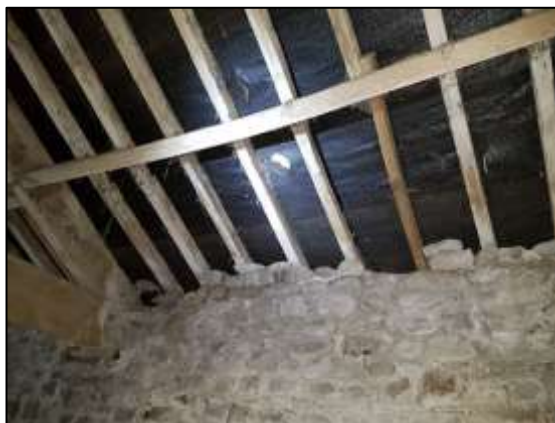
Plate 14. The roof of the southern barn was lined with a membrane which had a number of holes which provided access to potential roosts.
