RE: SCOPING BAT SURVEY: 33 ROGERSFIELD, LANGHO

I would report that we have undertaken a scoping bat survey on a red brick and rendered residential dwelling under a pitched, tiled roof at the above address. It is proposed that a flat roofed existing dormer on the North-east elevation is replaced with a pitched roof dormer. The existing structure was viewed to identify its possible use by bats.

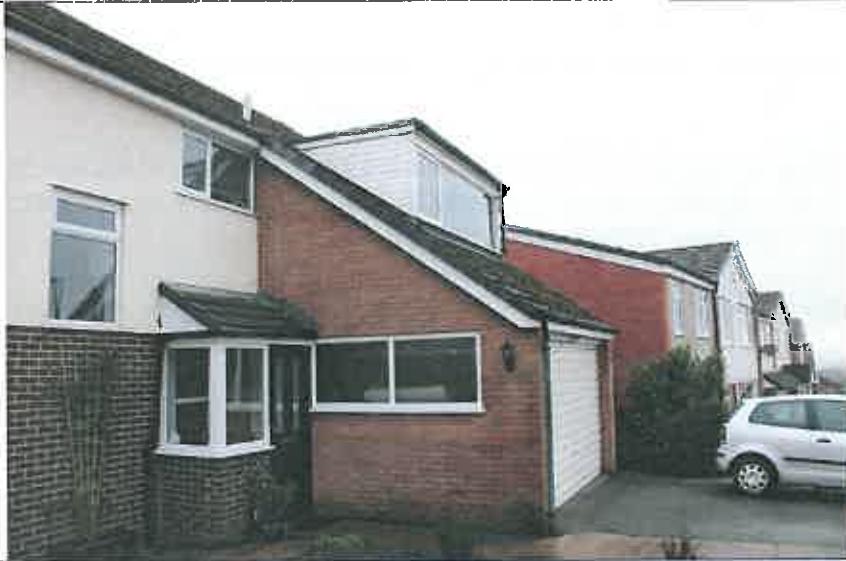
In the area of the building to be affected by the proposals, the external walls are constructed or red brick. uPVC soffit and fascia boards are present around the building but these are extremely well sealed both with each other and with the walls. The external walls in this area offer no potential for use by bats.

External red brick walls are well sealed.

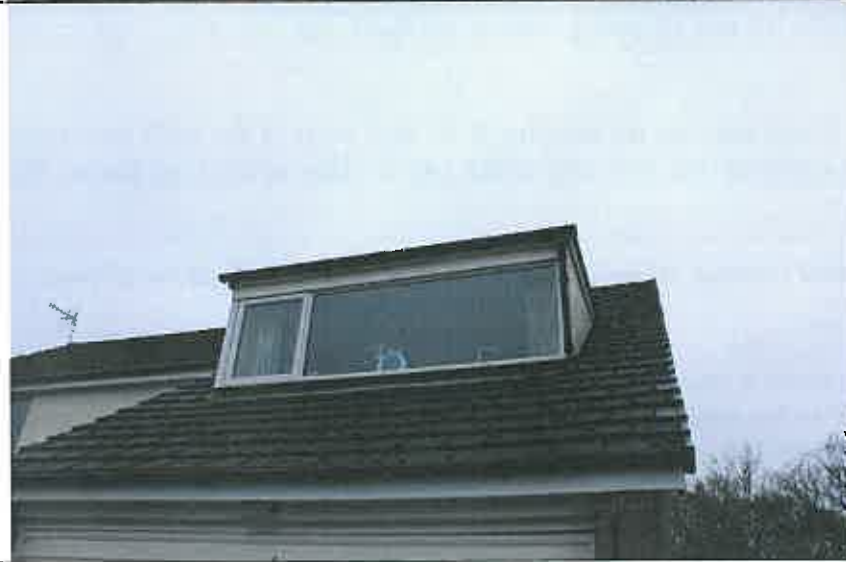
The existing dormer has a flat roof and offers no potential for use by bats. Small fascia boards and uPVC side panels around the dormer are also well sealed.

The house is roofed with concrete tiles which interlock immaculately and do not provide any potential bat roost sites. Moss growth is frequent over the roof.

The tiled roof is extremely well sealed as are soffits, fascias and side panels around the existing dormer window.

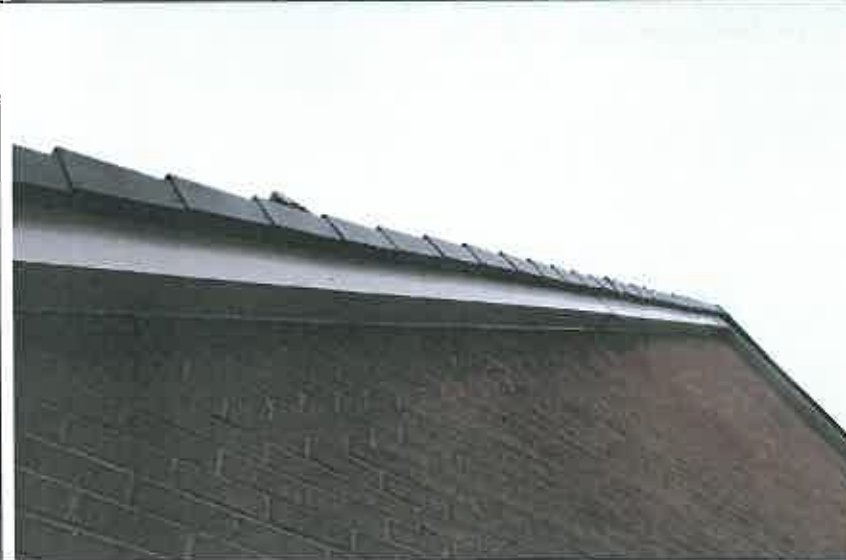
Soffit, fascias and roof verges around the building are extremely well sealed.
