Re: EPS – Daylight scoping survey: 11 Gisburn Road, Clitheroe, BB7 4NP

PRELIMINARY ROOST ASSESSMENT – BAT SURVEY REPORT

11 Gisburn Road, Bolton-by-Bowland, BB7 4NP

22 February 2017

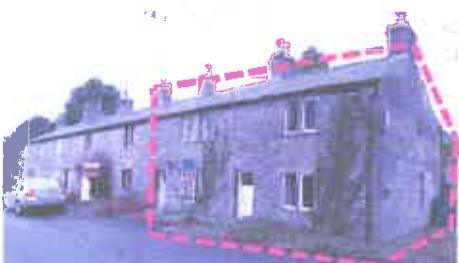
Figure 1: front / side elevations

The property is a two storey end of terrace dwelling (previously two separate cottages now combined) with stone and rubble infill wall construction and duo-pitched blue slate roofs (figures 1 to 3). To the rear of cottage No. 11 (on the left – figure 2) is a single storey lean-to extension with stone wall construction and mono-pitch cement fibre panel corrugated roof.

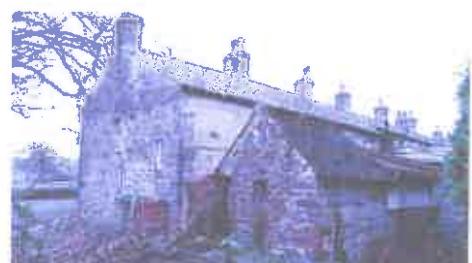
Figure 3: side and rear elevations

A lean-to roof extends across the rear of the adjoining cottage incorporating a small stone out-building with duo-pitched roof (figures 3 and 6). The lean-to roof section is clad in cement fibre corrugated panels (figure 5).

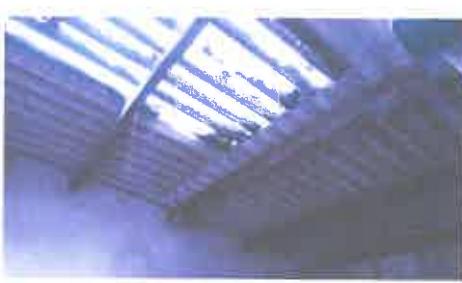
Figure 5: lean-to shed at rear

The external lean-to structure and out-building are cold and draughty, both are considered unsuitable in terms of attracting and supporting roosting bats.
