**BAT SURVEY AT -
EDISFORD BRIDGE FARM
CLITHEROE
BB7 3LJ**

**DATE AND TIME OF VISIT
15th Jan 2018 2.00pm**

REFERENCE NO. 5357

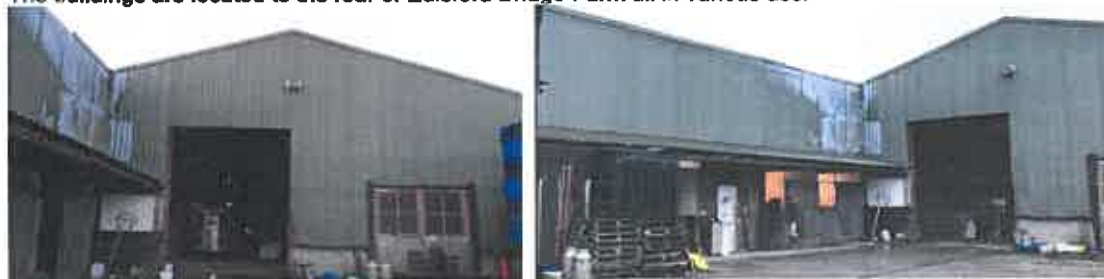
Steel portal frame farm building.

Area to be infilled

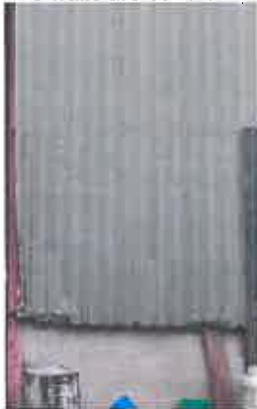
The walls are concrete block base walls with profile steel sheet s clad around a steel portal frame.

The interior of the building is accessible via door openings. The walls do not provide any crevices which would provide any potential habitat for bats.

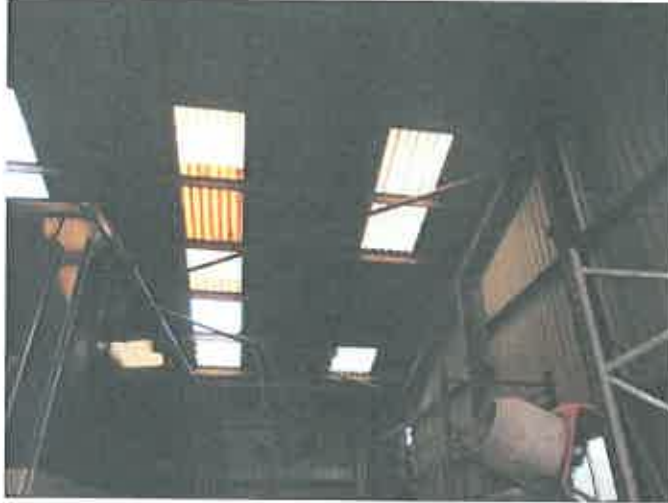
There is no enclosed roof space the underside of the roof sheets are clearly visible. They do not provide any potential for bat habitat.

The exterior of the building was examined for signs of staining, grease marks or droppings no evidence was found of any bat presence.
