LOWER CLERK HILL, WHALLEY LANCS.

HISTORIC BUILDING RECORD

January 2018

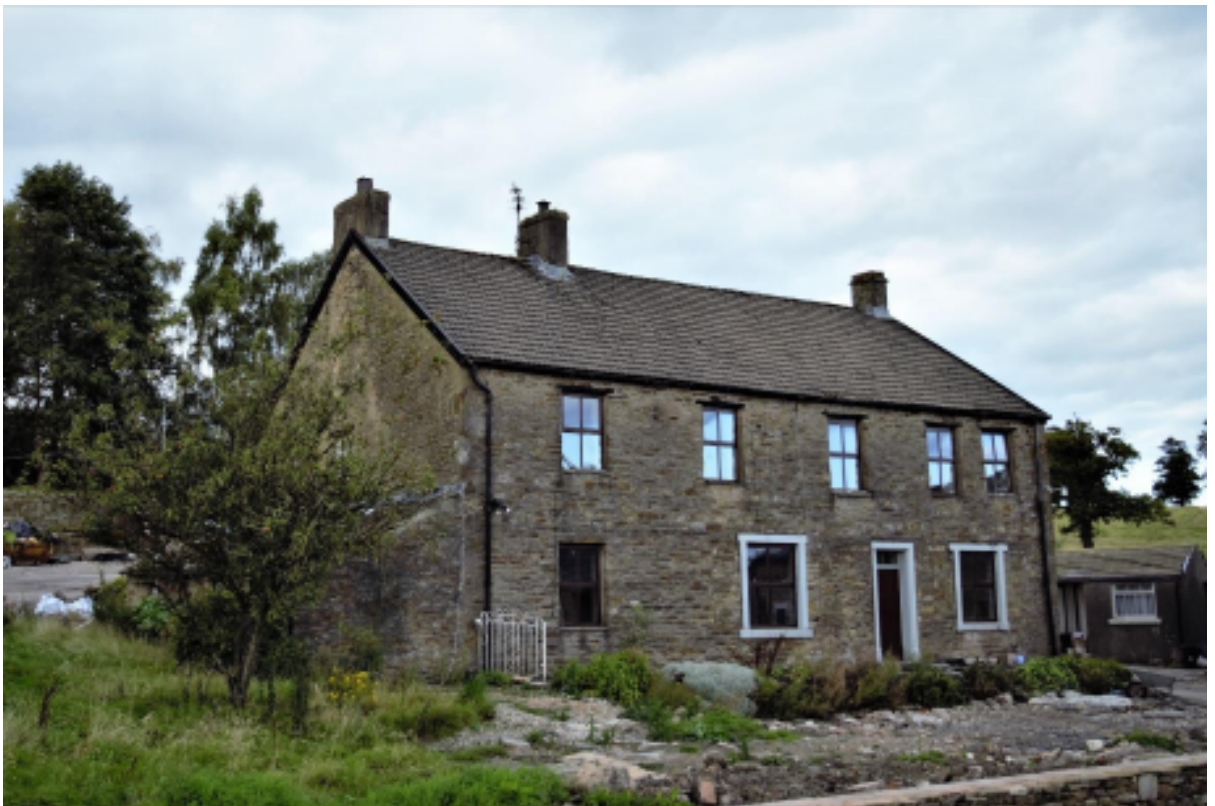
3.1.1. The house is a two story building of 5 bays, constructed of coursed random rubble and with a modern concrete tile roof. There are chimney stacks at both gables and a further stack on the ridge line about three quarters of the way along the ridge from the eastern end. The west gable and the ridge stack appear to be wide enough to hold up to three flues although they currently each have only a single chimney pot in place, while the eastern stack is much smaller and is likely to have a single flue. The approach to the house is via a short drive from Clerk Hill Road to the north but the principal frontage of the house, from the point of social and domestic use, appears to be the south facing elevation (Figure 5).

Figure 5. South elevation from south west.

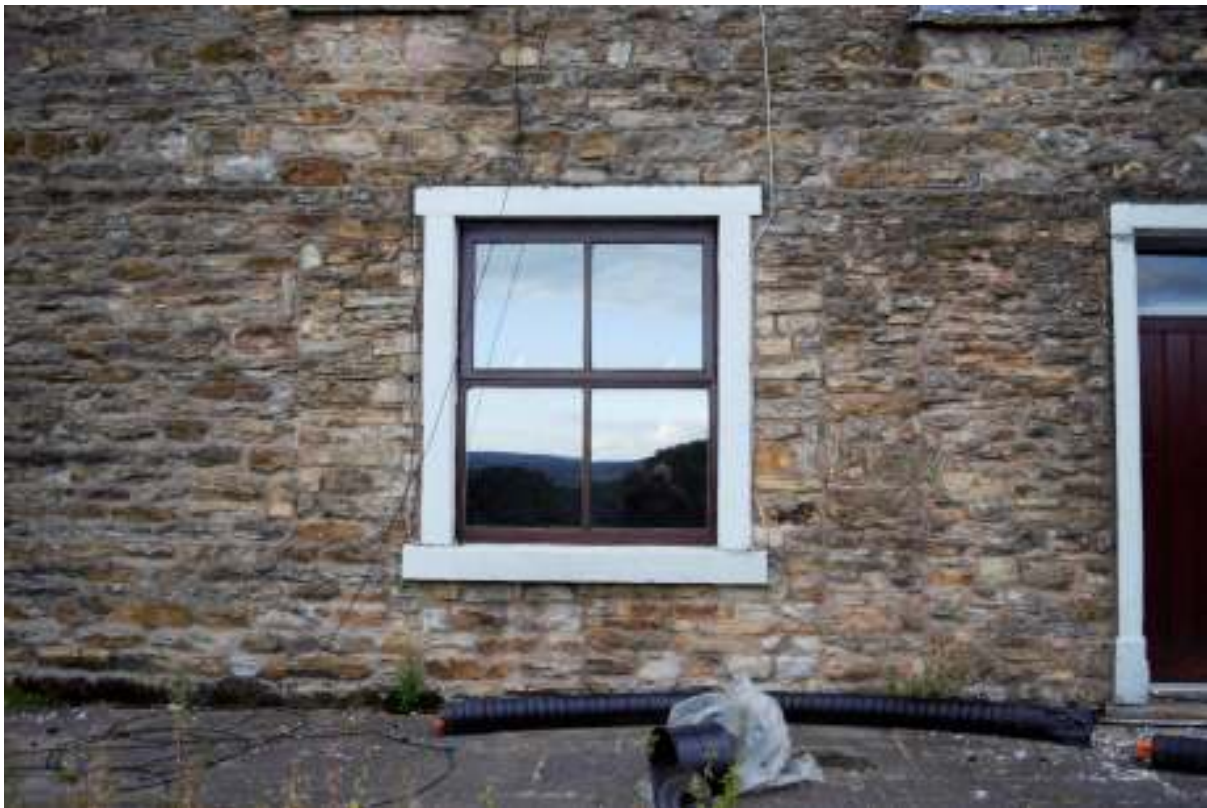
3.1.1.1.1. The south elevation, from left (west) to right has the south end wall of a single story lean-to built against the western gable. This has a blocked doorway. On the ground and first floors the first bay of windows has matching windows in vertical alignment, the windows being modern double glazed units of four panes. The ground floor then has a larger square window with dressed stone jambs, cill and lintel, the first floor window matching those of the west bay and being set to the west of the ground floor window opening. The masonry to left and right of the large ground floor window has straight joints indicating alteration in the original fenestration pattern with,

perhaps, a single wider and lower window being replaced with the current large opening or, alternatively, two smaller windows being part blocked and the wall between opened up to insert the current large frame (Figure 6).

Figure 6. South elevation, ground floor window in reduced opening with blocked door to left.

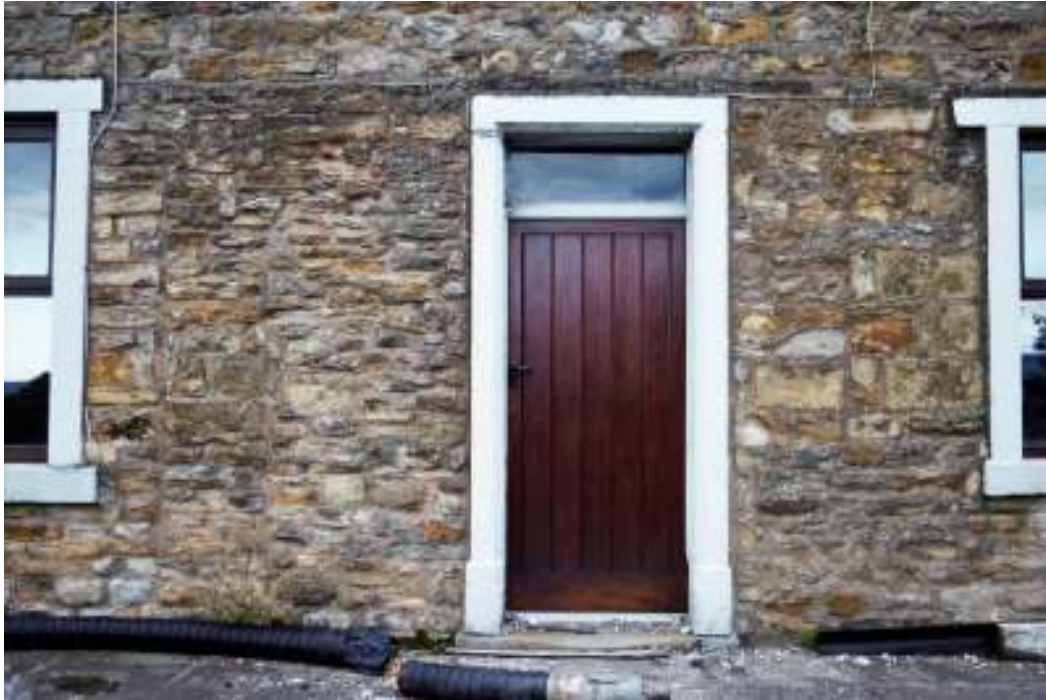
3.1.1.1.2. Approximately 0.3m to the right of the ground floor window frame is a straight joint in the masonry, running from ground level to the top of the probable former window's blocked opening. 450 mm to the right of this is a further straight joint to a similar height, then the current doorway which is framed by painted stone jambs and lintel matching its flanking windows. This shows the replacement of two smaller windows with the current window opening. The joint to the left of the door is likely to mark a former doorway, blocked and replaced by the current front door. The door itself is of vertical planks in a frame, or modern construction and with a rectangular light above. The doorway and windows' surrounds are stylistically contemporaneous and indicate a redesign of this part of the house frontage (Figure 7).

Figure 7. South elevation, door and altered door and windows.

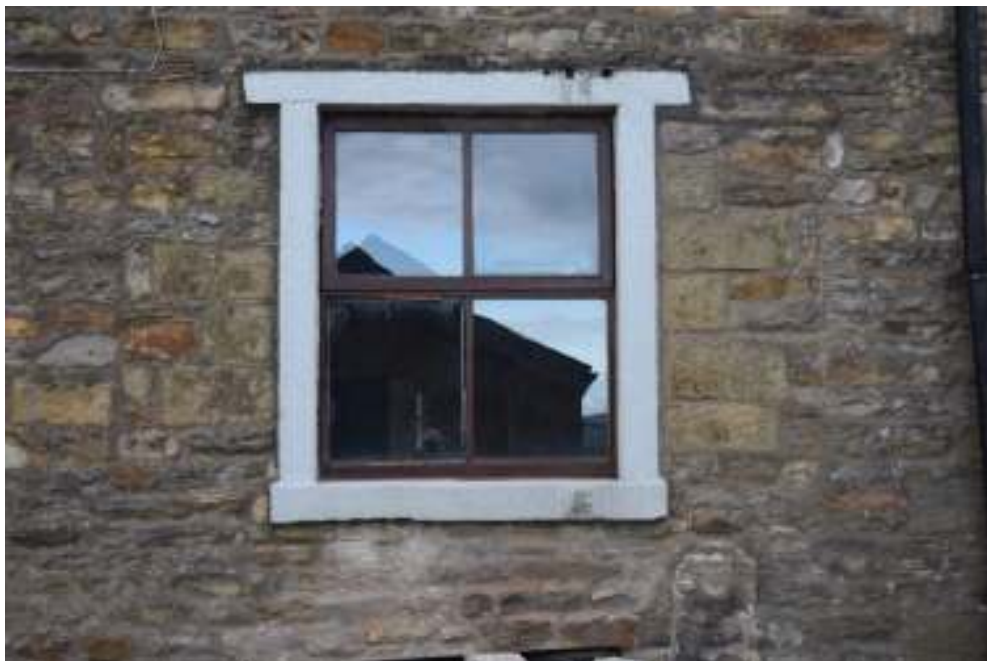
3.1.1.1.4. The eastern ground floor window matches that on the west of the door, being a large square opening with painted stone lintel, jambs and cill. There are indications that this too has been inserted into altered openings, some of the blocking material being quite well dressed ashlar rather than the rubble used elsewhere (Figure 8).

Figure 8. South elevation, east window with blocking of earlier opening.

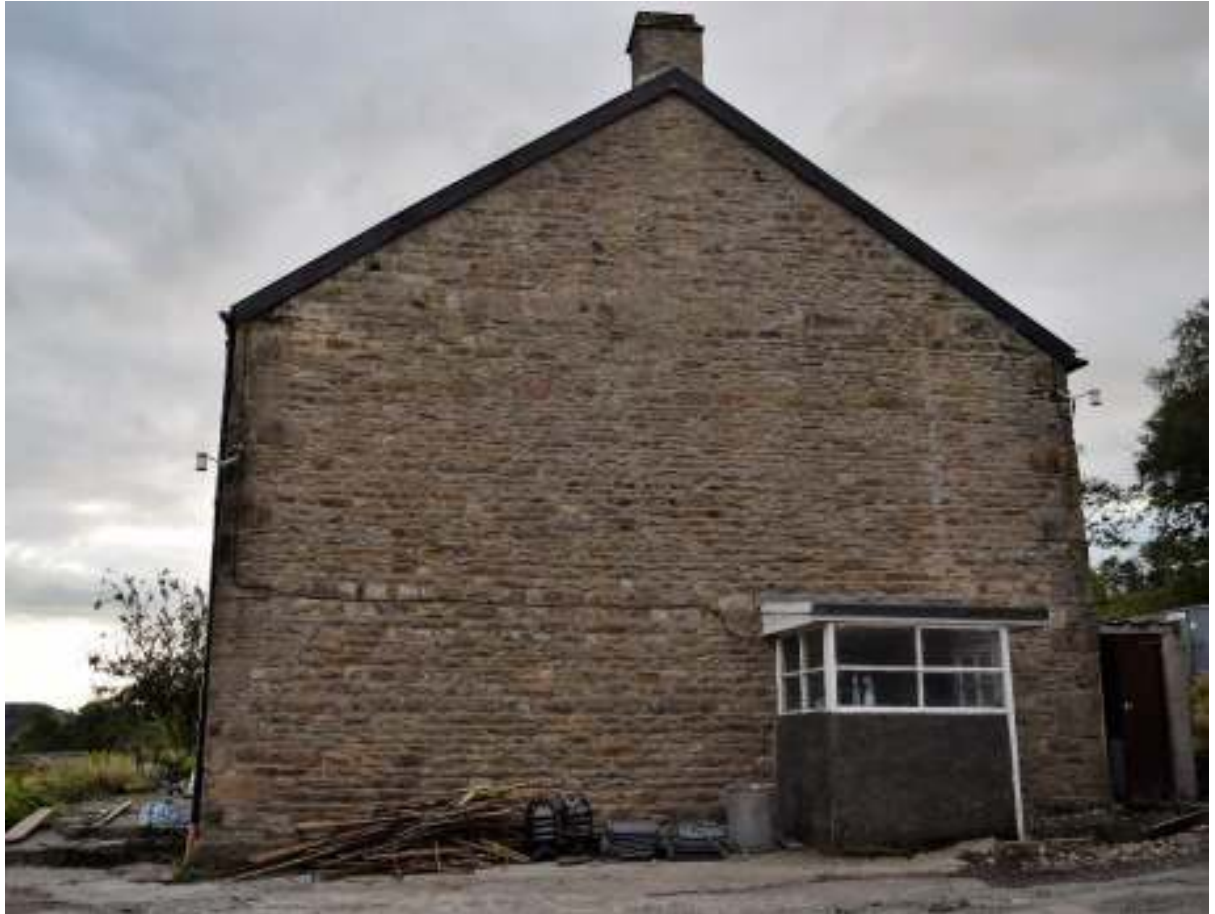
- 3.1.1.2.1. The east gable of the house has a small, modern porch on the northern end, sheltering the door to the north east room. The east elevation of a small, flat roofed outbuilding on the north elevation is on the right (north) end. The gable rises to a single chimney stack at the apex (Figure 9).

Figure 9. East gable elevation.

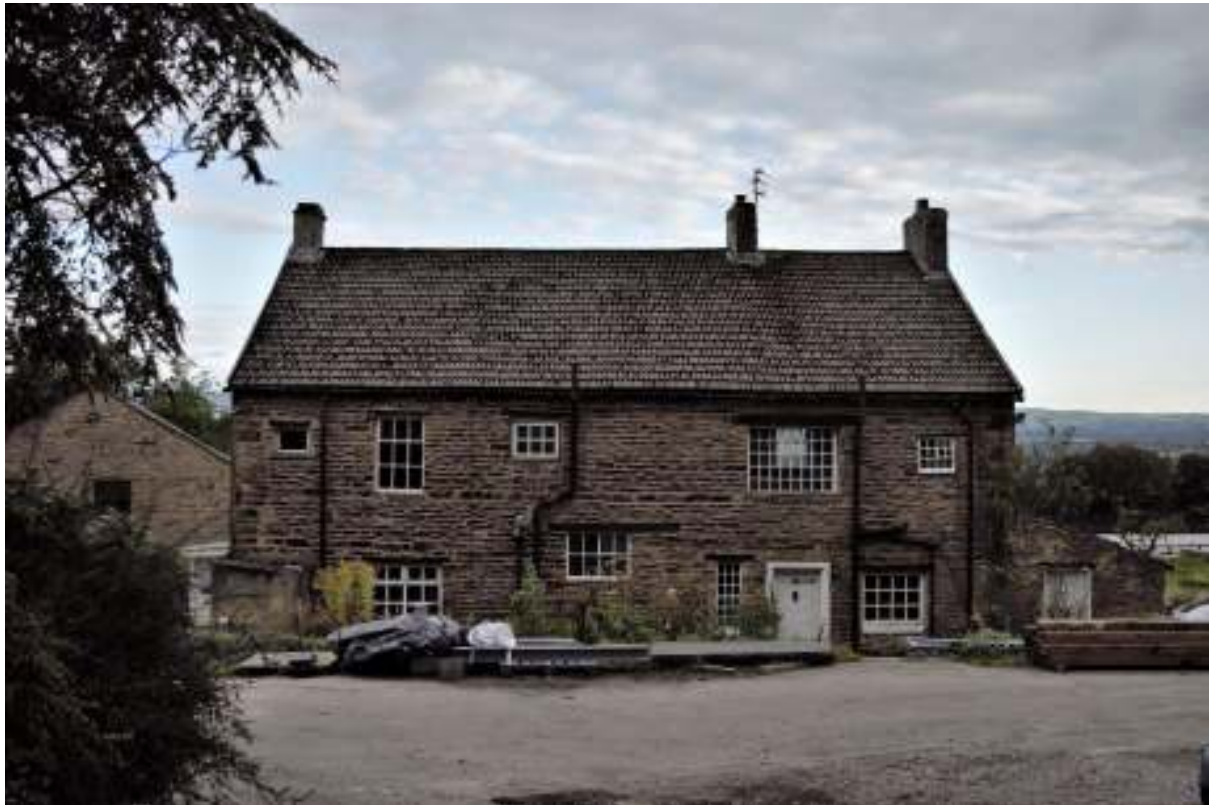
Figure 10. North elevation.

- 3.1.1.3.1. The north elevation has far more irregular fenestration than the south with evidence of significant alterations to window openings. These will be described from left (east) to right numbered 1 – 5 from the left, GF for ground floor and FF for first floor openings (Figures 10 and 11).

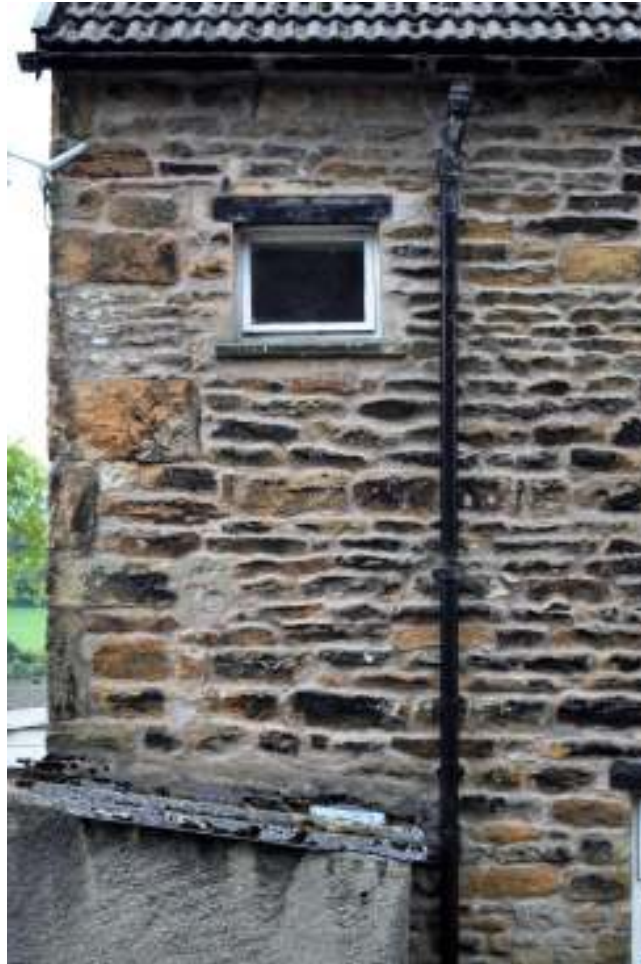
- 3.1.1.3.2. FF1: On the left (east) end is a small single story outbuilding with a monopitch roof sloping e-w. Above this on the first floor is a small, single pane window under a timber lintel which may be in an opening reduced from a larger window (Figure 12)

Figure 12. North elevation, eastern window to first floor NE room.

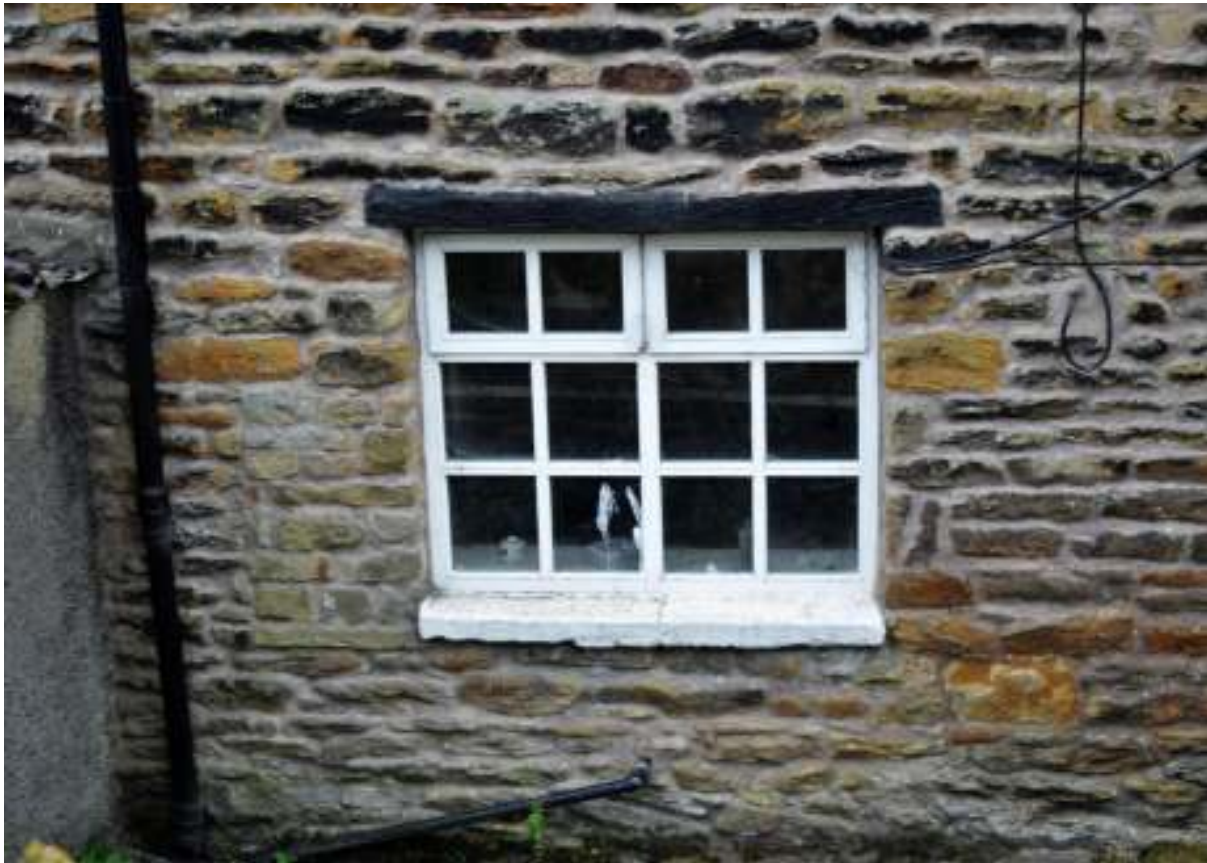
- 3.1.1.3.3. GF1: The eastern ground floor window is under a timber lintel with a stone slab cill. To the left of the current opening joints in the masonry indicate that the original opening may have been lower and wider, possibly holding a stone or wood mullioned window frame. The current window has 12 small panes set in a 4X3 arrangement with the upper four panes set in two separate canopy hung opening frames (Figure 13).

Figure 13. North elevation, ground floor eastern window.

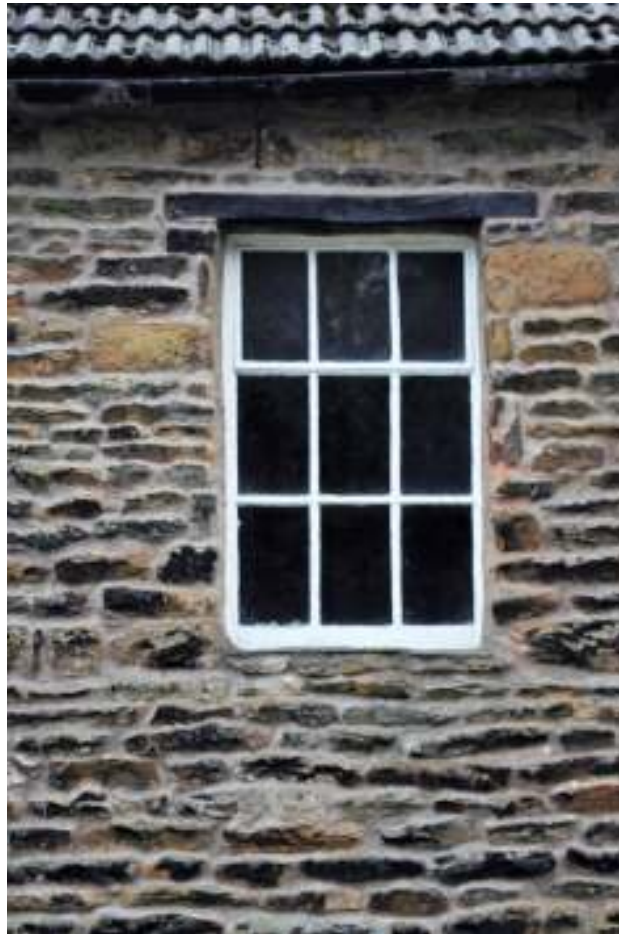
3.1.1.3.4. FF2: This is directly above GF1. It is a rectangular window under a wooden lintel with 9 panes in a 3 X 3 arrangement, the long axis of the rectangle being the vertical. The top row of panes is canopy hung in an opening light (Figure 14).

Figure 14. North elevation, FF2, second from right upper floor window.

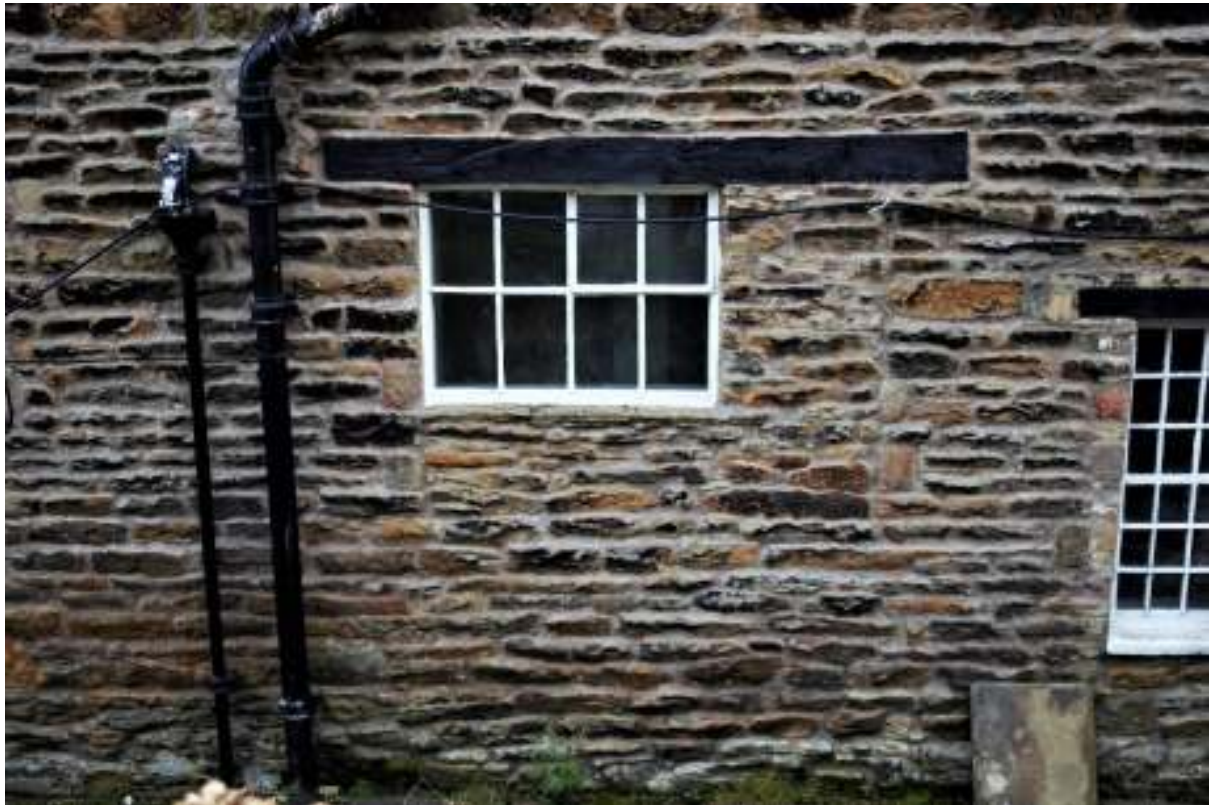
- 3.1.1.3.5. GF2: an 8 pane (4 X 2) window under a wide wooden lintel with masonry joints indicating the original window opening has been reduced in size. This lights the current staircase of the house, the reduction in size being to accommodate the stair landing (Figure 15).

Figure 15. Window in part blocked opening under wooden lintel.

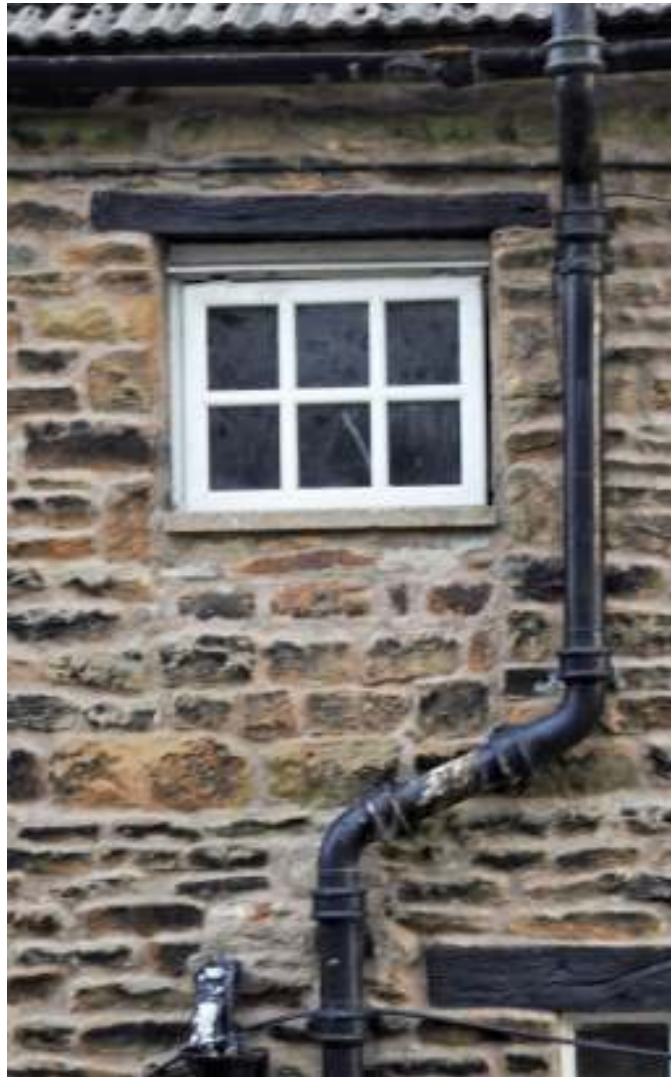
3.1.1.3.6. FF 3: above and offset left to GF2. FF3 is a small window in a reduced opening. The reduction in this case appears to be to provide privacy for a bathroom inserted into the upper floor (see below 3.2.2.2.27). The window is a modern canopy hung frame with 3 X 2 panes (Figure 16).

Figure 16. First Floor 3, window in reduced opening.

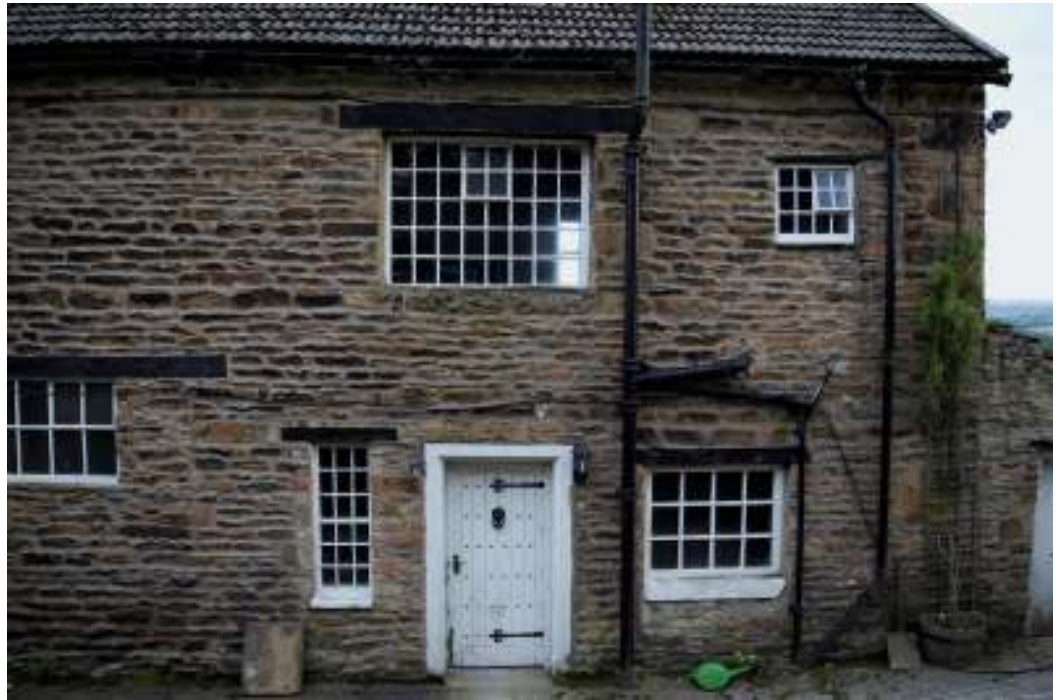
3.1.1.3.7. The west end of the northern elevation shows a considerable irregularity in the fenestration pattern, and differing window styles although some of these are modern windows so reflect a recent modification to the windows rather than the historic types. This may also be the result of alterations to door and window openings (Figure 17).

Figure 17. West end of north elevation.

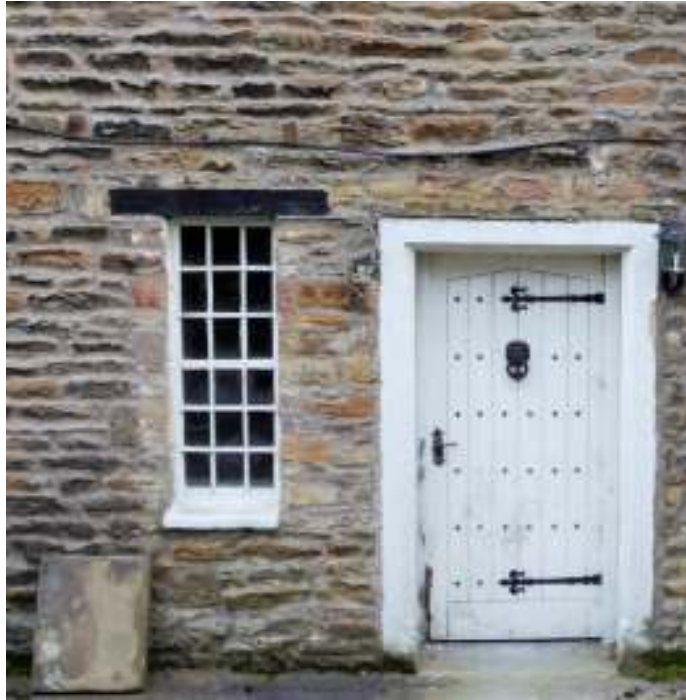
Figure 18. Ground floor window.

- 3.1.1.4. GF 3: just to the left of the door in this elevation. It is tall and relatively narrow with a 2 X 6 arrangement of small panes. It may have been inserted as there are slight differences in the masonry around it in comparison to the adjacent wall (Figure 18). This can also be seen in the doorway surrounds where small stones break the lines of the rubble coursing and there is a slight difference in masonry above the stone door surround (see also Fig 76 below for the interior face). The door is vertical planks in a frame with assorted modern decorative door furniture (Figure 19).

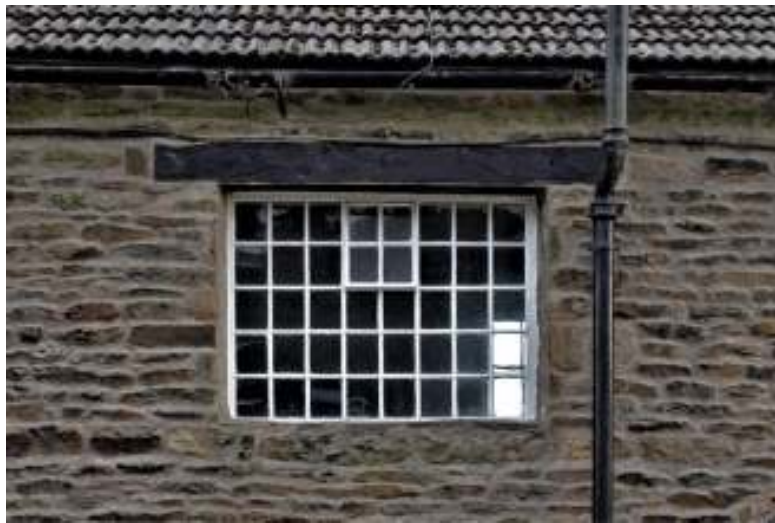
Figure 20. FF4 West end first floor window.

- 3.1.1.5. FF4: directly above the doorway FF4 is a large window under a wooden lintel. The window has small panes in an 8 X 5 arrangement. The centre pairs of panes in the upper two rows are canopy hung in a single light (Figure 20).

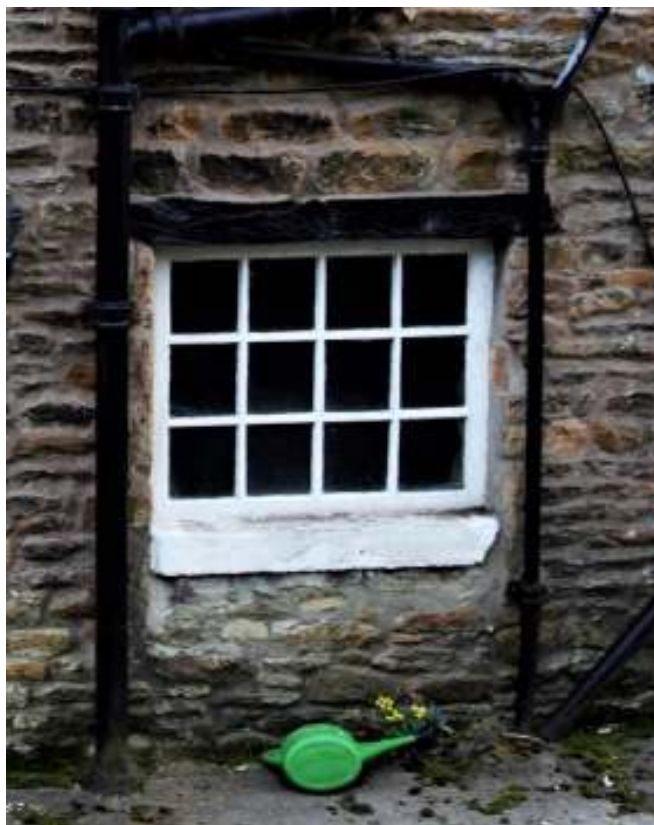
Figure 21. GF4 West end window in former door opening.

- 3.1.1.6. GF 4: under a timber lintel with small panes in a 3 X 4 arrangement. Below the window jambs straight joints indicate this may be an altered door, part blocked with the window inserted. The coursing of the masonry above the lintel may indicate that this has been lowered slightly (Figure 21).

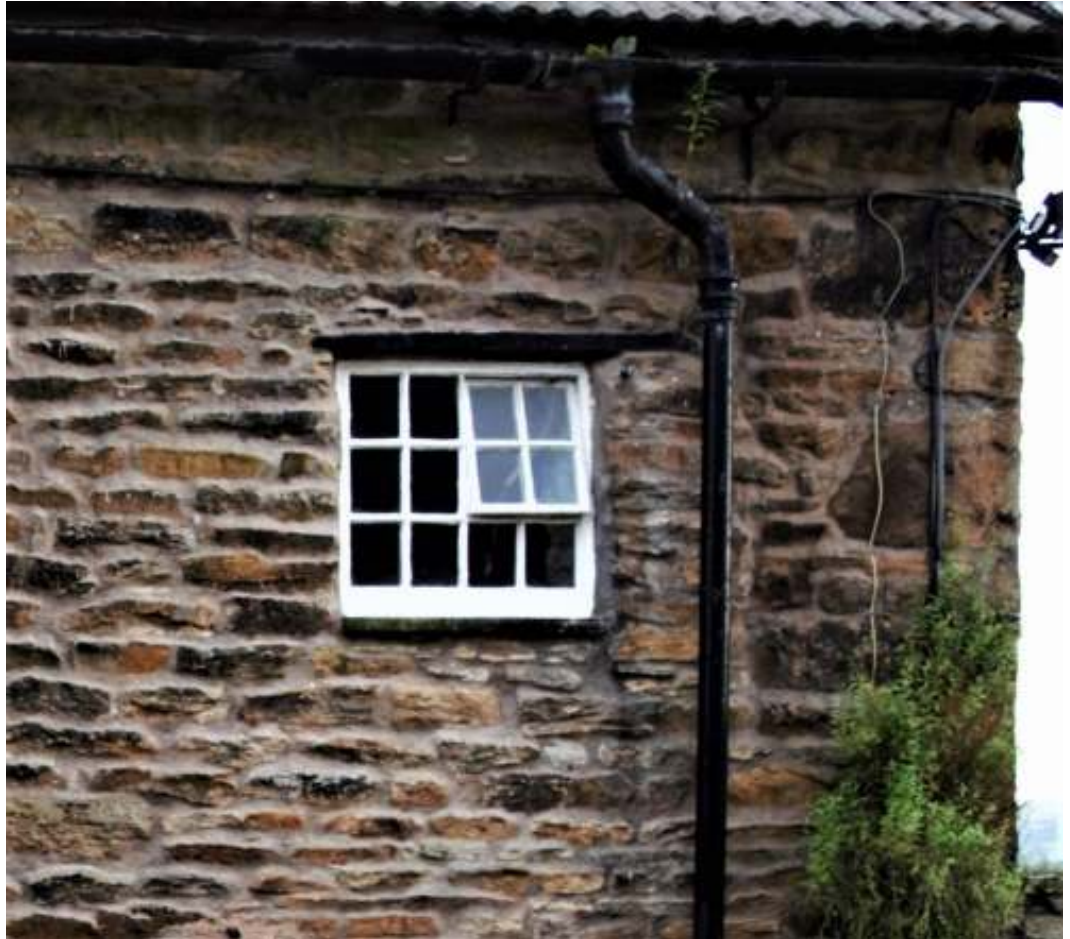
- 3.1.1.7. FF5: a small window near the gable end under an asymmetric wooden lintel. It has square panes in a 4 X 3 arrangement. The right hand pair of panes of the upper two rows are canopy hung in an opening light. The lintel extends well to the west of the west window jamb and may indicate the original window opening was wider (Figure 22).

Figure 22. FF 5 West end window.

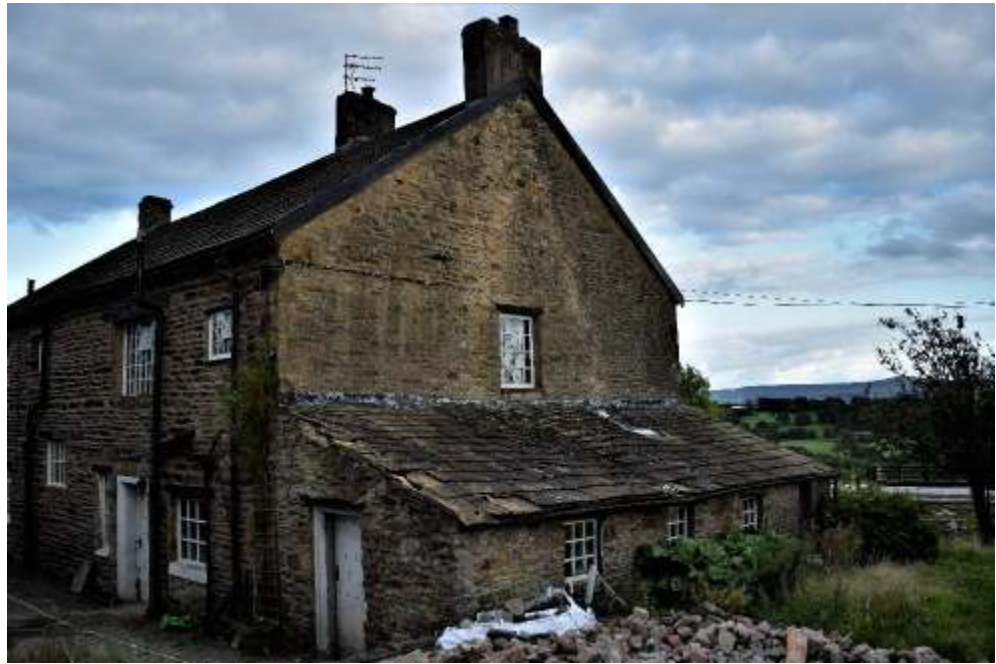
Figure 23. West gable end with lean-to.

- 3.1.2.1. This is the west gable end, the lower part covered by a single story lean-to under a stone slab roof (Figure 23).

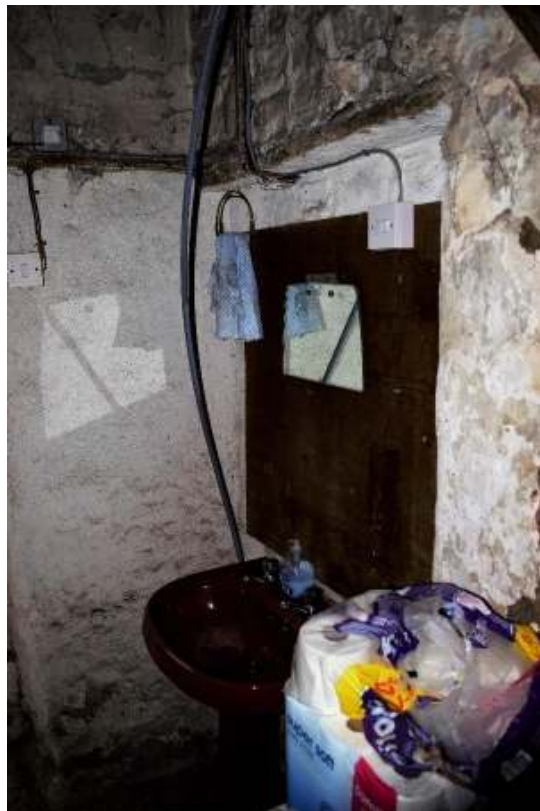
- 3.1.2.2. The lean-to conceals a blocked window toward the north end of the wall, a door which would have entered the south west room of the house and a second blocked window towards the south end of the gable wall (Figures 24, 25 and 26).

Figure 24. Blocked door to NW room of house, part hidden by panel and basin.

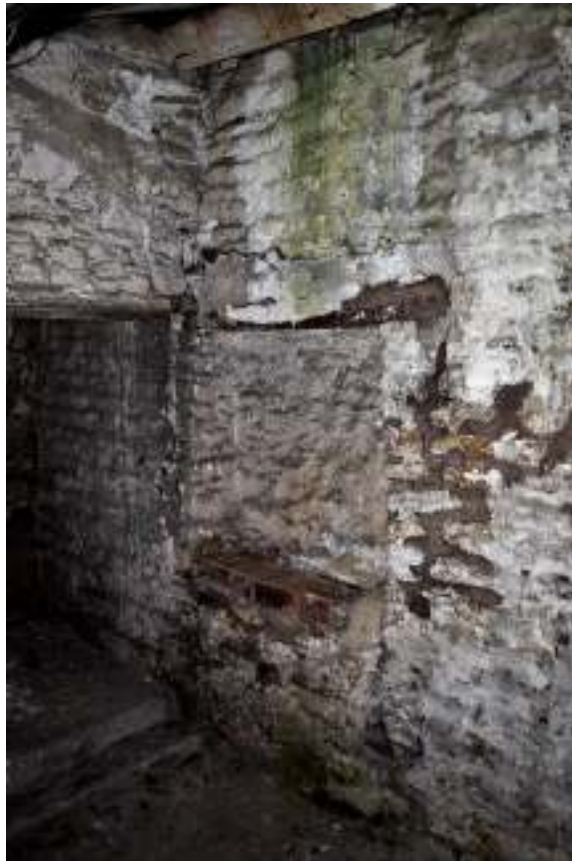
Figure 25. Blocked door to SW room of house.

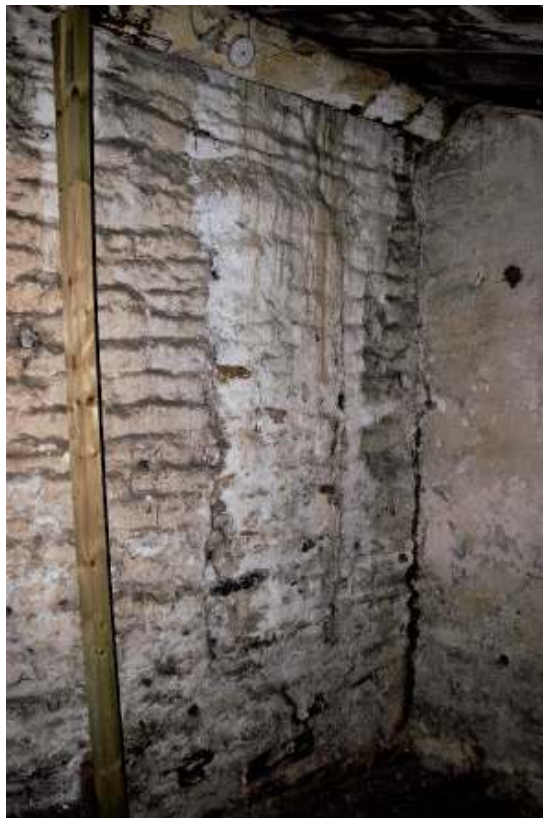
Figure 26. West gable, blocked window to SW room of house.
For the use of PWA Planning and Mrs and Mrs McHugh.

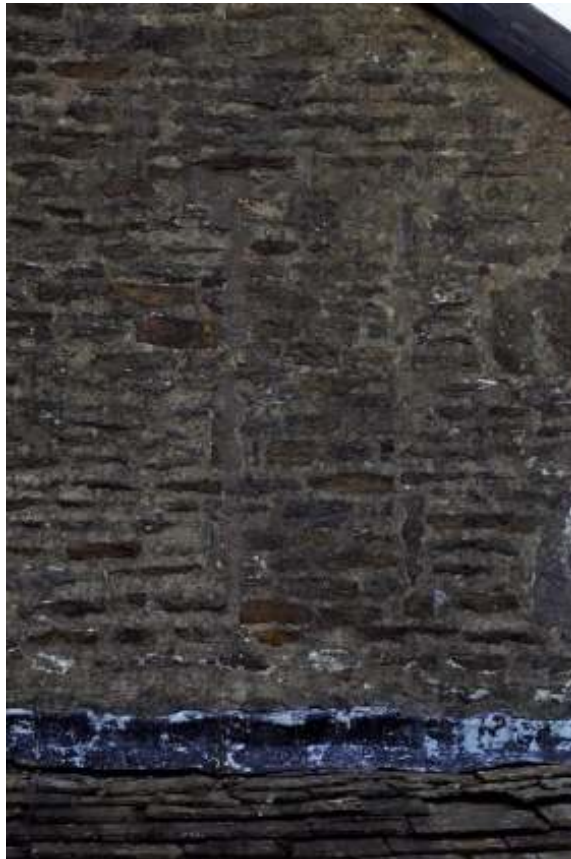
- 3.1.2.3. Towards the southern end of the gable on the first floor is a tall rectangular blocked opening. This would have been a window to the south west room on the upper floor (Figure 27).

Figure 27. Blocked window to south west first floor room.

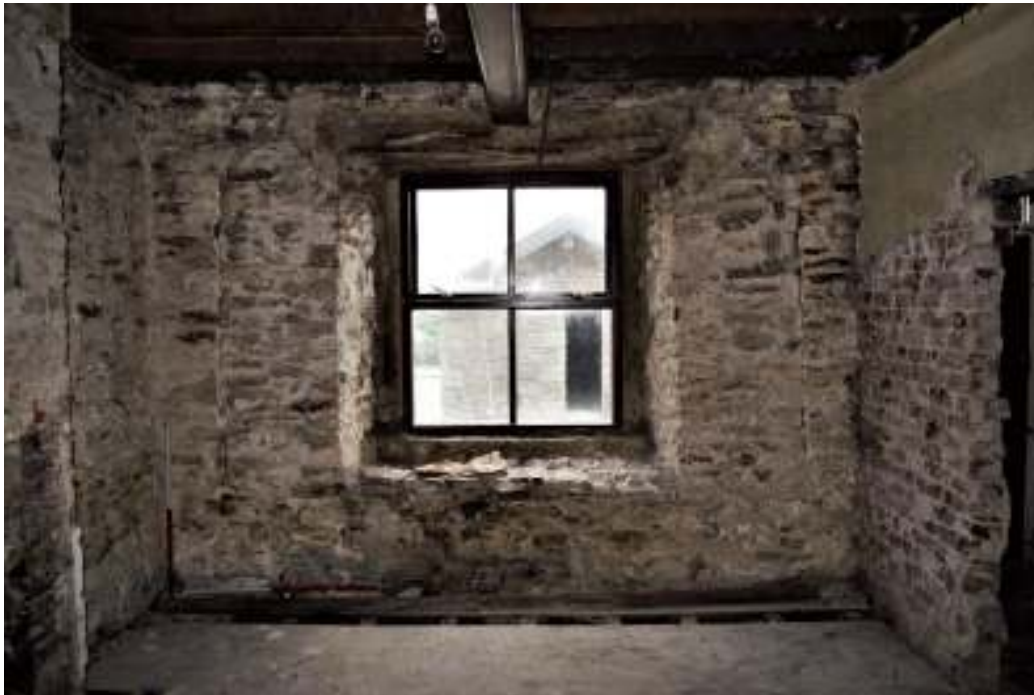
3.2.1.1.3. The eastern room, south elevation, has a large square window with a modern frame. The masonry on either side of this has vertical straight joins. It is most probable that the original fenestration was a pair of windows similar in size and shape to the west end windows with the present opening inserted and the original window openings reduced to give a single large light to the room. This opening has a substantial timber lintel which supports the southern end of one of the ceiling beams which would originally have been embedded in the masonry between the original window openings (Figure 30).

Figure 30. South east room, south elevation, window replacing two narrower openings.

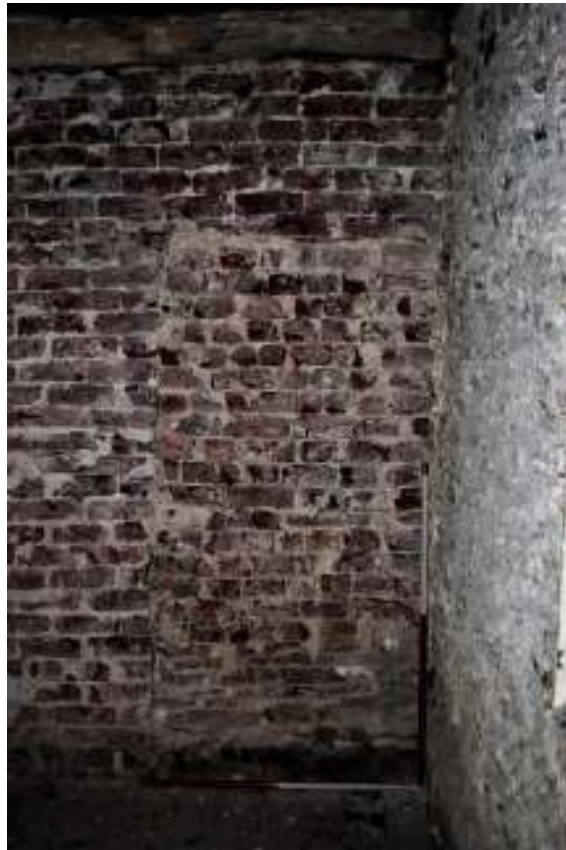
3.2.1.1.4. The west wall is an inserted, single brick thick, portion. It has a blocked doorway at the northern end (Figure 31) and a door that appears to have been cut through just south of the centre point (Figures 32 and 33). The wall “underbuilds” one ceiling beam (Figure 34).

Figure 31. South east room, west elevation, blocked door at northern end.

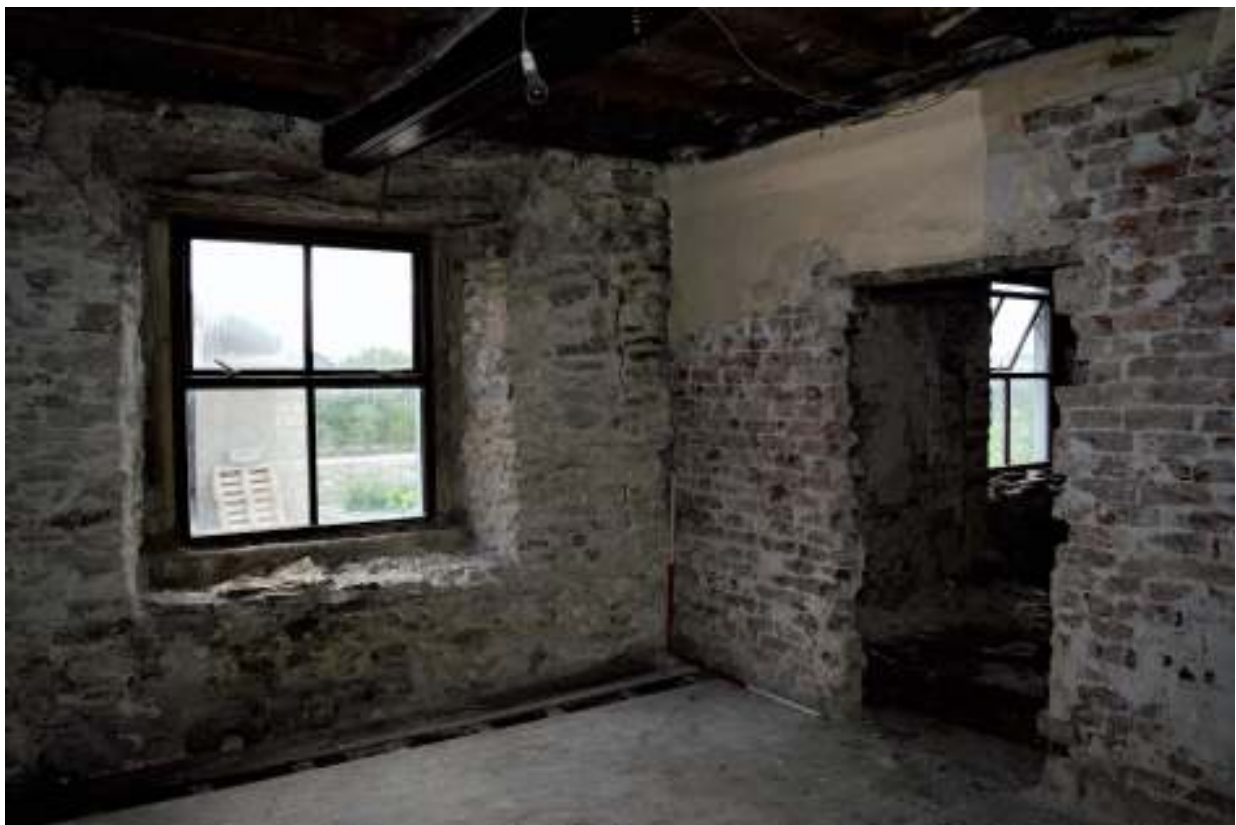
Figure 32. South east room door, south west corner with south window and inserted door in west wall.

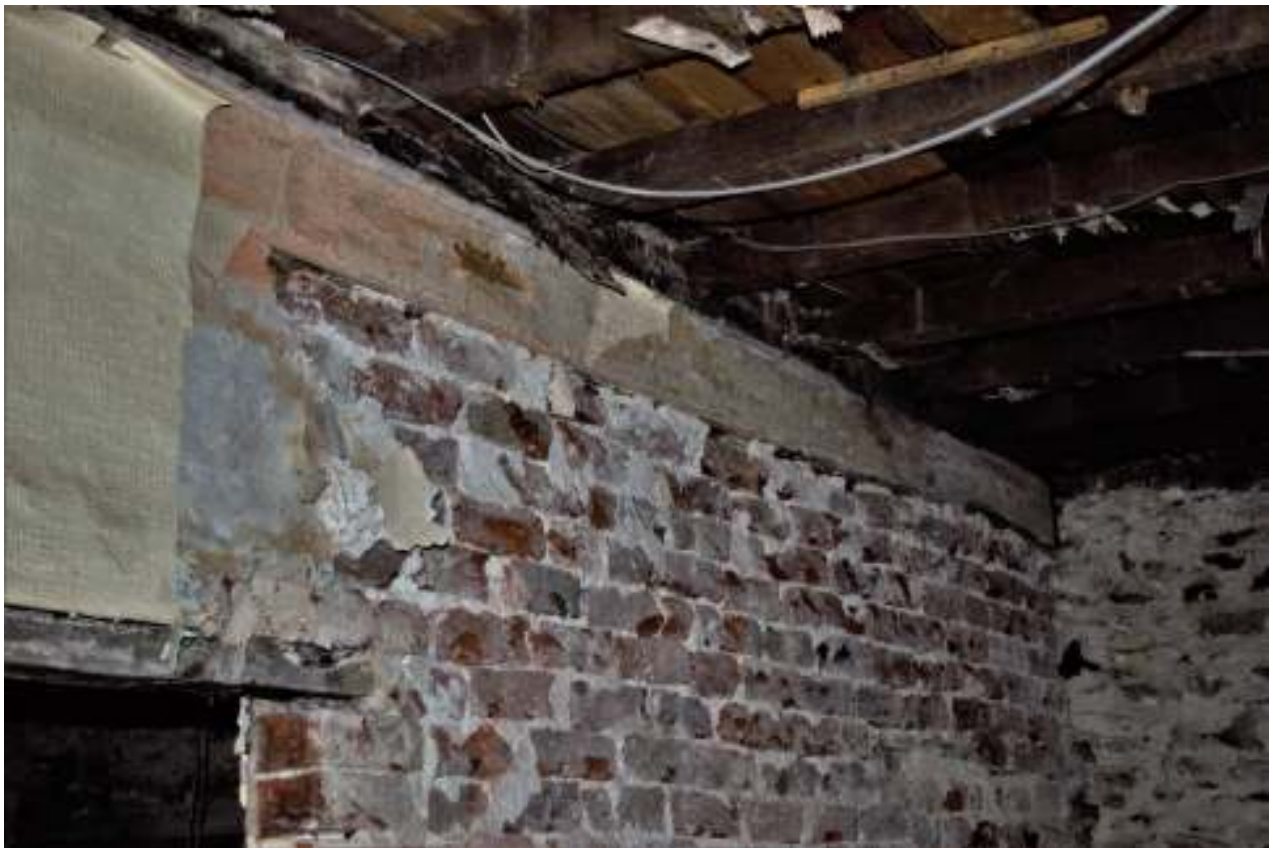
Figure 33. Door in W elevation SE room cut through inserted wall.

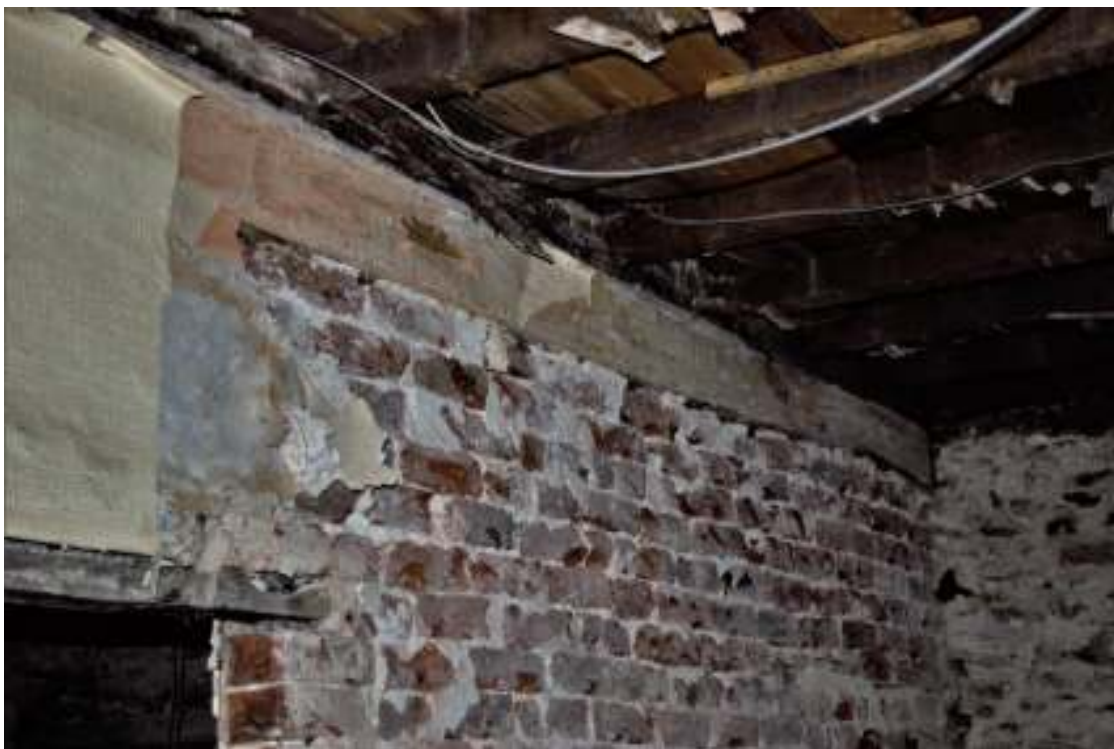
Figure 34. South east room, inserted brick wall below ceiling beam.

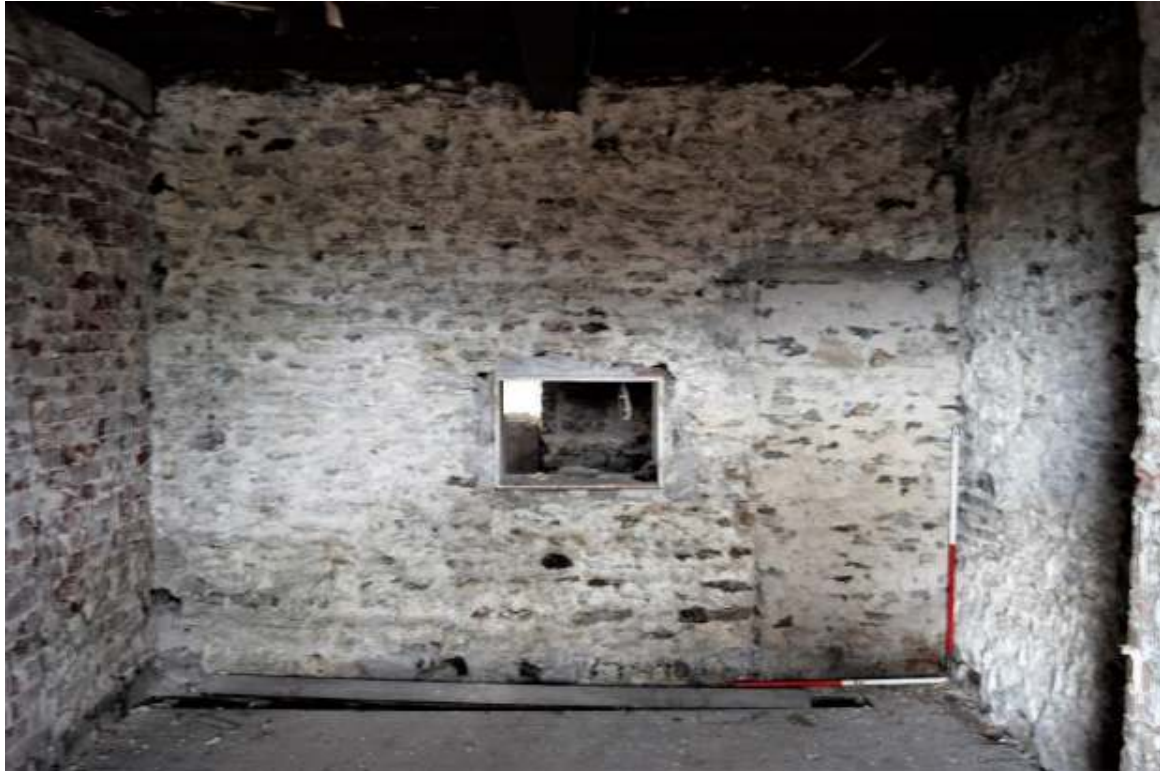
- 3.2.1.1.5. The north wall has a small hatch approximately central to the wall and c. 0.9 m above floor level. This is a service hatch cut through the spine wall, connecting to the kitchen in the north range of rooms. On the left (eastern) end of the wall is a former doorway under a timber lintel, the door blocking being rubble masonry (Figure 35).

Figure 35 South east room, North elevation wall hatch and former door to kitchen.
