LOWER CLERK HILL, WHALLEY LANCS.

HISTORIC BUILDING RECORD

January 2018

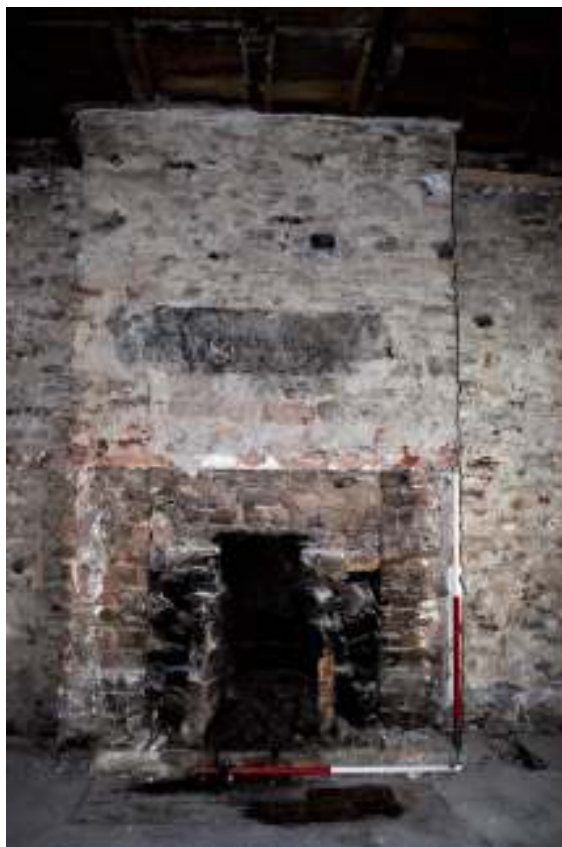
- 3.2.1.1.6. The east wall, the gable of the house, has a fireplace which appears to originally have had a high firebox opening under a stone lintel with brick supporting cheeks. This was later reduced to a smaller firebox, brick built inside the primary firebox and reducing the height to the mantel. (Figure 36). The chimney breast was built against the original wall face with a straight joint visible on both sides (Figure 37).

Figure 36. South east room, east elevation fireplace.

- 4.7. Fireplaces appear to have been added to many rooms, the chimney breasts being added over the facing plaster of the walls, rather than being keyed to the masonry as one might expect. The flues from these will run in the thickness of the gables and the main dividing wall that supports the middle chimney. It is likely that the “applied” chimney breast either replaced or were added over, earlier, smaller fire surrounds with the visible stone slab surrounds visible perhaps showing the early size of the fireplaces with the chimney breasts added to these and were perhaps altered to allow a more elaborate mantelpiece to be displayed in the rooms to raise their status, perhaps associated with 19th C alterations to the front elevation windows and doorway..

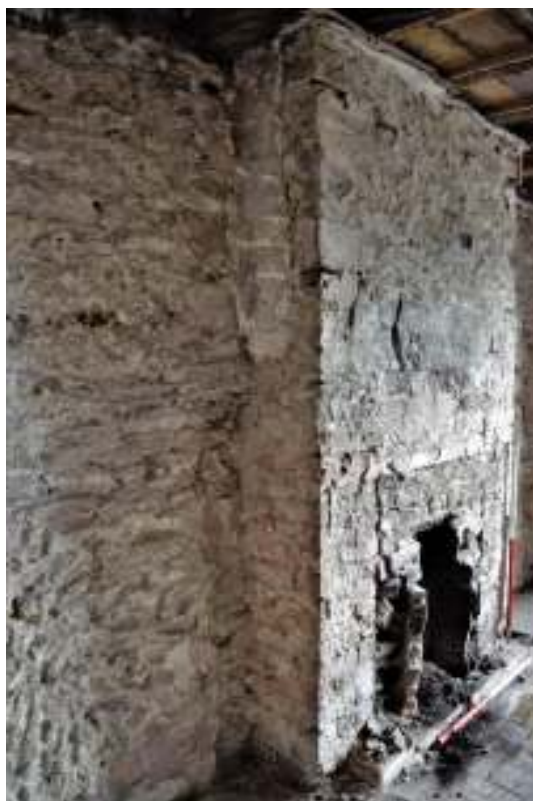
Figure 37. South east room, chimney breast straight joint with wall.

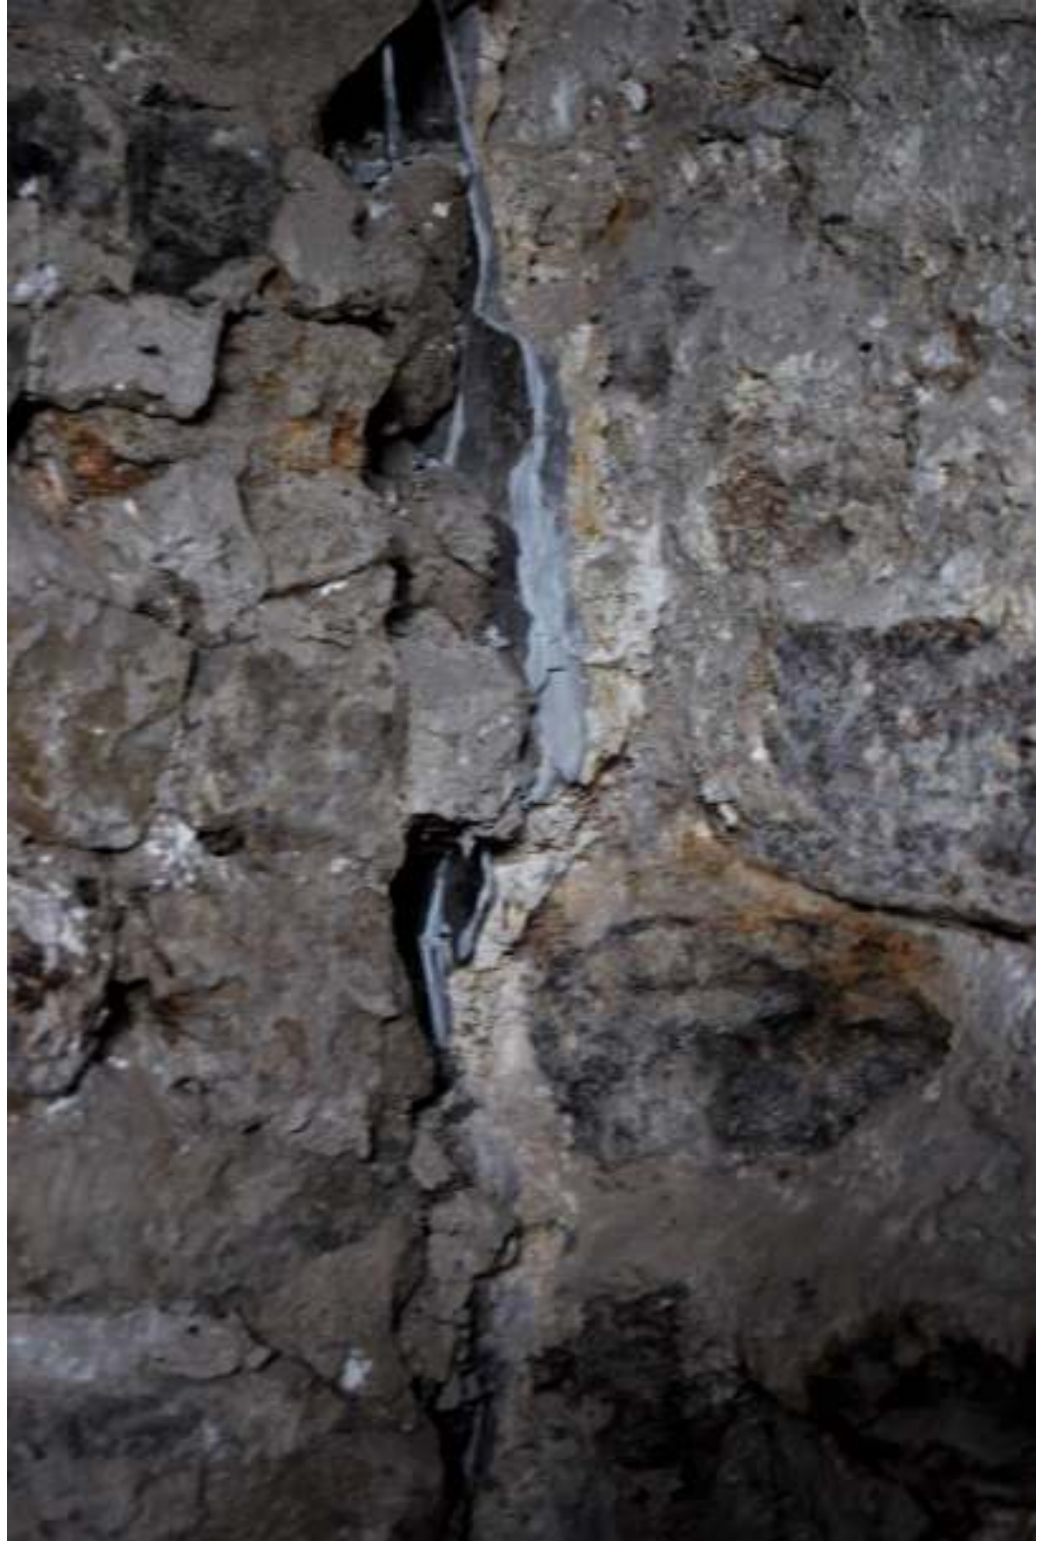
- 3.2.1.1.7. In common with other insertions (of fireplaces and dividing walls) in the building the additions was built straight onto the plaster of the wall, rather than this being hacked off to provide a better key for the added structures to the original masonry (Figure 38).

Figure 38. South east room, chimney breast butted against wall plaster.

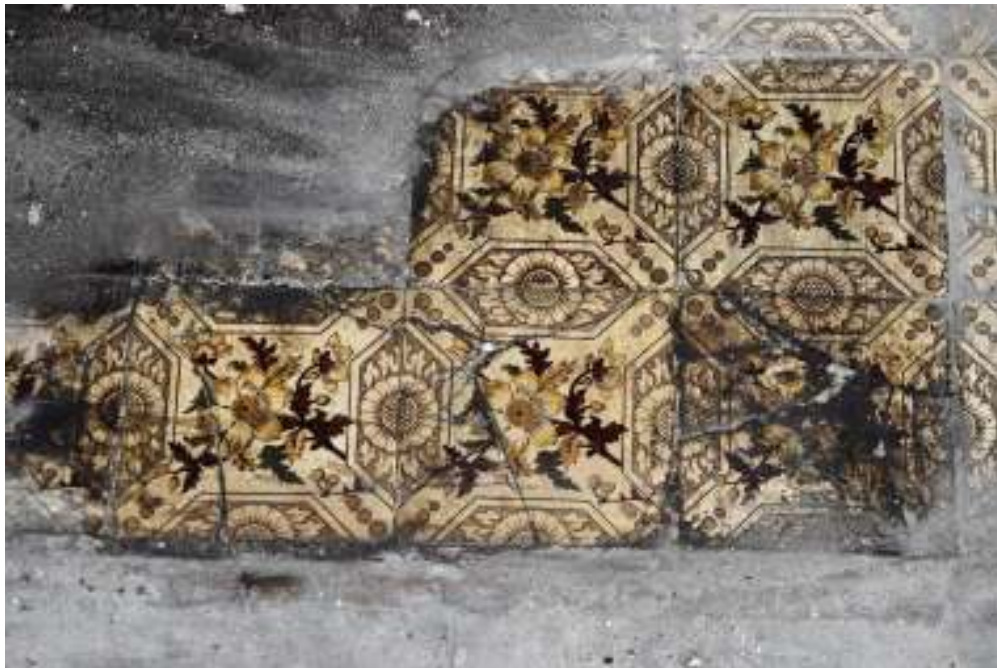
- 3.2.1.1.8. The hearth of the fireplace has the remains of tiled decoration, probably 19th C in date (Figure 39).

Figure 39. South east room, hearth tiles in front of fireplace.

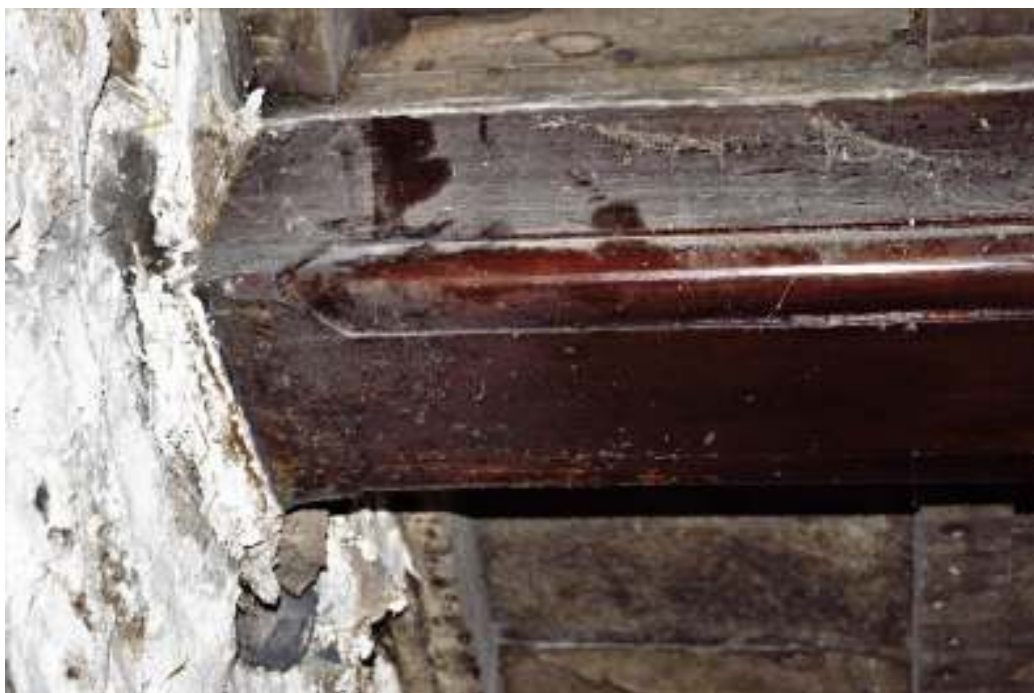
- 3.2.1.1.9. The ceiling beams run S-N and have ovolo mouldings on the lower arrisses, terminating just short of the walls in an angled stop with a run out stop between the end of the moulding and the wall face. The upper arrisses are cogged to receive the floor joists of the first floor (Figure 40).

Figure 40. South east room ceiling beam moulding and stop detail.

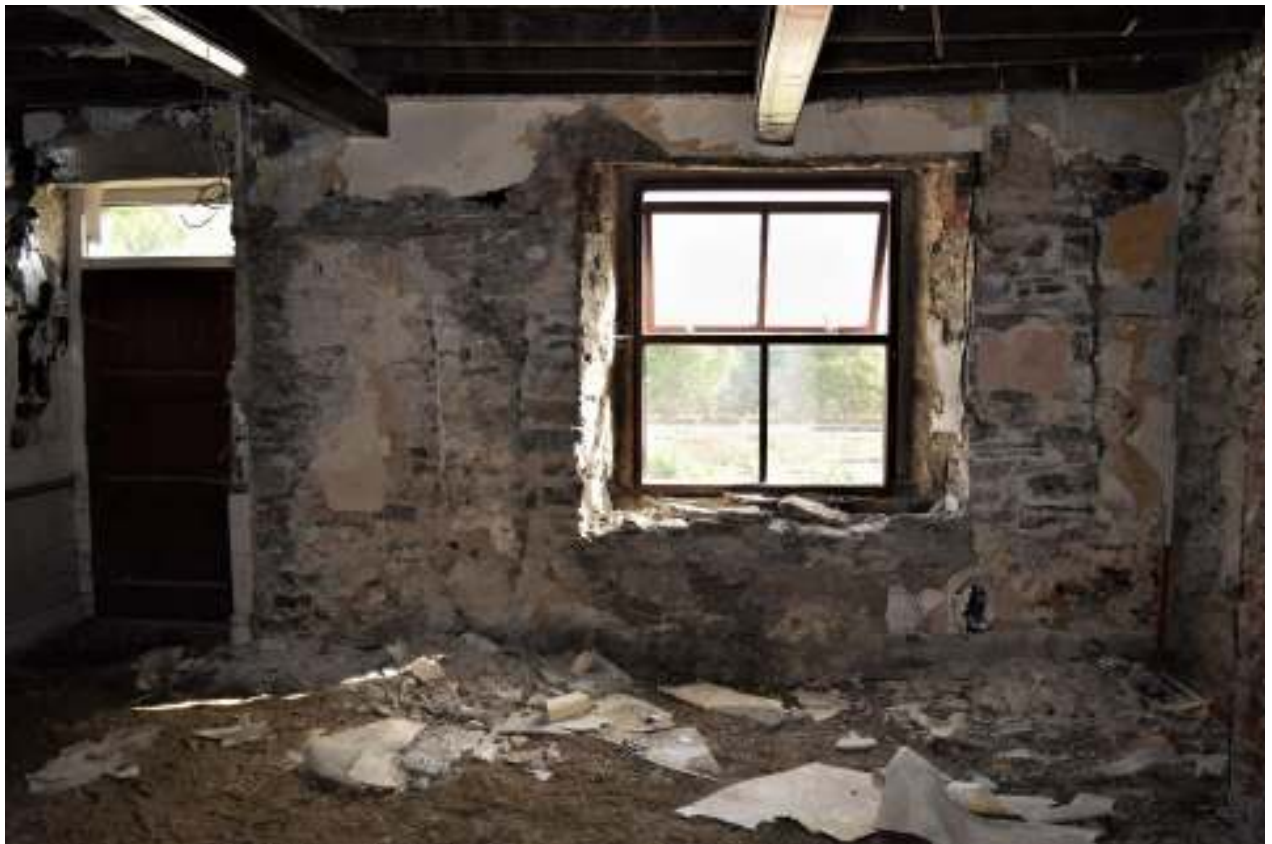
3.2.1.1.11. The south wall has the front door of the house with, on the right (west) the joint lines of the blocked original doorway (Figure 41 and 42). Right of this is the large square window. The window opening is below the end of one of the ceiling beams which is supported on a substantial timber lintel ((Figure 43). To either side of the window there are vertical masonry joints that indicate, like the window in the south east room, this is an alteration with the large square window inserted in what was the wall between two smaller windows with the former openings partially blocked (Figure 44).

Figure 41. Centre room, south elevation.

- 4.5. A major alteration to the house appears to have been made, probably in the 19th C, when the front door was moved slightly to the east and large single windows were inserted to replace pairs of the original windows. The O.S. 25 inch:1 mile map of 1910 shows the building

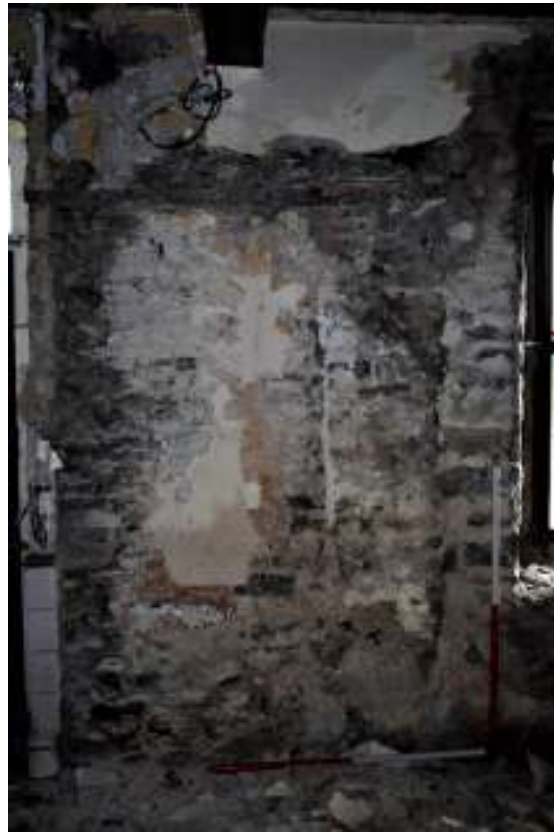
Figure 42. Central room, south elevation masonry joints.

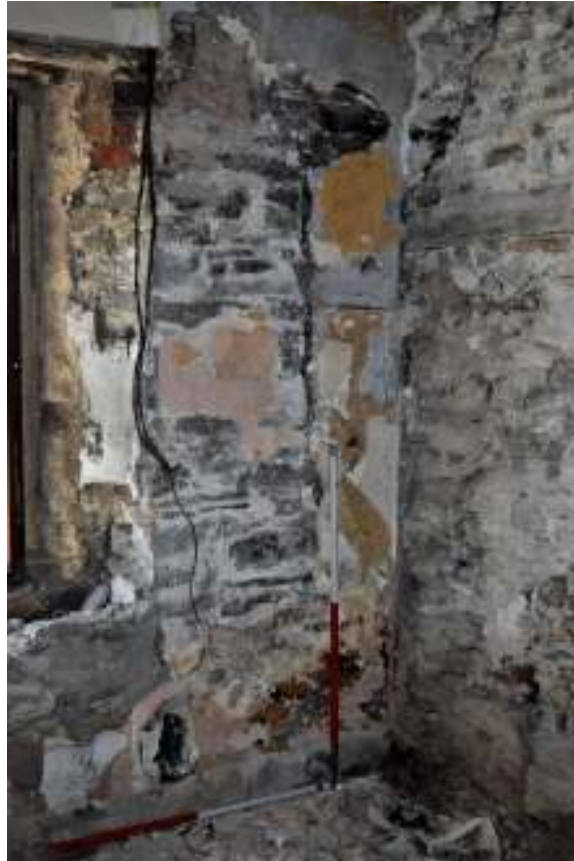
Figure 43. Masonry joint indicating blocking, south elevation window.

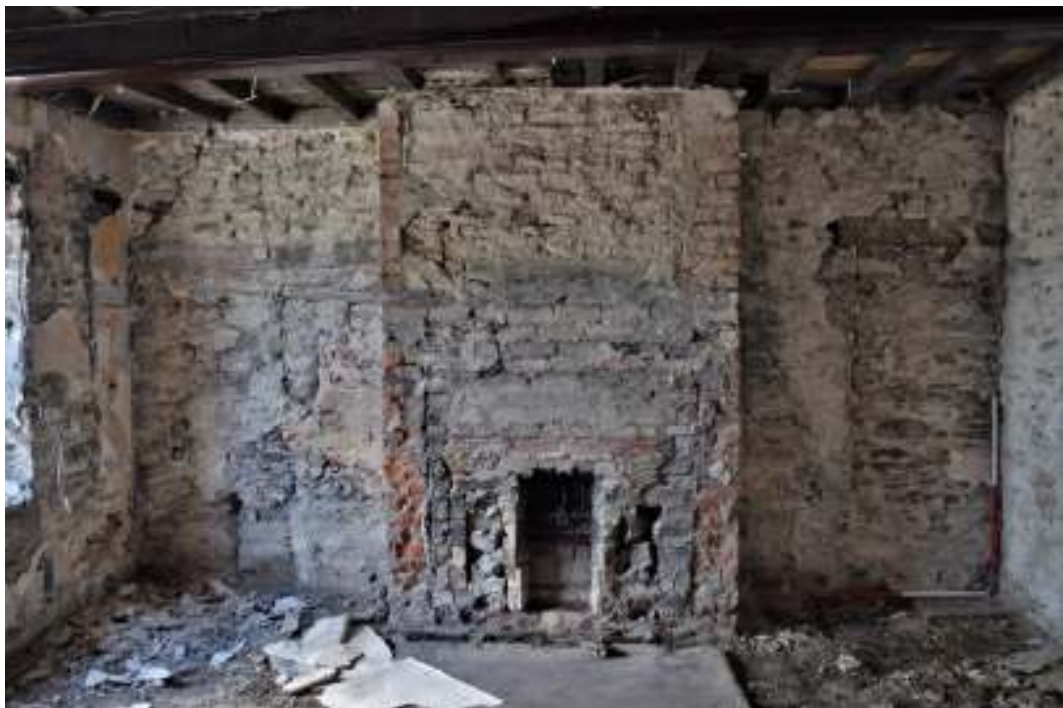
3.2.1.2. The west elevation has a fireplace approximately centrally. To the left and right there are blocked doorways, both under timber lintels (Figure 44).

Figure 44. Centre room west elevation.

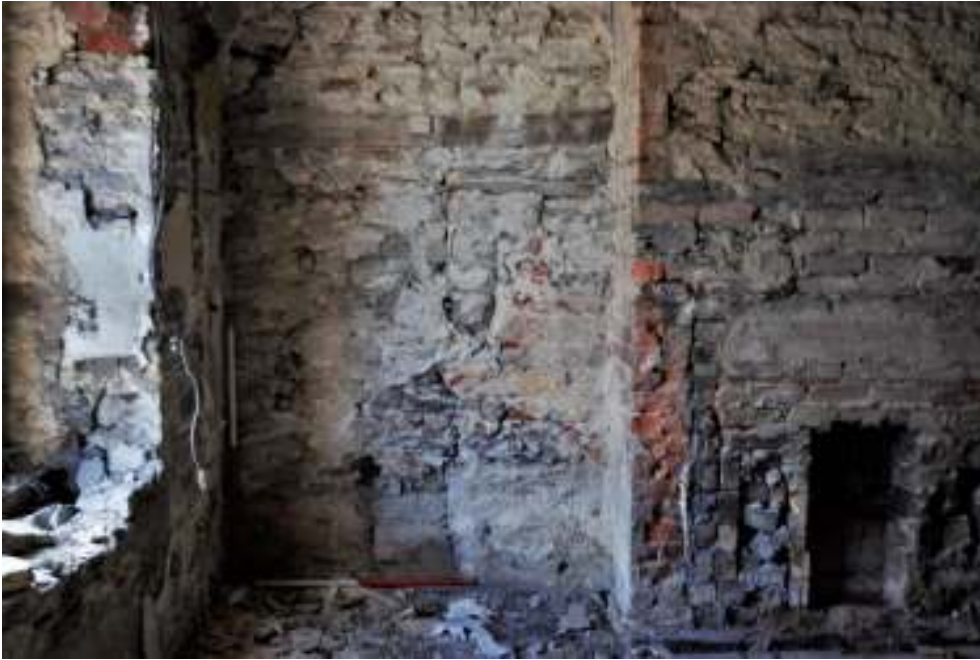
- 3.2.1.3. The lower part of left had blocking has been further altered with brickwork, some of which forms a sloping line from the left (south) towards the chimney breast to the north (Figure 45). Removal of some of the blocking and the sloping bricks revealed the flue interior. A probe indicated it joins the main chimney flue. This flue either served a small fireplace inserted into the blocking of the earlier doorway or was to service a stove or similar standing in the room in front of the wall face. This seems unusual given the presence of the larger fireplace immediately to the right of this position (Figure 46).

Figure 45. Centre room flue inserted into south door blocking.

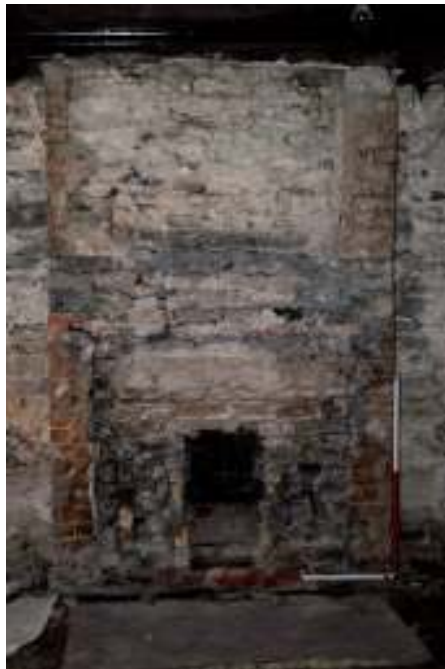
- 3.2.1.4. The chimney breast has been built against the wall face with brick side walls infilled with rubble masonry above a stone slab in the front face, and brick below the lintel and round the current firebox (Figure 47).

Figure 47. Centre room W elevation Fireplace and chimney breast.

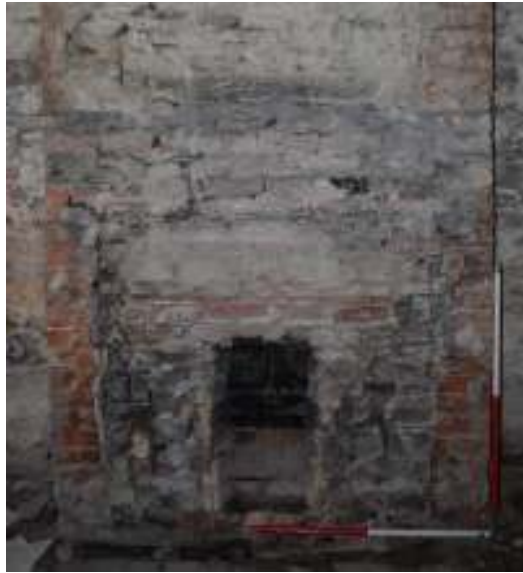
Figure 48. Fireplace detail.

- 3.2.1.5. It is likely that the original firebox was the full width of the space between the brick side wall and there may have been a timber lintel below the stone slab, the brickwork at this point being three courses with the bed face as the face of the wall and the left hand brick cheek wall being two brick thickness to that height and only one above. The firebox may also have been reduced in width twice, the outer blocking being reasonably well-placed brick with brick rubble fill between this and the present firebox wall (Figure 48).

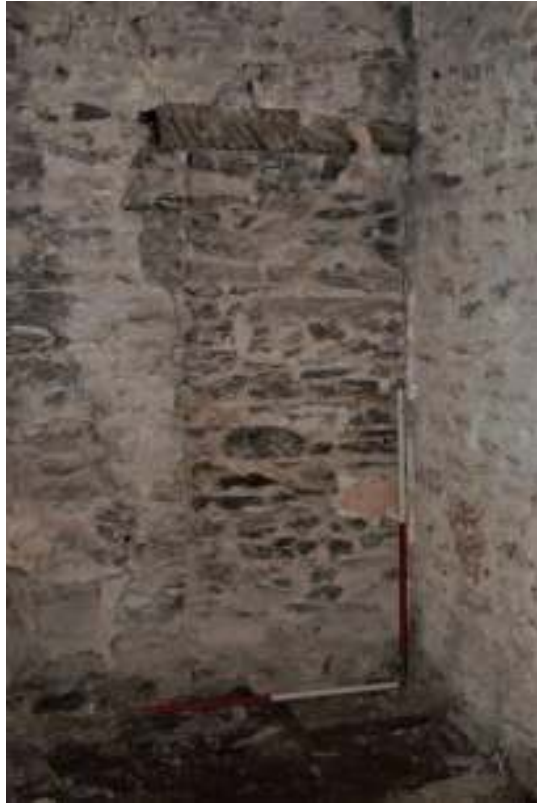
- 3.2.1.6. At the north end of the elevation there is a former doorway under a timber lintel, the face of which has nailed on lathes for plastering, blocked with rubble masonry (Figure 49).

Figure 49. Centre room W elevation north blocked doorway.

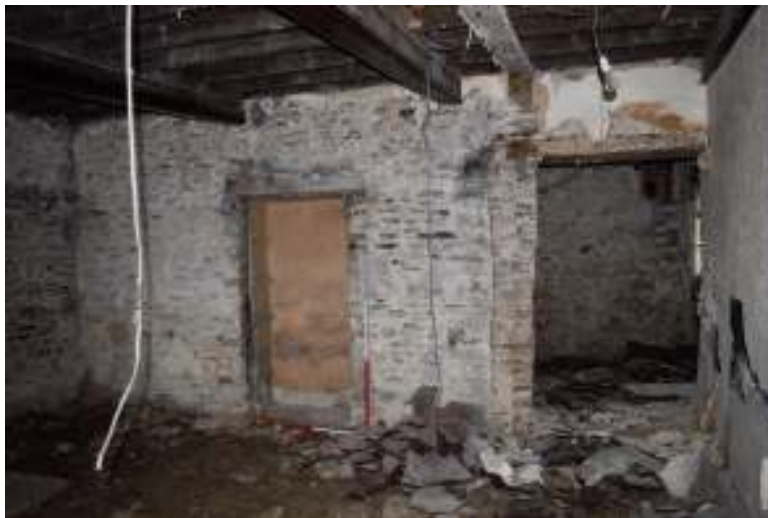
Figure 50. Centre room north elevation.

- 3.2.1.7. The north elevation has a former doorway at approximately the centre point. This has a timber lintel and has been part blocked to form a cupboard in the thickness of the wall (Figures 50 and 51).

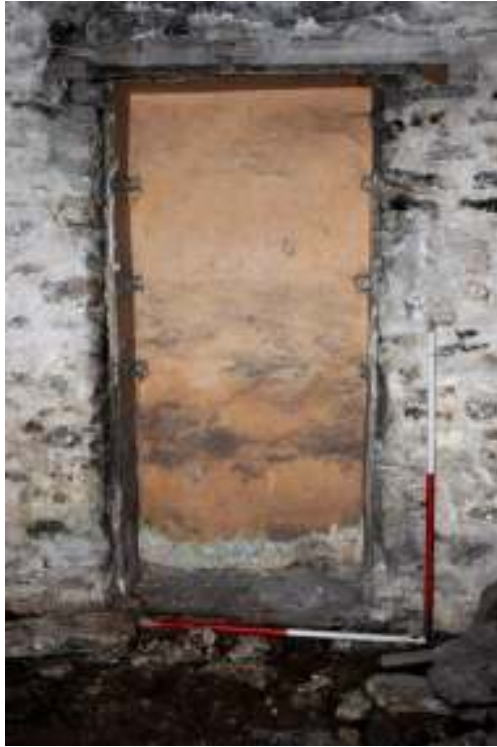
Figure 51. Centre room north elevation cupboard in blocked doorway.

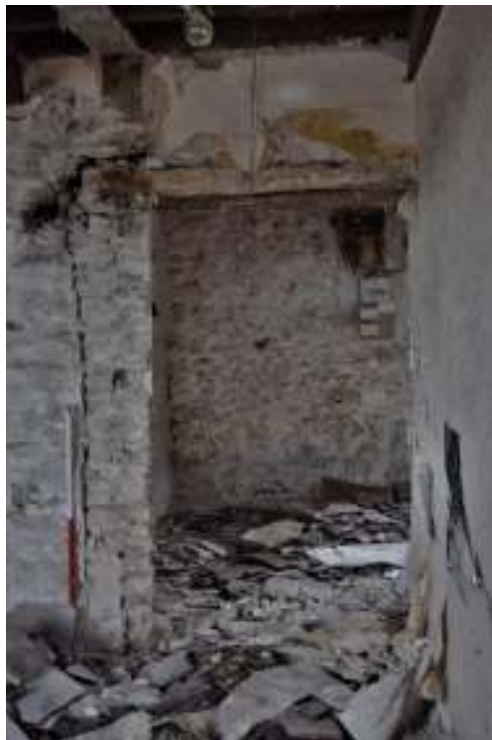
- 3.2.1.8. At the eastern end of the elevation is a doorway through to the north range of rooms. This is under a timber lintel and has been narrowed on the left hand (west) side (Figure 52).

Figure 52 Centre room north elevation door with narrowing on left.

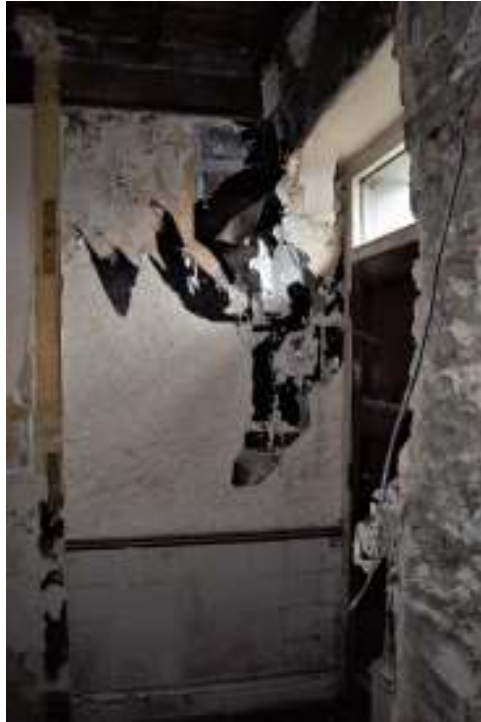
- 3.2.1.9. The west elevation is the reverse of the single skin brick dividing wall described above with blocked door at the north end and inserted door in the centre. The southern end has had applied tiles and decorative finish with the trace of a vertical partition, probably as part of a small entrance lobby in the corridor (Figure 53).

Figure 53. Entrance lobby traces centre room west elevation.

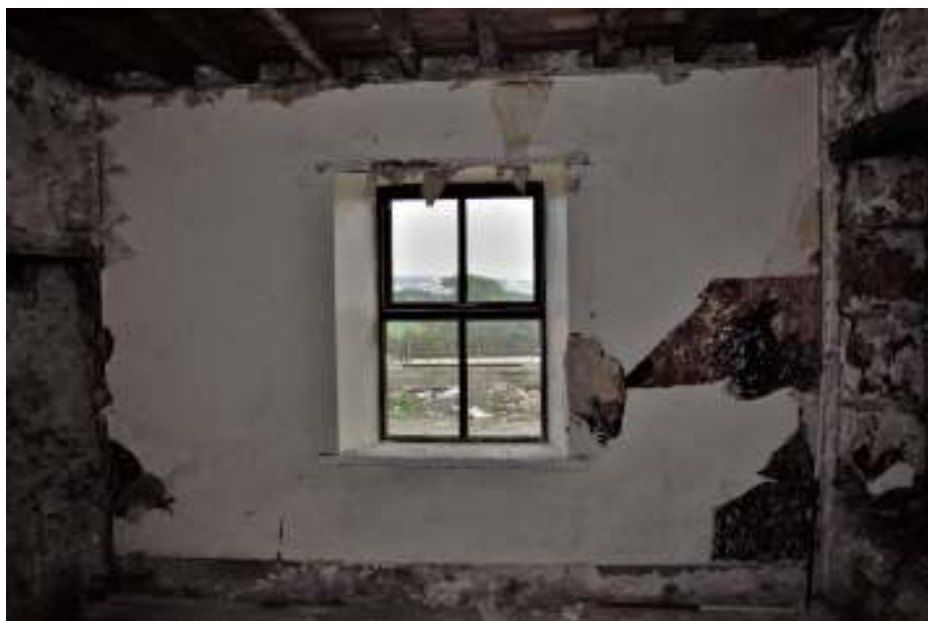
Figure 54. Southwest room, south elevation.

- 3.2.1.10. The west room has a window in a deep splay in the south elevation (Figure 54).

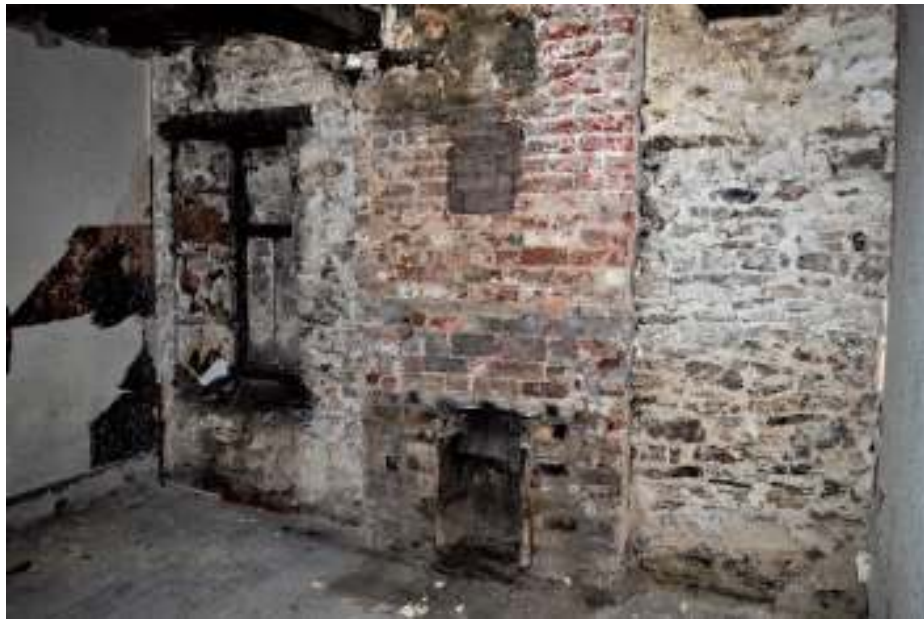
Figure 55. Southwest room, west elevation.

3.2.1.11. The west elevation has evidence of a number of alterations (Figure 55).

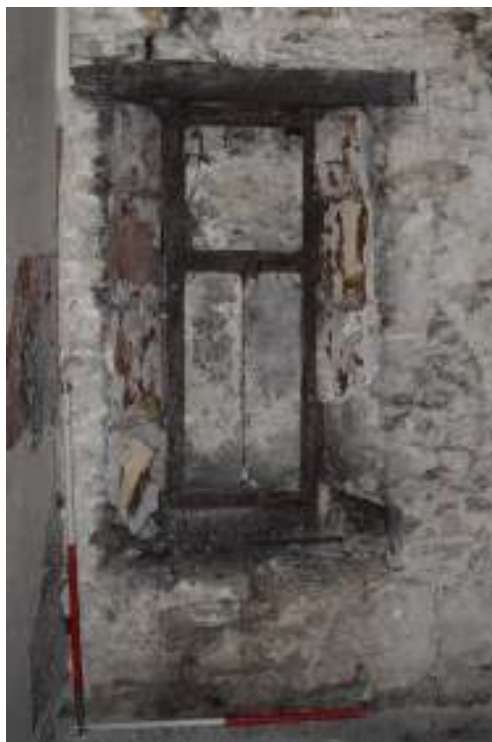
3.2.1.12. At the southern end is a tall rectangular window in a deep splay. This has been blocked on the outer face of the wall (visible on the external description, para above) and the internal splay seems to have been converted to a cupboard or storage niche with shelves (Figure 56). The original wooden window frame is still present (Figure 57).

Figure 56. Southwest room, former window splay in west elevation.

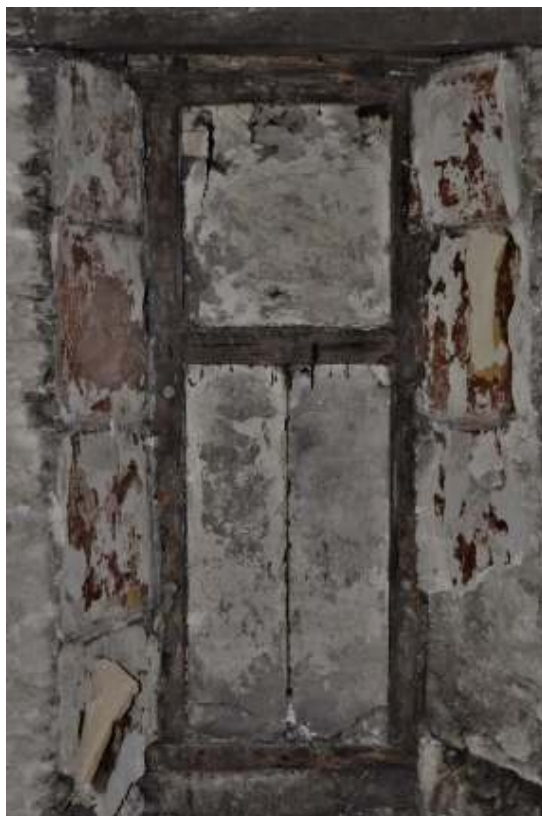
Figure 57. Southwest room, west elevation window frame.

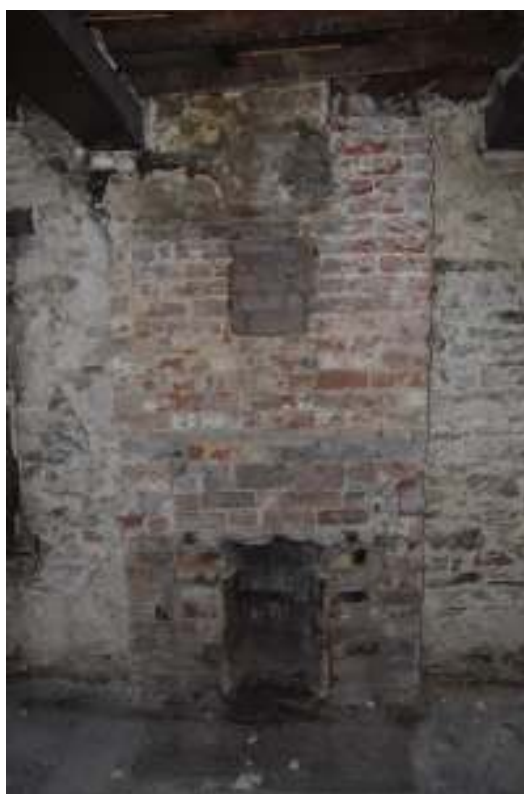
3.2.1.13. In the centre is an inserted chimney breast (Figure 58)

Figure 58. Southwest room, west elevation fireplace.

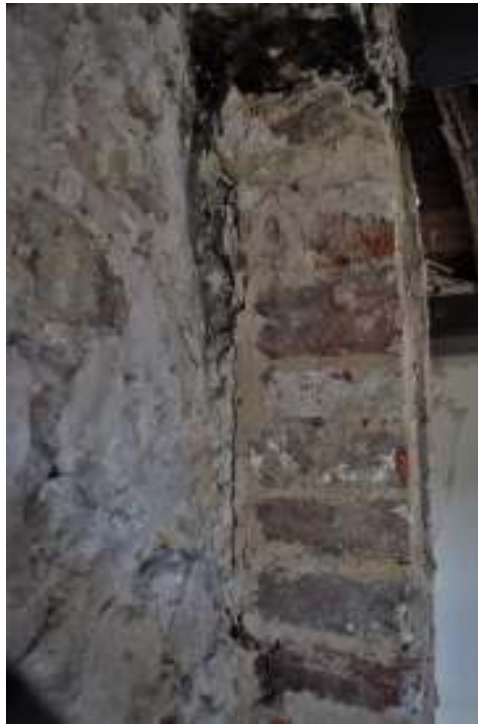
- 3.2.1.14. This is constructed of brick and, like many others in the house, attached over the original plaster of the wall. This originally had brick cheeks to a stone mantel which supported the upper part of the chimney breast. The firebox was later reduced in volume with brick infill and a moulded fireclay fireback and cheeks (Figures 59 and 60). In the upper part of the chimney breast is a blocked opening, probably originally to allow access to the upper part of the chimney flue for sweeping. The southern side of the top section of the chimney breast on the in this room is of stone.

Figure 59. Southwest room chimney breast over original wall plaster.

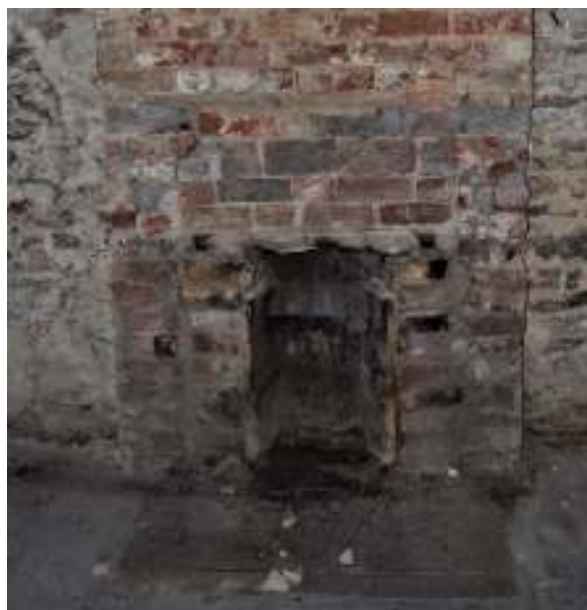
Figure 60. Southwest room west elevation fireplace with details of alteration.

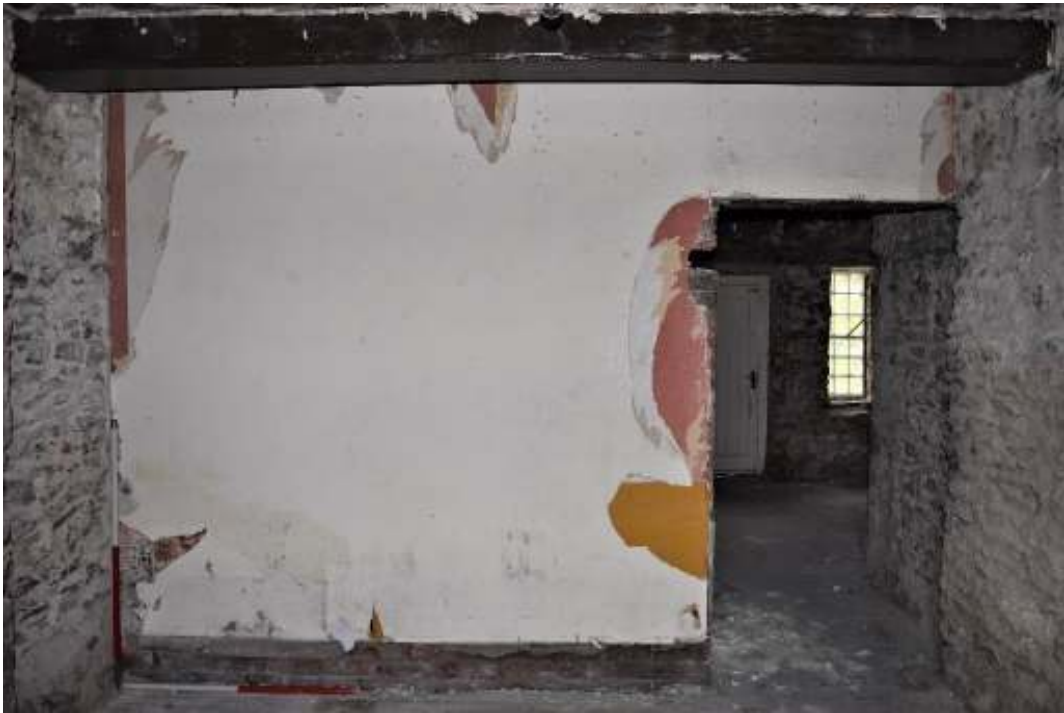
- 3.2.1.15. The north elevation has a door on the east end allowing access to the rear range of the house (Figure 61).

Figure 61. Southwest room, north elevation.

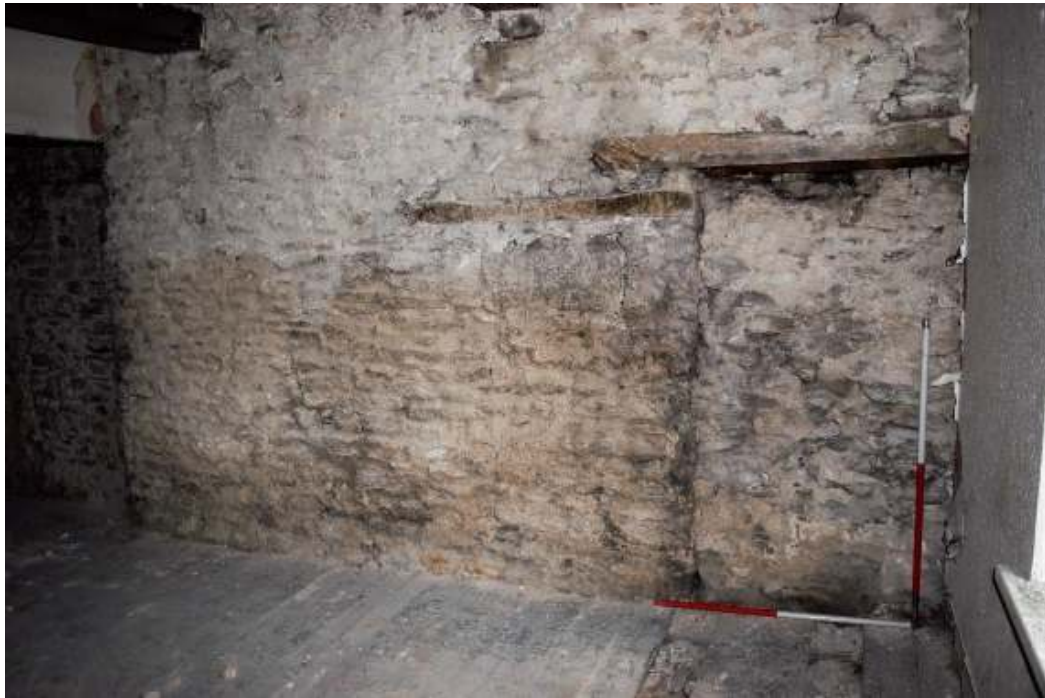
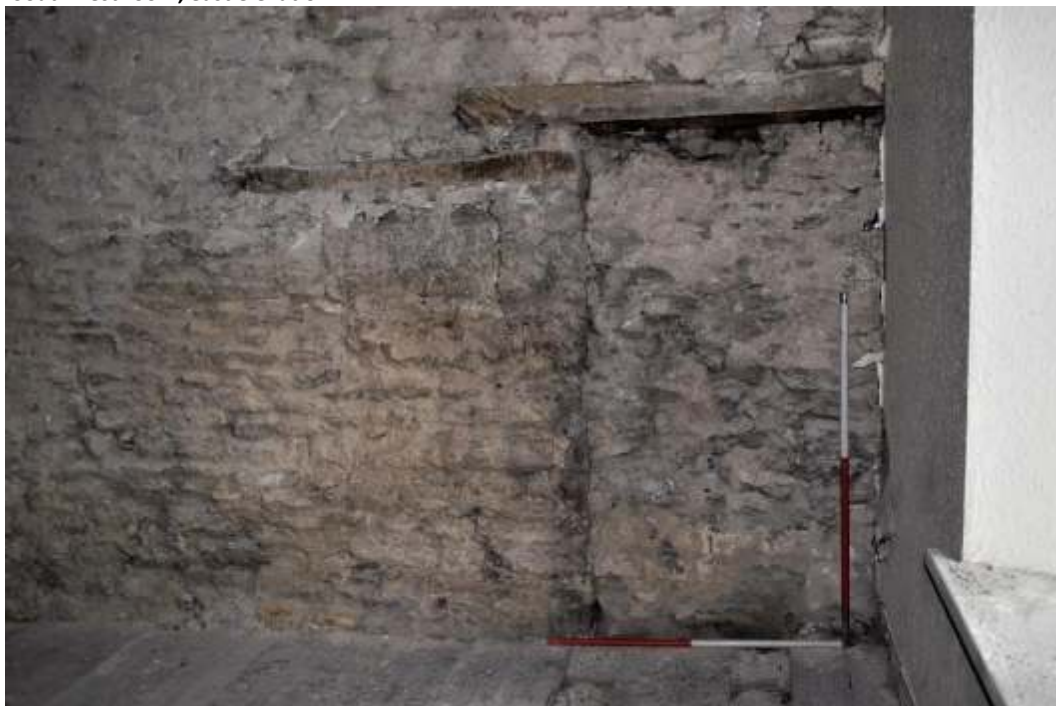
- 3.2.1.16. The east elevation has a blocked doorway under a wooden lintel at the southern end. To the north of this at a lower level is a second wooden lintel which appears to have had a small opening below it. (Figures 62 and 63)

Figure 62. Southwest room, east elevation.

Figure 63. Southwest room, blocked door and opening in east elevation.

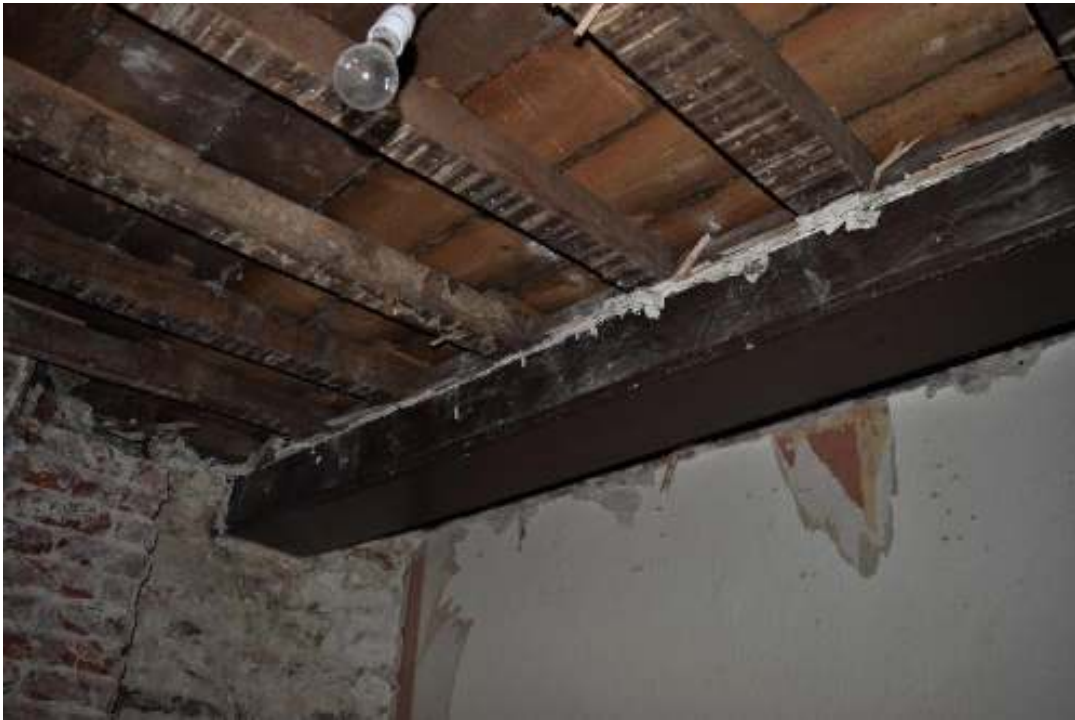
3.2.1.17. The ceiling beams in this room run E-W and have simple chamfers with no apparent stops (Figure 64). The floor joists for the first floor appear to be cogged into the beams and the remains of the later lathe and plaster ceiling are still evident although, in common with the rest of the building, most of the ceiling has been stripped out.

Figure 64. Southwest room ceiling beam.

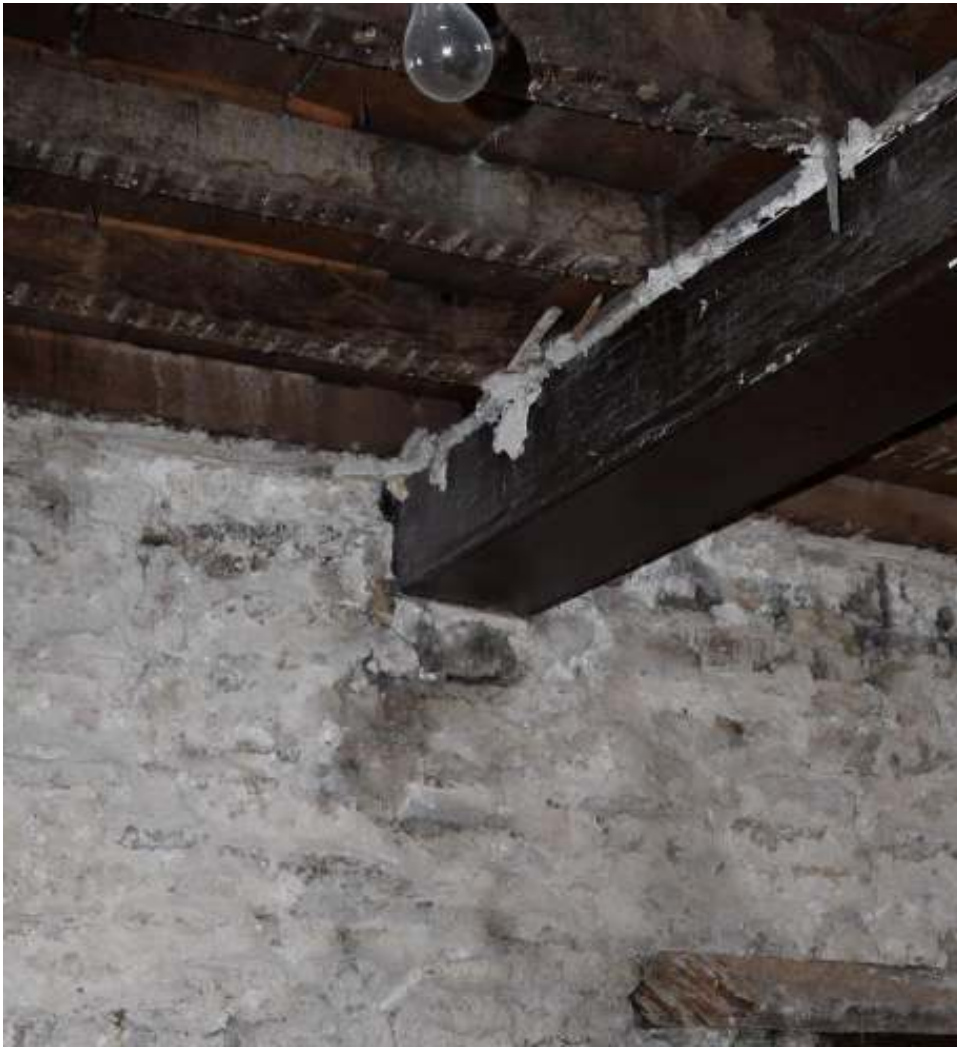
3.2.1.18. These beams may indicate an alteration or addition to an earlier building as the ends of the beams in the east wall appear to have been inserted into sockets cut in the wall with a “cushion stone” below to level the beam up to the required height (Figure 65).

Figure 65. Southwest room ceiling beam entry point to eastern wall.

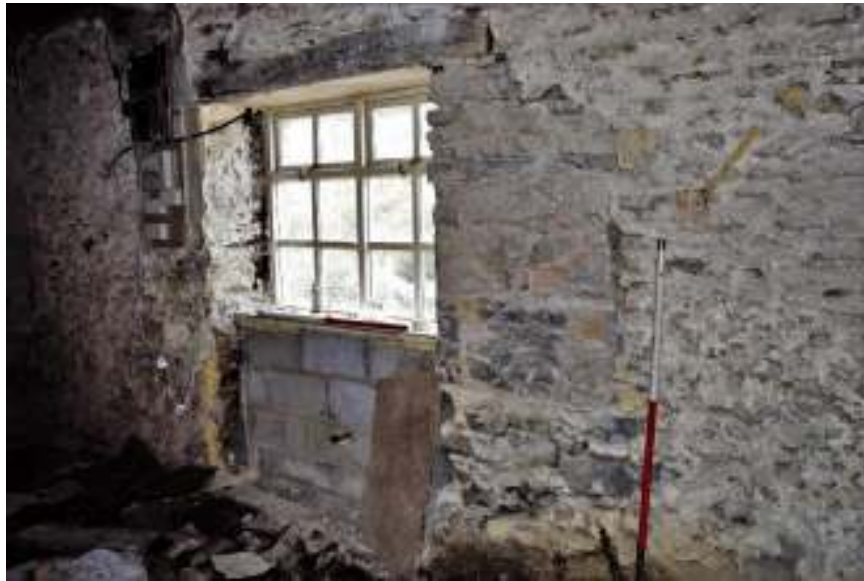
- 3.2.1.20. The north elevation is the northern elevation of the house. There is a window in the centre of the wall (GF 1). To the east of the window straight joints (mirroring in size and shape the area on the outer face of the wall) indicate the position of an earlier window opening which appears to have been wider and lower than the present window, the size and shape suggesting a wood or stone mullioned window with a single row of lights in the original opening. Below the window the wall is faced with modern concrete block in a recess, possibly where the wall has been cut back to provide room for service pipes and the face “made good” rather than there having been a door opening at this point, there being little indication on the outer face of a door (Figure 66).

Figure 66. Northeast room, north elevation window detail.

- 4.6. The north rear elevation also had changes to the windows with what may have been an early stone mullioned window in a wide, low opening being replaced by the larger and squarer kitchen window. The back door may also have been inserted to replace the earlier doorway to the west, now part blocked with a window above the blocking masonry, the small window to the left of the doorway perhaps being built in at the same time and using brick to finish the internal jambs. These changes (as well as the part blocking of an upper window) help to resolve the rather eccentric fenestration pattern of the north elevation.

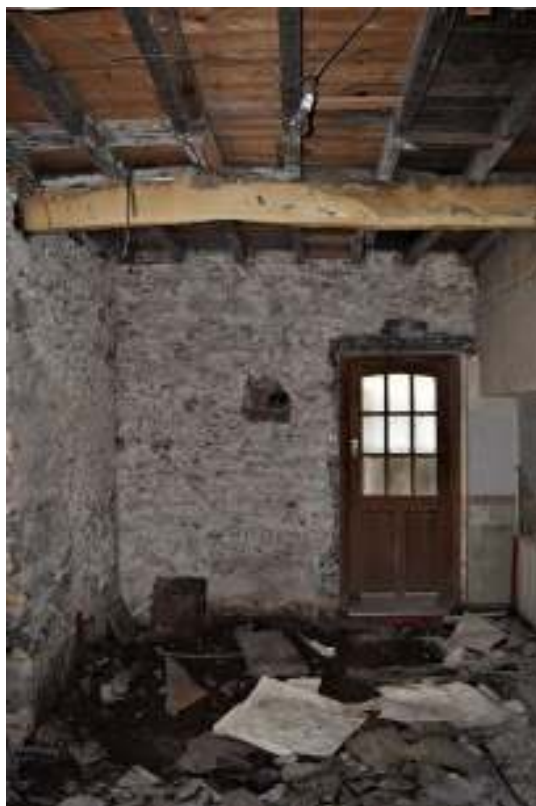
- 3.2.1.21. The east elevation has the current door to this part of the house, under a wooden lintel with a small opening to the north which holds a pipe and brick blocking, the pipe probably being part of a ventilation system for the former kitchen. (Figure 67).

Figure 67. Northeast room east elevation.

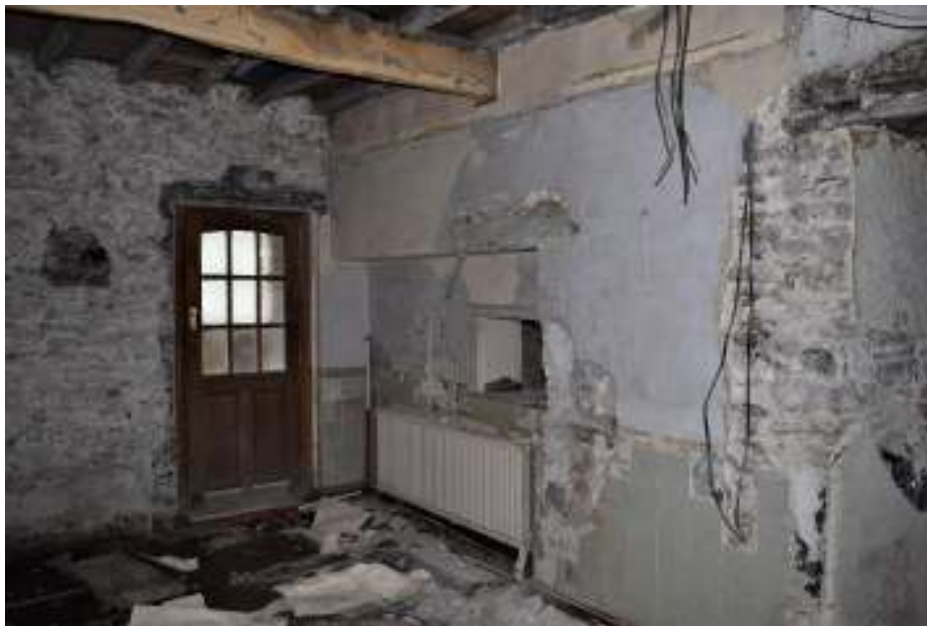
- 3.2.1.22. The south elevation has a recess at the west end. At the east end of the recess is the location of the blocked door way to the front range of the house with the service hatch approximately in the centre of the recessed area (Figure 68).

Figure 68. Northeast room south east area from NW.

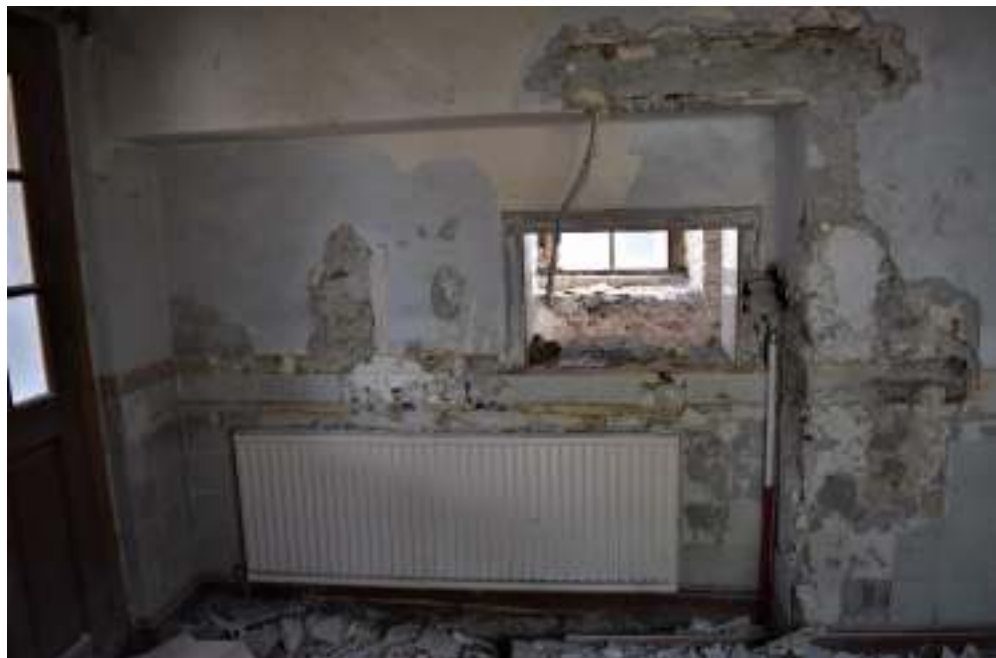
- 3.2.1.23. The recess has a substantial timber lintel over and a large timber block set in the stonework to the west (Figure 69).

Figure 69. Northeast room south wall recess features detail.
