LOWER CLERK HILL, WHALLEY LANCS.

HISTORIC BUILDING RECORD

January 2018

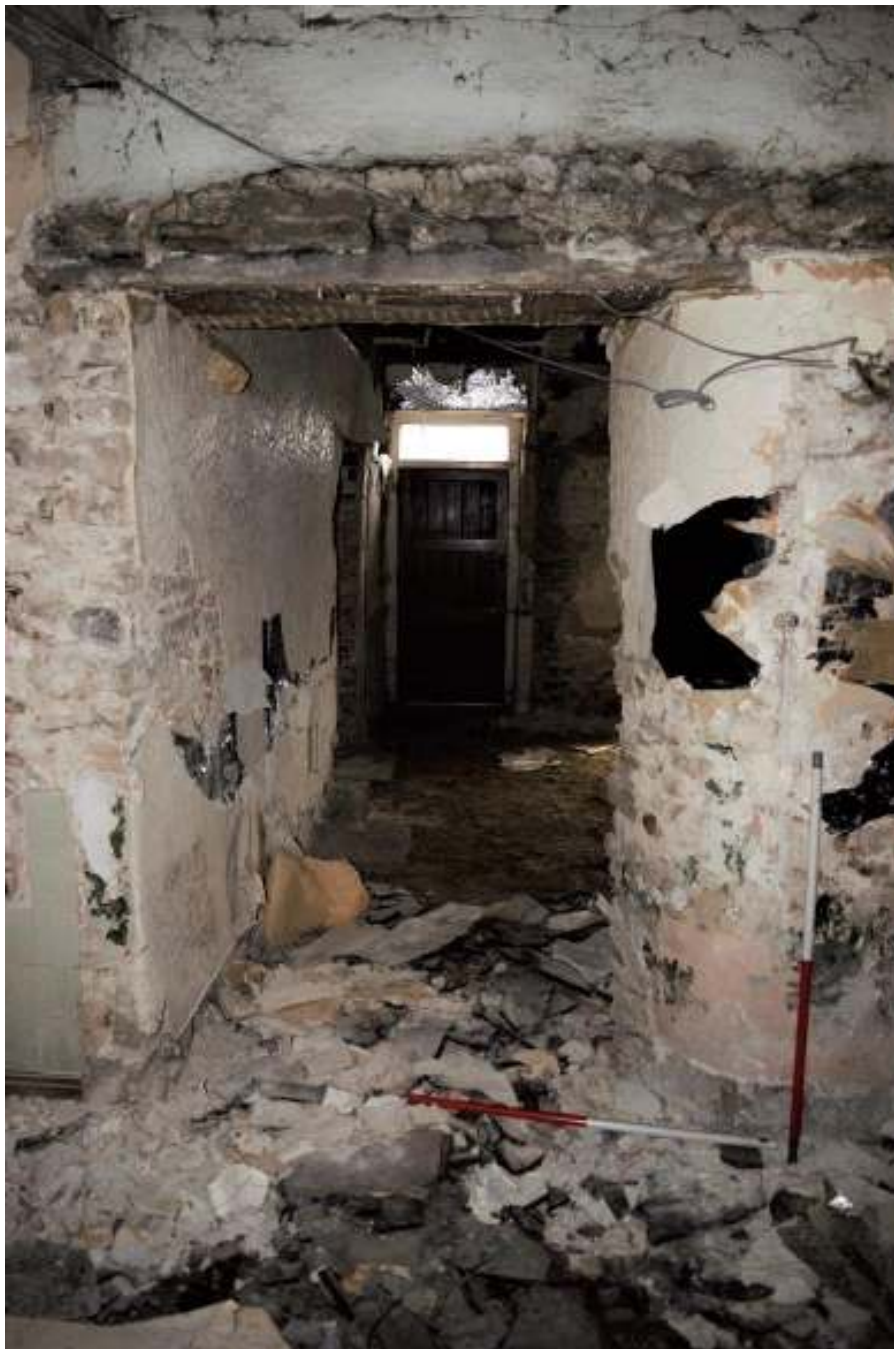
the south elevation. The opening is under a fairly lightweight timber lintel and has been narrowed on the western side with a short section of masonry, built with a curving face which avoids a sharp corner on the wall (Figure 70).

Figure 70. Northeast room S wall, door to S rooms and front door.

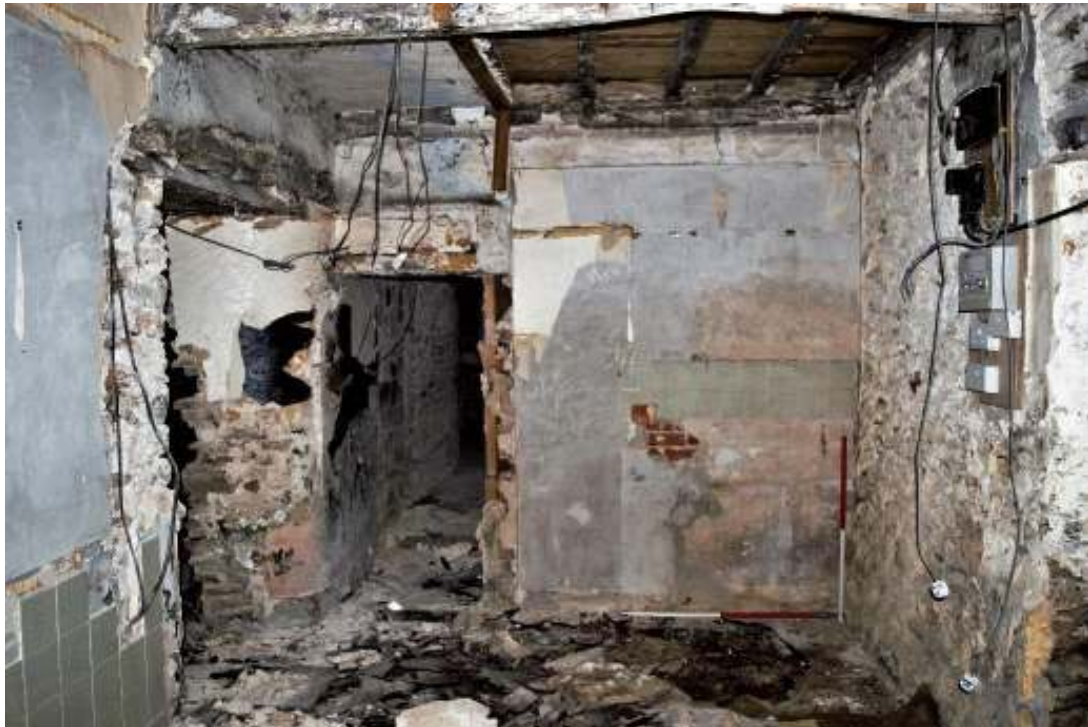
3.2.1.25. The west elevation appears to be another single skin brick wall inserted into the building. It has a door at the southern end which provides access to the staircase and to western room (Figure 71).

Figure 71. Northeast room, west elevation.

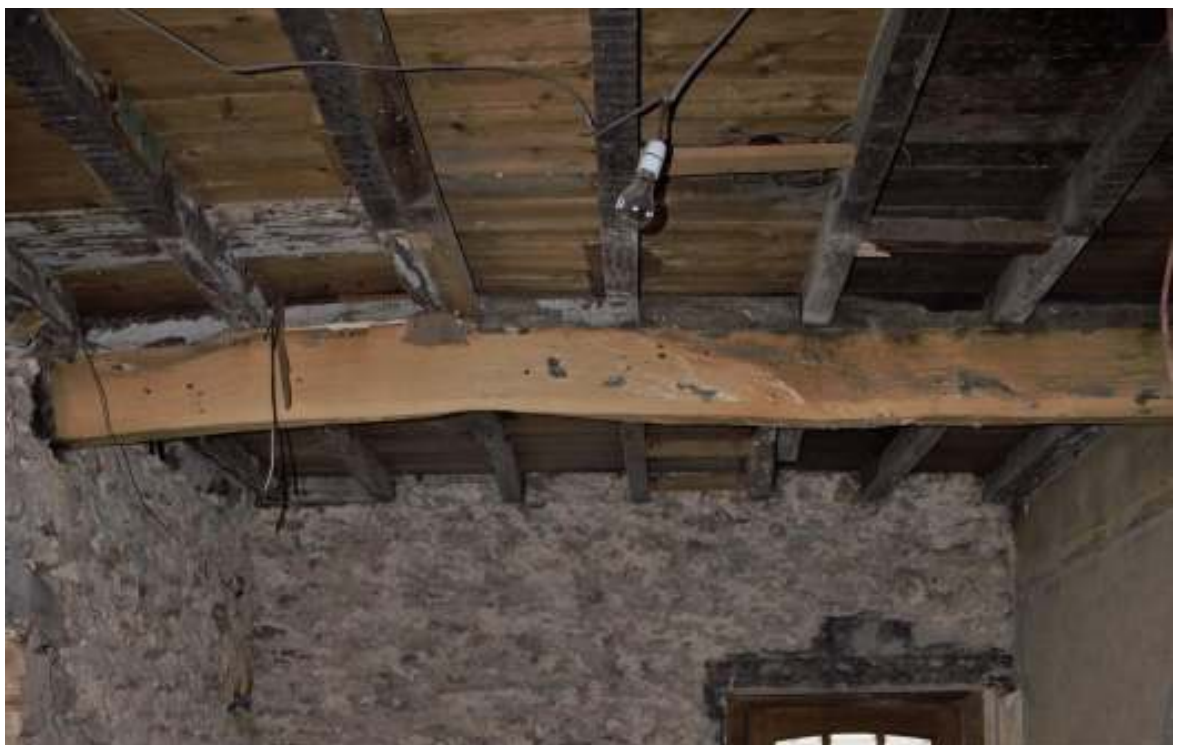
3.2.1.26. The ceiling beams run N-S and are of squared timber, sometimes of small scantlings so that areas of the outer surface survive. There are simple chamfers, with stepped run out stops on the southern ends (Figures 72 and 73).

Figure 72. Northeast room, ceiling beam.

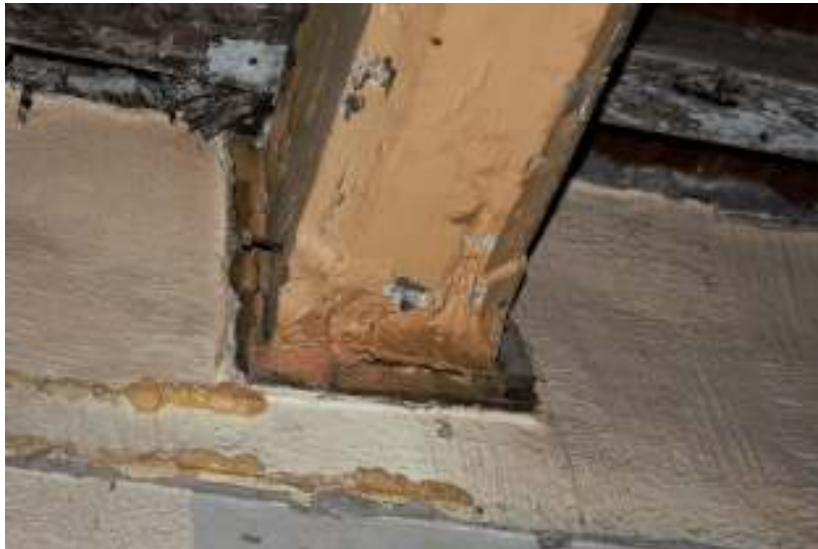
Figure 73. Northeast room, ceiling beam chamfer and stops.

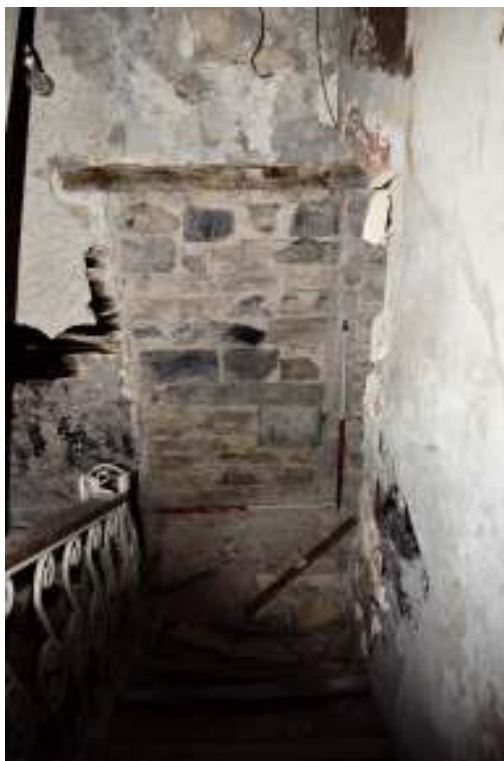
Figure 74. Stairwell , blocked door in south wall.

3.2.1.27. The stairwell is a rectangular space created by the construction of inserted brick walls to form the east and west walls, the north wall being the north wall of the building and the south wall the main wall dividing the north rooms from the south rooms of the house. These have doorways at the southern ends creating a passage between the two principal rooms on the northern side of the house. The south wall has a blocked doorway under a timber lintel with the blocking material being well dressed ashlar, presumably recycled from another, demolished, structure. The door would have connected to the centre front room (Figure 74).

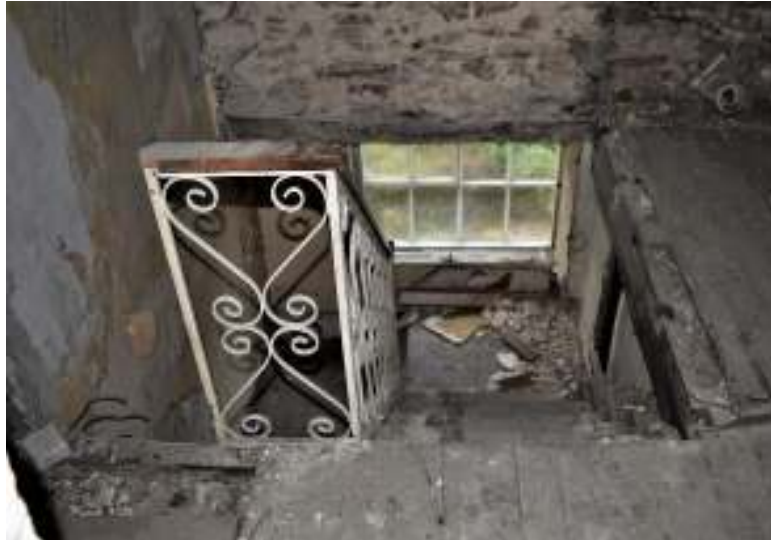
Figure 75. Stair window from first floor.

- 3.2.1.28. The staircase has modern looking wrought steel balusters. There are five steps to the half landings which have another two steps dividing it before the staircase “dog legs” back to rise to the first floor. The landings are lit by a window in the north wall (GF 2), reduced in size by blocking the lower part to accommodate the stairs and landing (Figure 75).

- 4.8. The present staircase is an insertion, shown by the empty cogging in the access through the first floor where floor joists have been removed to create the opening for the stairs. The current banisters are recent (lightweight wrought mild steel, probably later 20th C) although they may replace an earlier set. This may have been an additional staircase to that against the west gable if the house was subdivided or an insertion relating to the reorganisation of the interior space, again perhaps associated with the changes to the fireplaces and the front windows being carried out.

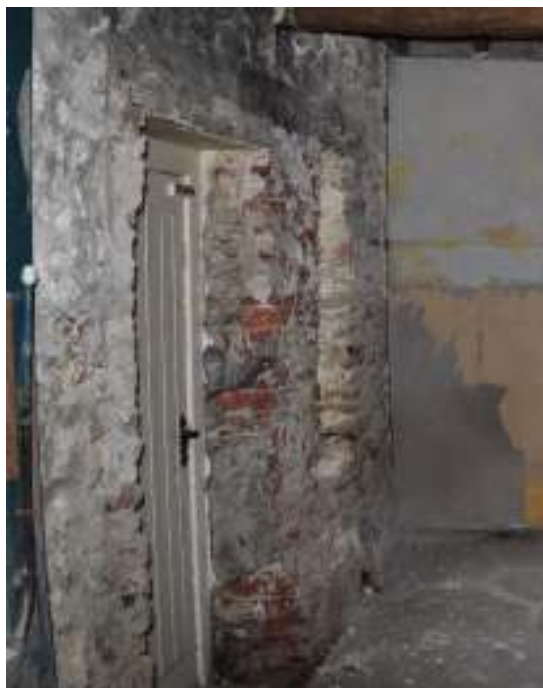
Figure 76. North west room door and window surround.

- 3.2.1.29. The north west room has the north entrance door and two windows (GF 3 and GF 4) on its north elevation. These are under a single timber lintel (the exterior face has a short timber lintel over the window) with brickwork forming the door jams which may indicate that the doorway and window are inserted into a formerly wider opening (Figure 76).

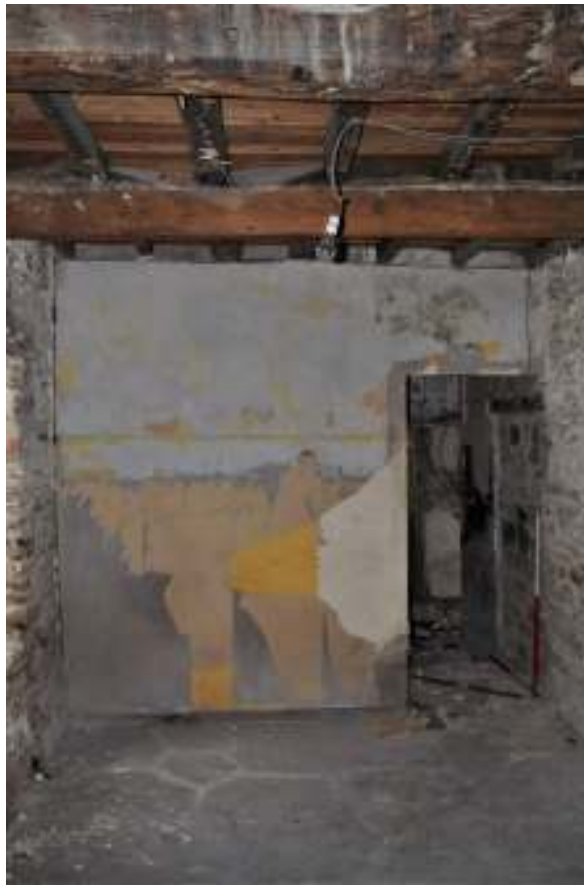
Figure 77. North west room east wall.

- 3.2.1.30. The east elevation is the inserted single-skin brick wall that forms the west wall of the stairwell with the doorway at the southern end (Figure 77).

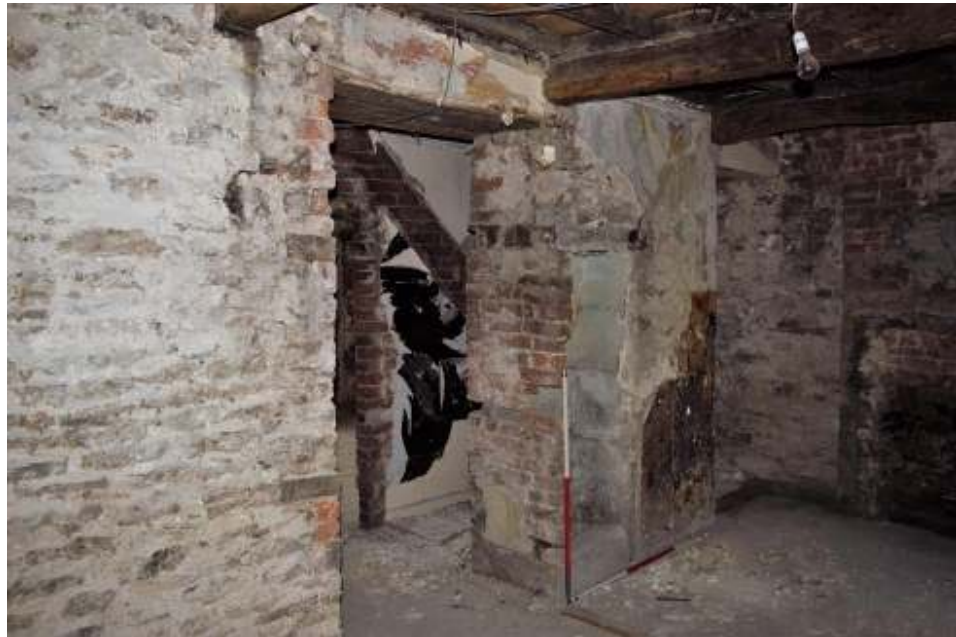
Figure 78. North west room, south wall doorways.

- 3.2.1.31. The south elevation has a doorway approximately centrally and approximately opposite the entry door on the north elevation. This opens into a small rectangular space which has a doorway in its south wall enabling access to the front, south west, room from the rear room. A second doorway at the west end of the south elevation enters the same rectangular space which formerly held a staircase and was the access door to the stairs, the staircase having been removed (Figures 78). The stairwell was formed by the construction of a single skin brick wall which now forms the north wall of the south west room (see above, para. 3.2.1.15) with the entry door cut through the spine wall that divided the front and rear ranges of rooms, relocating an earlier doorway in this wall. The current through passage from the north west to south west rooms appears to be partly cut through the spine wall and the eastern wall of the space (which tapers in thickness, see plan above, Fig. 28) and partly the re-use of the original doorway to the south of the current opening that has been partially blocked. Figure 79 shows the stairwell side of the door, with a substantial timber lintel which has been cut off when the new doorway was created and brickwork which fills part of the former door and makes good the western jamb for the new doorway.

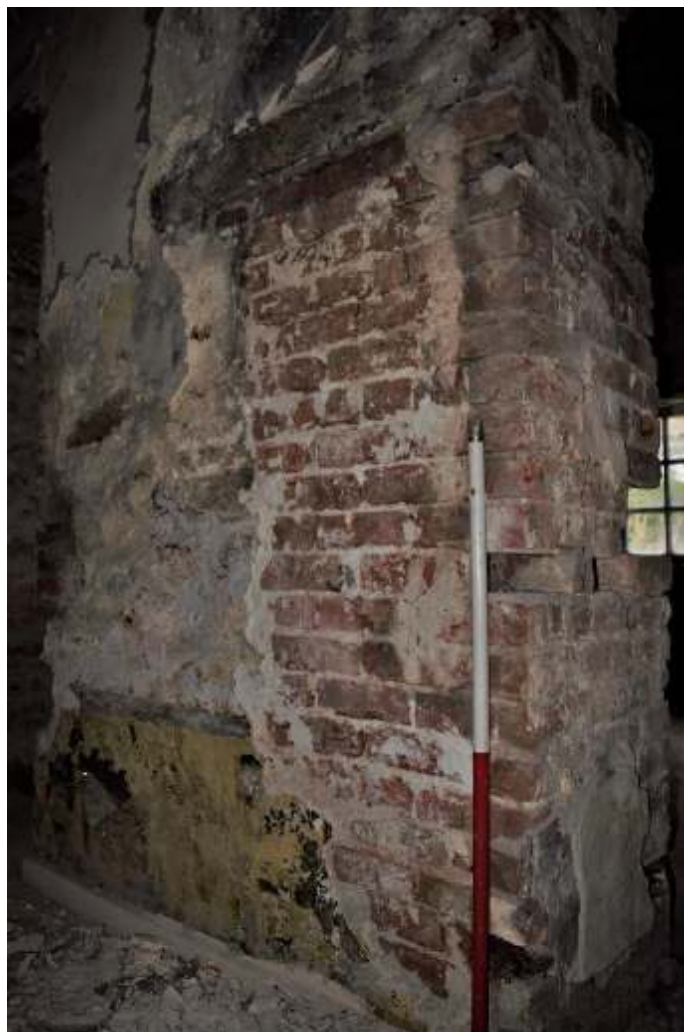
Figure 79. Northwest room, former stairwell, part blocking of original doorway and new opening to the east.
For the use of PWA Planning and Mrs and Mrs McHugh. © MACCS January 2018

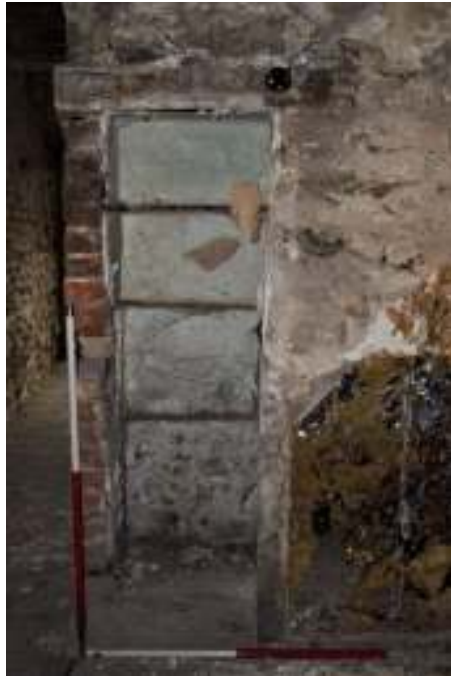
Figure 80. Northwest room, cupboard created in part blocked former doorway.

- 3.2.1.32. The original doorway was not completely infilled, with a single skin brick wall across the southern side, returning to form the western jamb of the new doorway, creating a recess where the northern part of the doorway had been, this then being fitted with shelves and used as a cupboard (Figure 80).

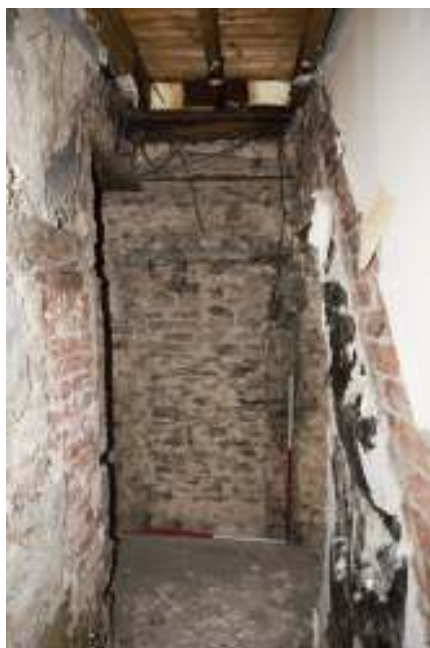
Figure 81. North west room, blocked door between south range rooms in east wall of passage through the staircase space.

- 3.2.1.33. On the eastern wall of the short passage between the two doors that connect the north west and south west rooms is a blocked door, which would originally have allowed access between the south west room and the main chamber on the south east of the house (Figure 81).

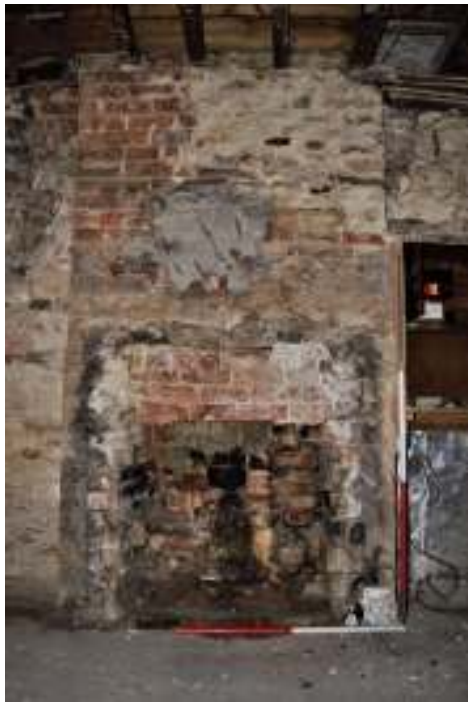
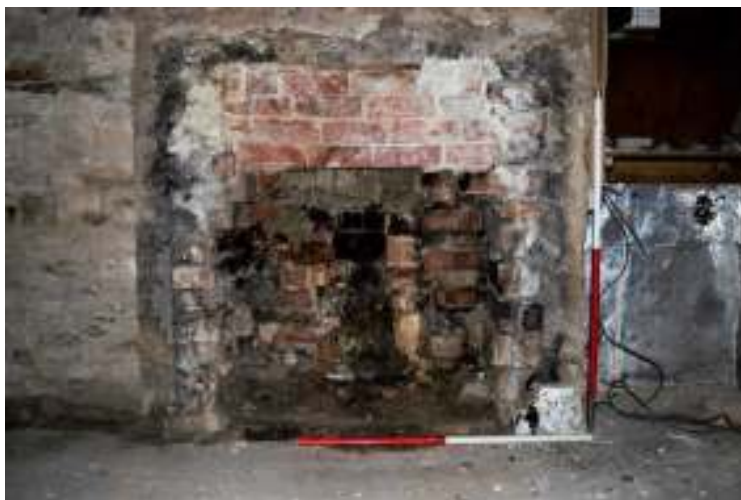
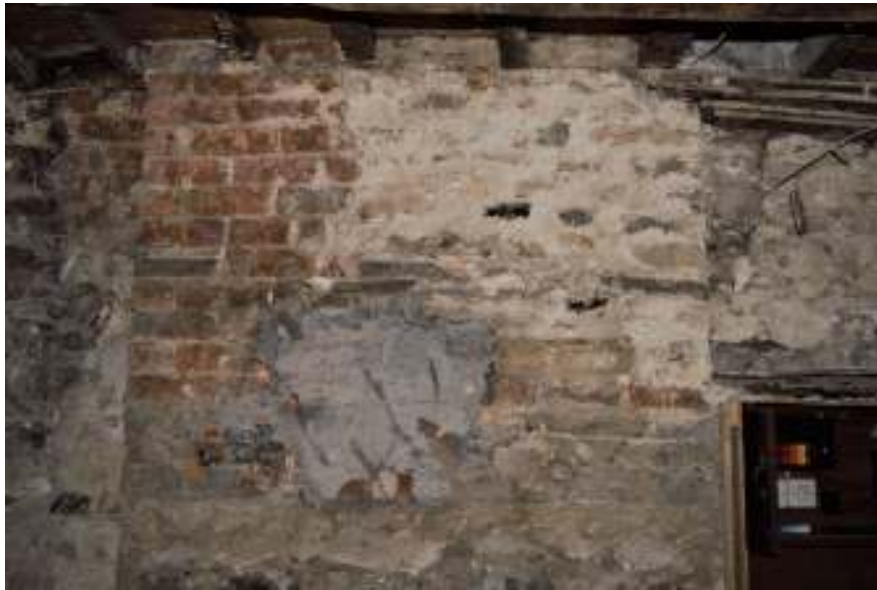
3.2.1.34. The west wall of the north west room has a fireplace, approximately centrally placed. As with others, this appears to be an insertion, there being a straight joint between the chimney breast and the wall behind. The original fireplace had stone slab cheeks with a stone lintel, with the chimney breast above being constructed of stone on the north side and brick on the south, the join being irregular. The firebox has been reduced in size, using brick, and the brickwork above the mantel may indicate alterations when this was done, there being further alterations visible in the wall above on the first floor (see below, para.). Above the former mantel is a patch of grey cement mortar that indicates the position of a blocked sweeping hole in the chimney breast which suggests that there may have been a range in this fireplace at some point in its use, the range making access to the flue for sweeping difficult (Figures 82, 83 and 84)

Figure 82. North west room, fireplace against west wall.

Figure 83. North west room, details of firebox reduction in fireplace.

Figure 84. Blocked former sweeping hole in chimney breast.

- 4.7. Fireplaces appear to have been added to many rooms, the chimney breasts being added over the facing plaster of the walls, rather than being keyed to the masonry as one might expect. The flues from these will run in the thickness of the gables and the main dividing wall that supports the middle chimney. It is likely that the “applied” chimney breast either replaced or were added over, earlier, smaller fire surrounds with the visible stone slab surrounds visible perhaps showing the early size of the fireplaces with the chimney breasts added to these and were perhaps altered to allow a more elaborate mantelpiece to be displayed in the rooms to raise their status, perhaps associated with 19th C alterations to the front elevation windows and doorway..

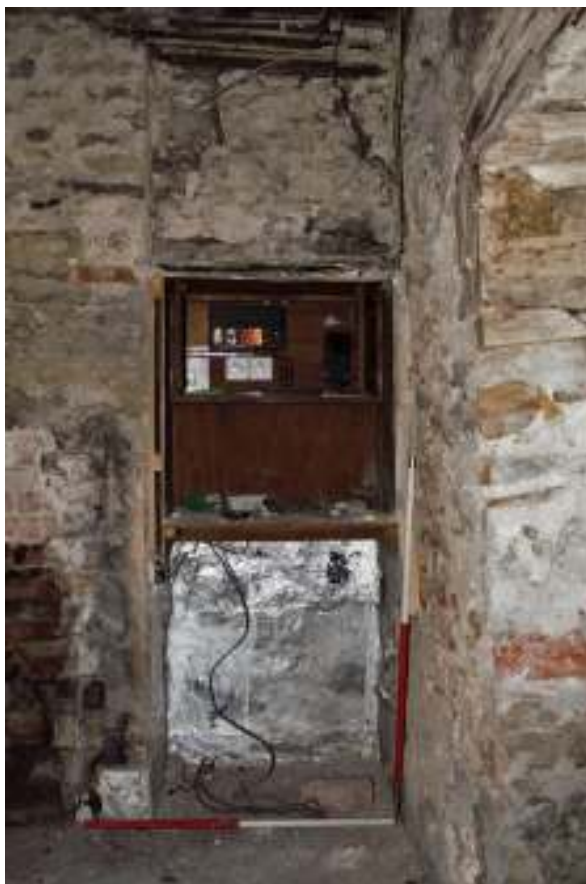
- 3.2.1.35. To the right (north) of the chimney breast is a recess now containing a cupboard. The wall above the cupboard is supported by timber lintel and uses part of the depth of the former door that was noted in the external description at the north end of the gable inside the west lean to (Figure 85).

Figure 85. North west room, west wall cupboard in blocked doorway.

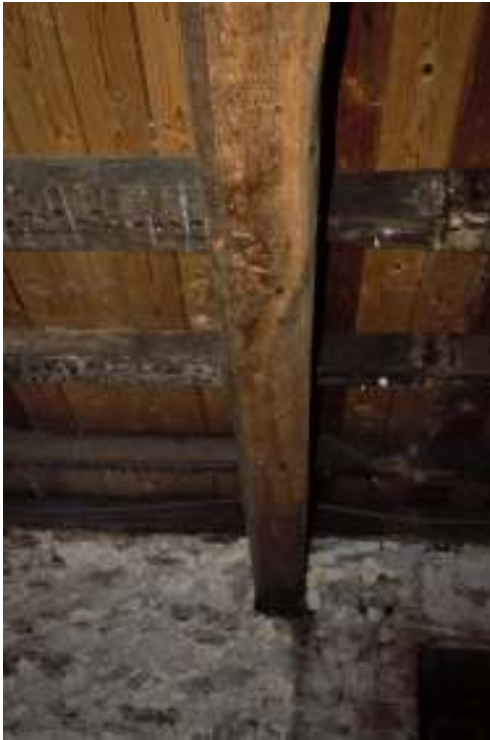
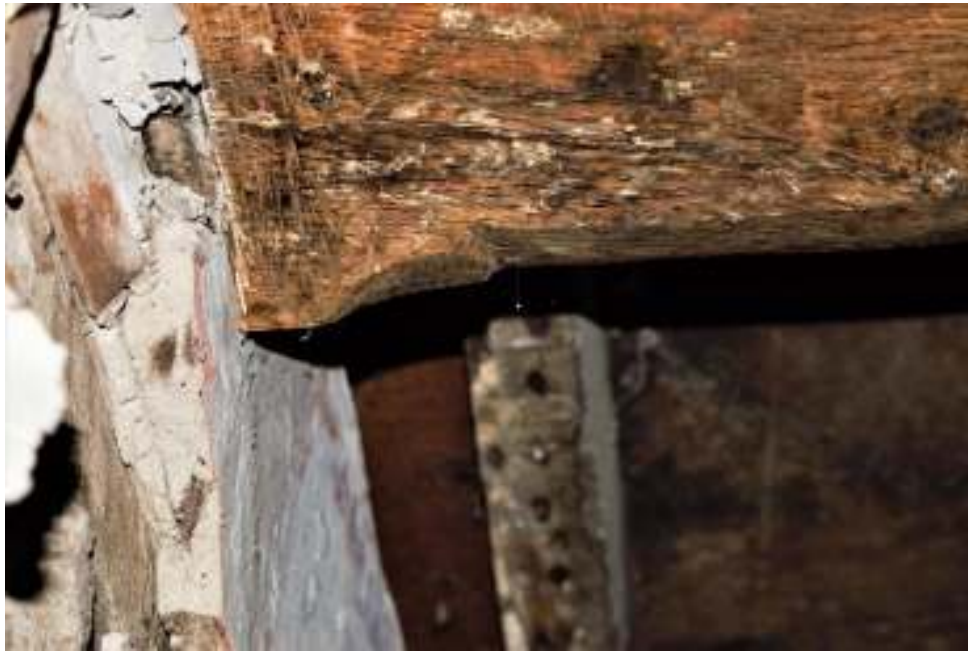
3.2.1.36. The ceiling beams run N – S and are chamfered with decorative “lamb’s tongue” stops. The first floor joists are coggled into the upper edges of the beams. Some sapwood is present on one beam (Figures 86 and 87). Several of the joists carrying the upper floor are recycled timbers with mortices, holding the cut off tenons in some cases, visible on the side faces (Figure 88). These were most likely the horizontal members of timber framed walls in a building dismantled and the timbers salvaged for re-use as is common.

Figure 86. North west room, ceiling beam with sapwood on right.

Figure 87. North west room, detail of stop on beam.

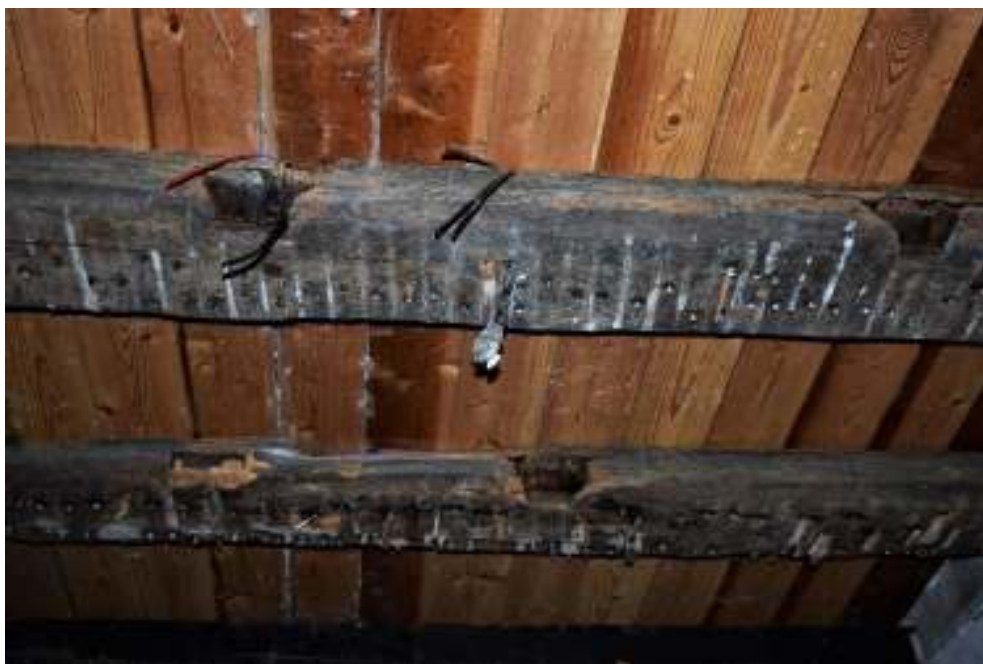
Figure 88. North west room, ceiling joists of re-used timbers.

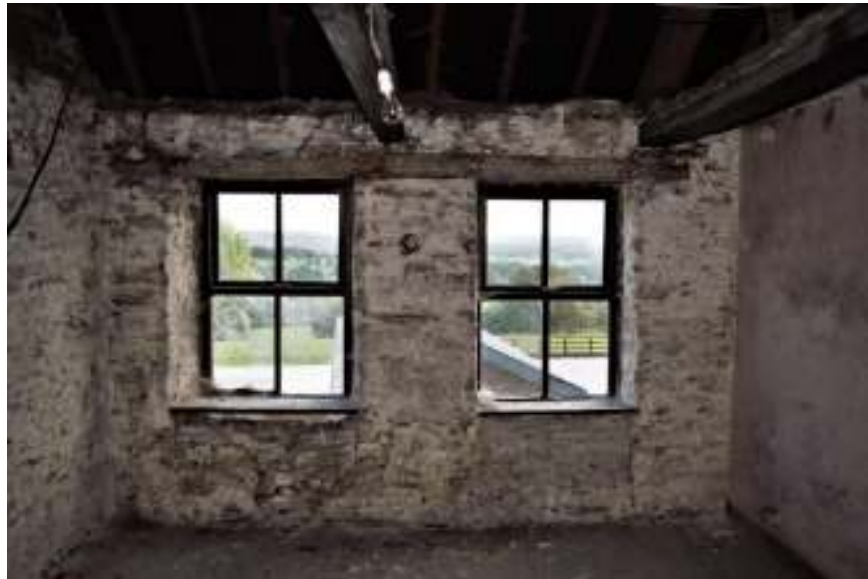
Figure 91. Upper floor south east room, south wall.

3.2.2.2.1. This has a pair of windows in the south wall, the size and shape matching the upper floor windows on this frontage and the western ground floor window. The frames and glass are modern double glazed units. Both windows are under a single long timber lintel, possibly to help spread the pressure of the ceiling beam that joins the wall in the pillar of masonry between the windows. Below each window opening joints in the stonework suggest there may have been either a taller window, or that there was a shallow recess in the window splay here, possibly for a bench seat. As the joints are not matched in the external wall face, the latter is considered the most likely (Figure 91).

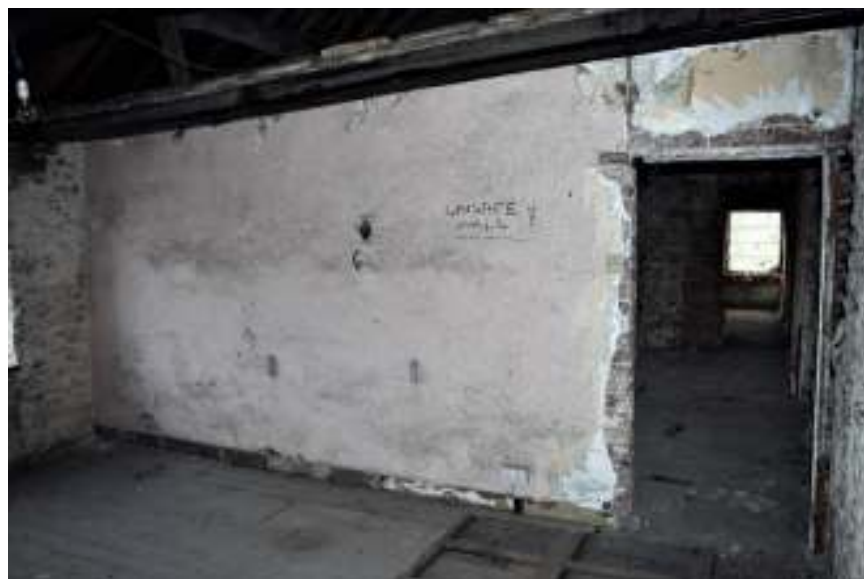
Figure 92. Upper floor, south east, room west wall.

3.2.2.2.2. The west wall is a single thickness brick wall, butted onto the front wall and the central spine wall with a door at the northern end (Figure 92)

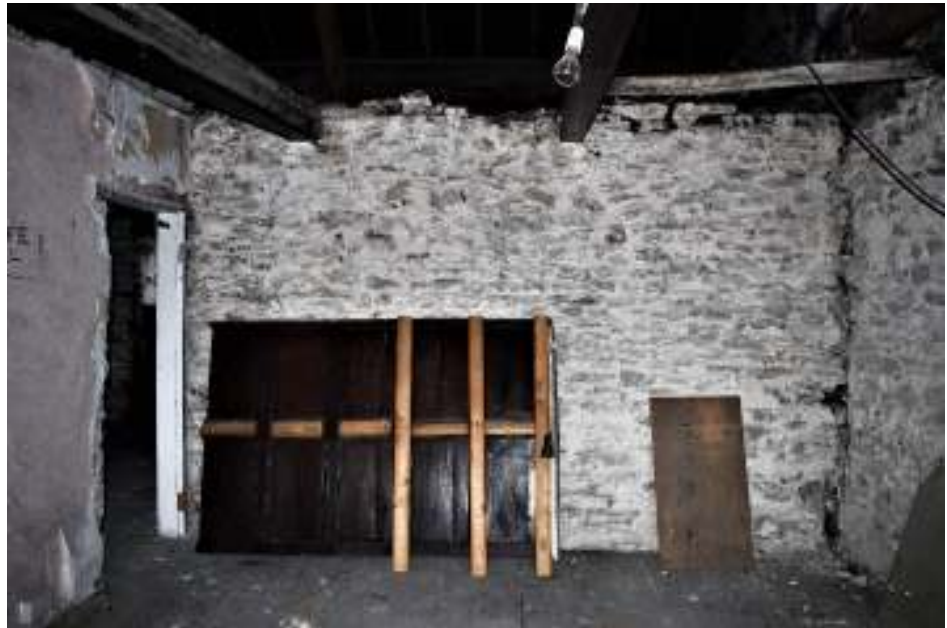
Figure 93 Upper south east room, north wall.

3.2.2.2.3. The north wall is featureless rubble masonry. The bonding to the gable on the east end is not particularly good but the wall does not seem to have been butted against an earlier gable (Figure 93).

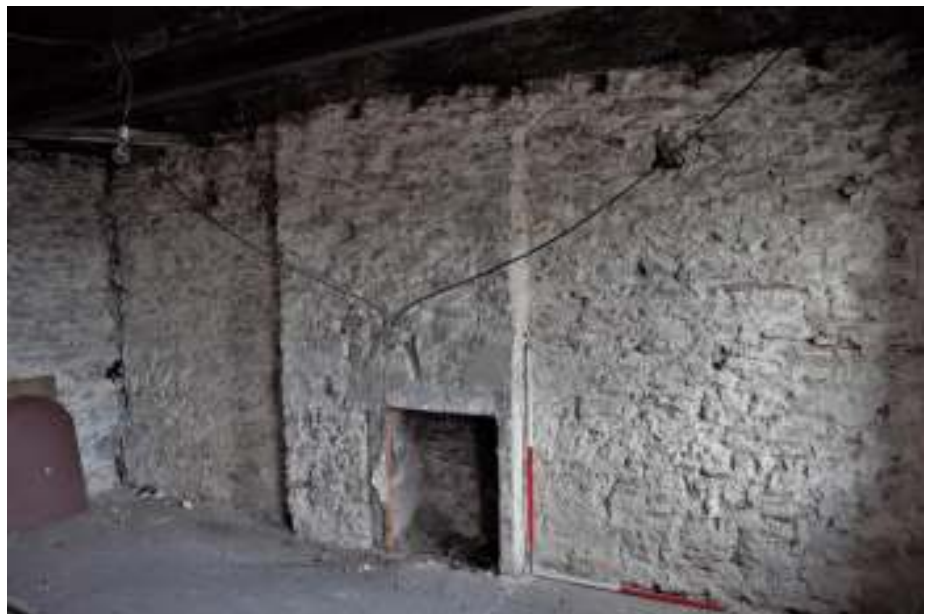
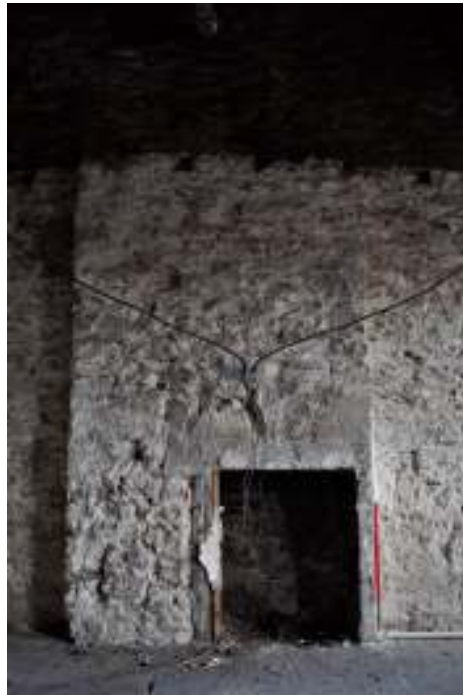
- 3.2.2.2.4. The east wall has a chimney breast with fireplace roughly centrally placed. Like many of the other chimney breasts, this has been added to the gable wall (Figure 94). The fireplace has stone cheeks and a broad stone lintel with the firebox placed asymmetrically to the chimney breast. This is probably to accommodate the flue from the fireplace on the ground floor within the chimney breast structure (Figure 95).

Figure 94 Upper south east room, east wall.

Figure 95 Fireplace and chimney breast.

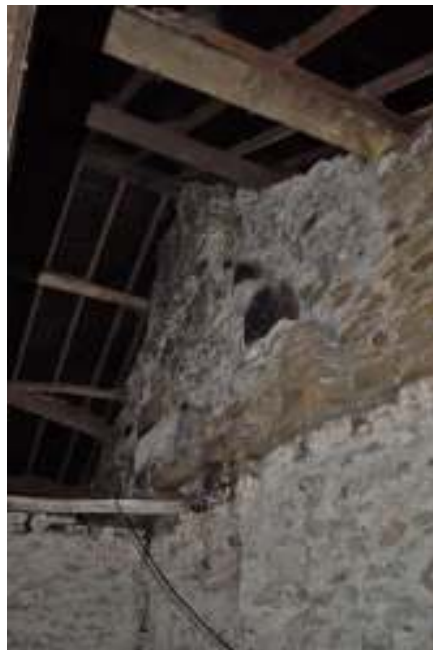
- 3.2.2.2.5. Above the former ceiling level (marked by the pale remains of the removed wall plaster below) at the northern end of the wall the chimney breast is built to curve towards the north as it rises into the gable, meeting the lower part of the chimney stack. The stack is thicker than the gable wall and the extra thickness on the interior is supported by a timber baulk which bridges between the chimney breast of the southern range and a large stone block which projects from the wall to support the northern end of the upper chimney structure (Figure 96).

Figure 96. Upper chimney breast of east gable wall.
For the use of PWA Planning and Mrs and Mrs McHugh.

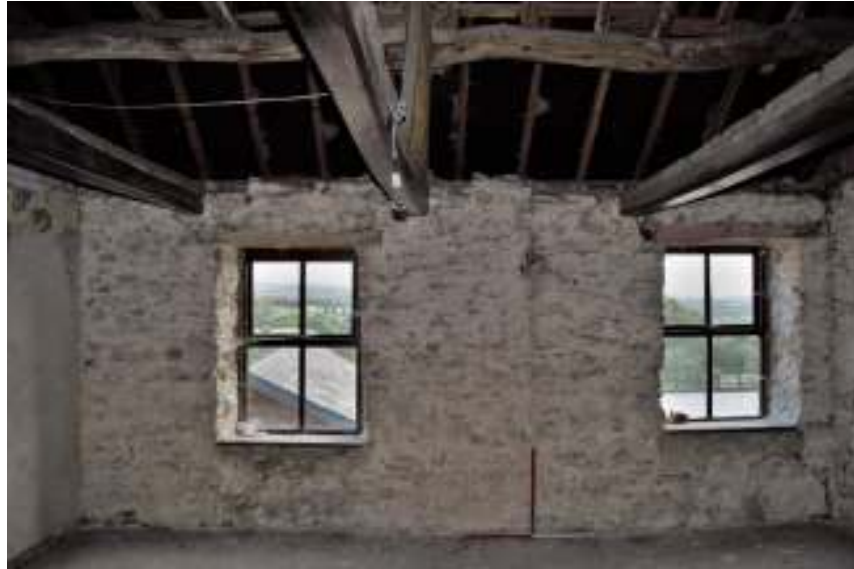
Figure 97. Upper south central room south wall.

- 3.2.2.2.6. The room has two ceiling beams, the eastern being the tie beam for a roof truss. The beams have ovolo moulded chamfers and stepped run out stops, reflecting those in the room below.
- 3.2.2.2.7. The central room on the south range is likely to have been, originally, the western half of a single room (the south east room being the other part). The south wall has a pair of windows (Figure 97).

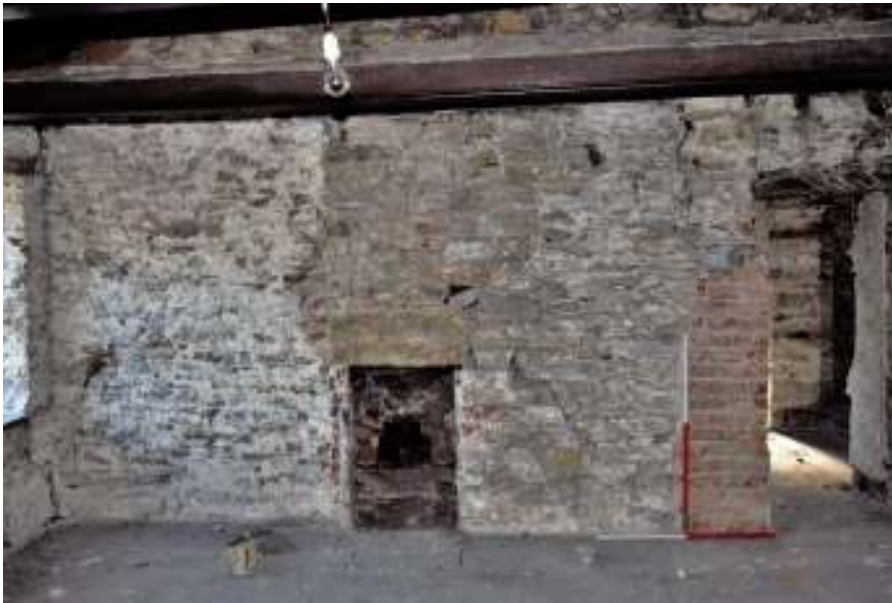
Figure 98. South central room, west wall.

- 3.2.2.2.8. The west wall has a wide, centrally placed, chimney breast with the fireplace offset to the southern side, probably to accommodate a flue from the fireplace in the room below on the northern side of the chimney breast. Between the north side of the chimney breast and the north wall is a doorway to the western room (Figure 98).

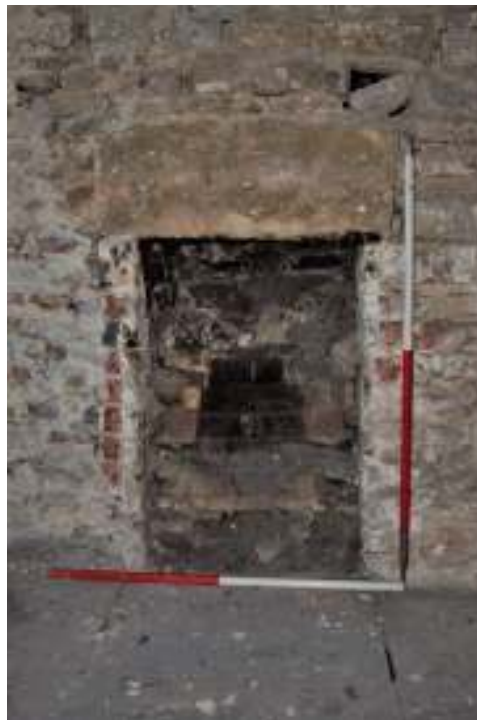
Figure 99. Upper south central room fireplace.

- 3.2.2.2.9. The firebox of the fireplace has a single skin brick cheek on the southern side with a deep stone lintel (Figure 99).

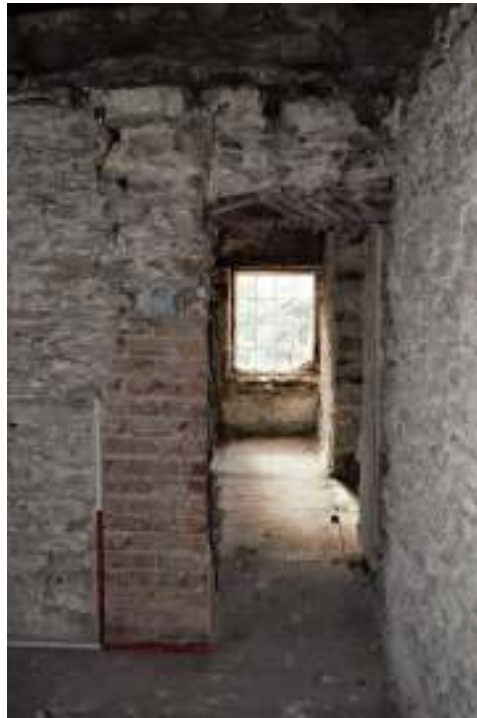
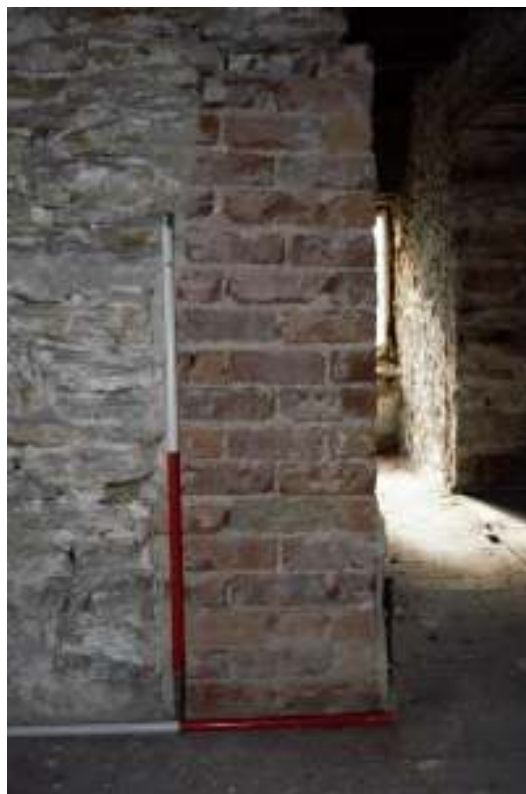
- 3.2.2.2.10. The right (north) side of the chimney breast appears to have been extended northwards in brick from the original stone structure, perhaps to create a neat edge for the door to the western room (Figure 100 and 101).

Figure 100. Upper south central room, west wall doorway.

Figure 101 Brick corner on north of chimney breast.

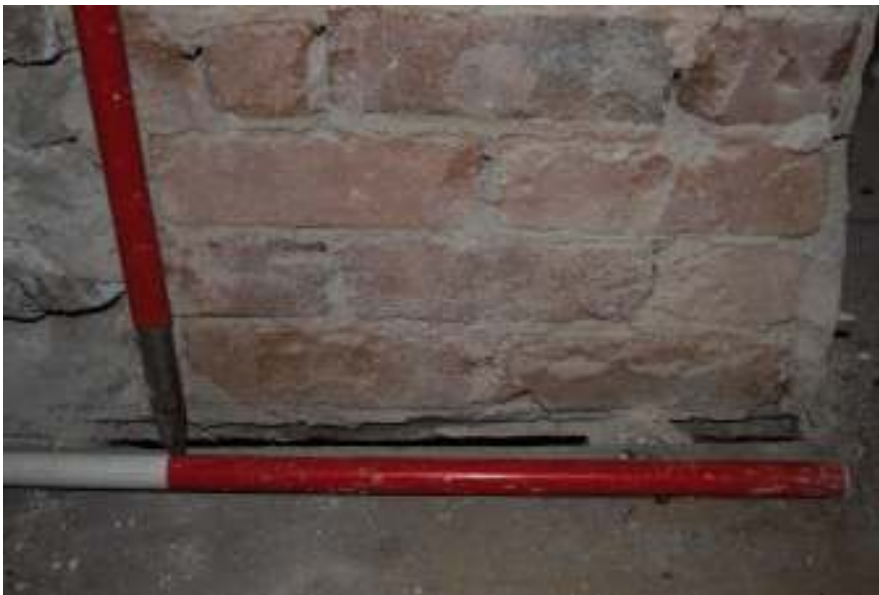
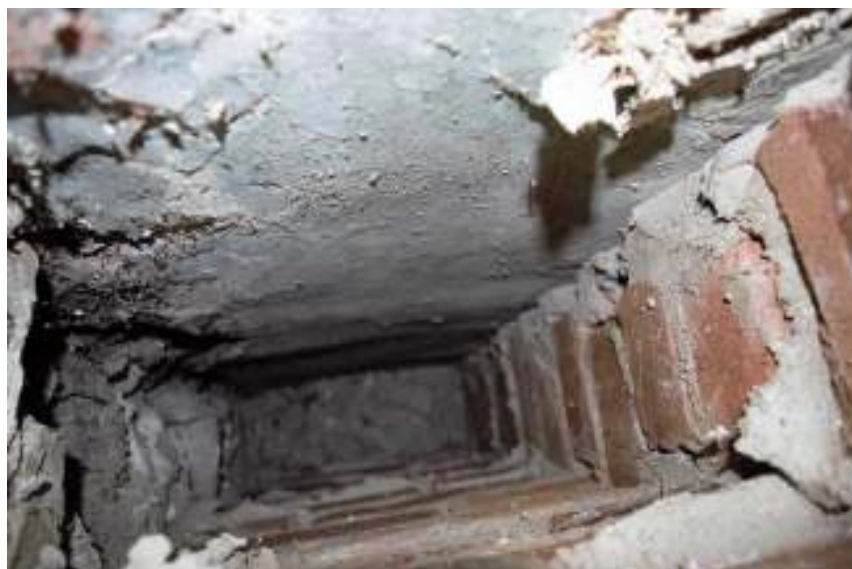
- 3.2.2.2.11. This is a strange construction as it sits directly on the floorboards, with no supporting structure in the room below and investigation showed it to be hollow (Figures 102, 103).

Figure 102. Base of brick corner.

- 3.2.2.2.12. The brickwork is possibly from the door being cut through and the brickwork provides a clean edge to the doorway, being left hollow to reduce the weight that the floor had to support. It is not a fireplace flue as it has no connections to the other flues and the interior is not sooty.
- 3.2.2.2.13. The north wall has a doorway approximately in its centre and another at the eastern end (Figure 103).

Figure 103. Interior of brick corner from top.

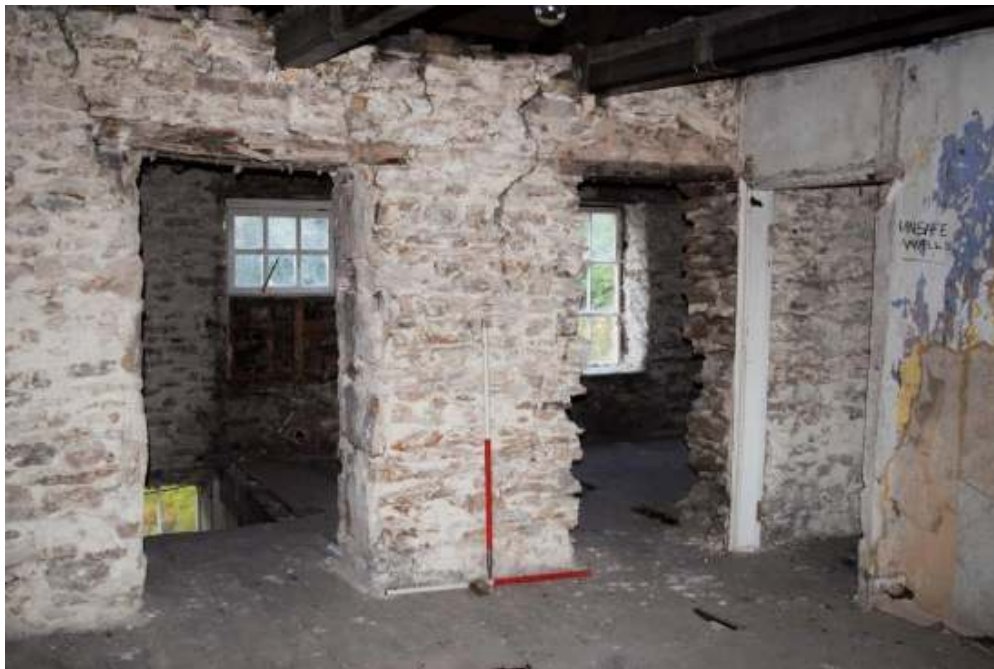
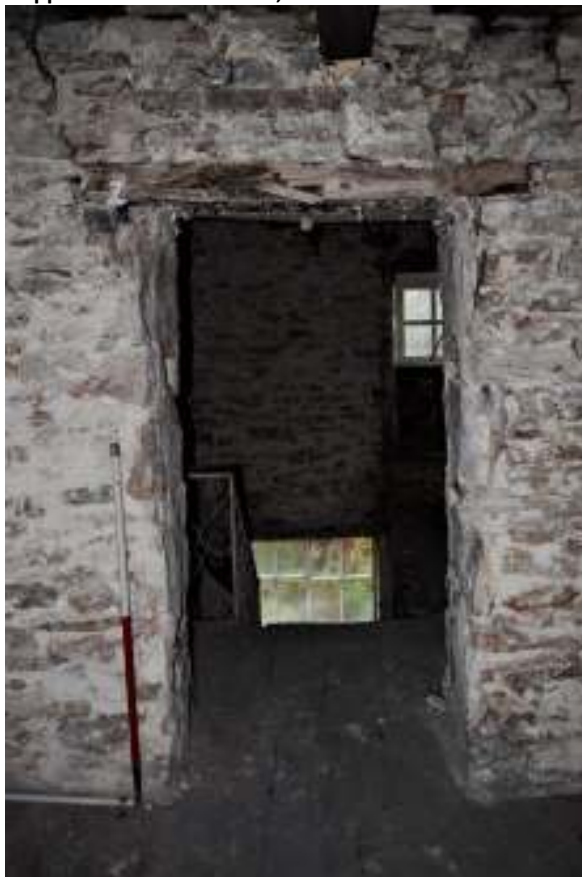
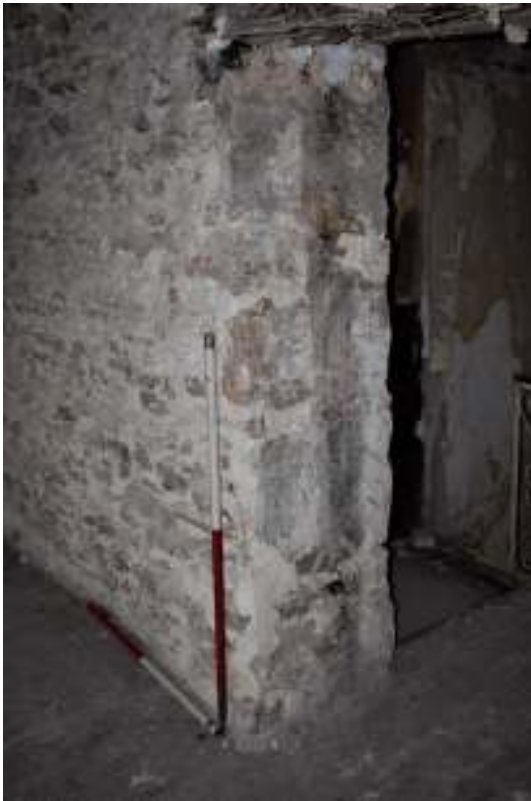
- 3.2.2.2.14. The centrally placed (west) door is probably the original entrance to the room, the jambs being well finished with slabs applied to the ends of the wall masonry coursing to create smooth jambs (Figures 104, 105 and 106).

Figure 104 Upper south central room, north wall.

Figure 105 Upper south central room, west doorway.

Figure 106 Upper south central room, west doorway, jamb detail.

3.2.2.2.15. The eastern doorway has much rougher jambs, indicating that it has probably been cut through the wall to create a new doorway when the interior of the house was reorganised at some point (Figure 107). Both doorways have timber lintels above which ceiling beams enter the wall, this has resulted in structural cracking over both doorways.

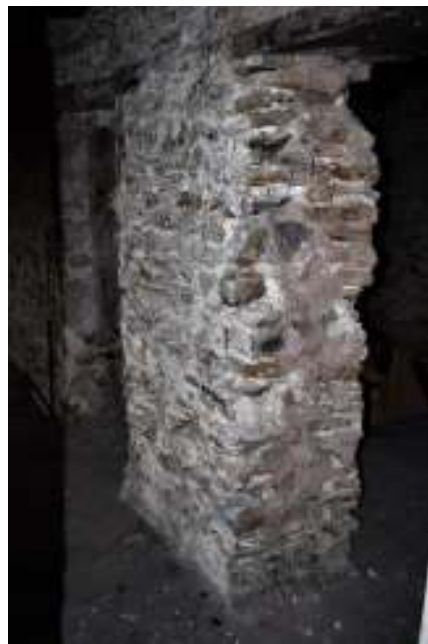
Figure 107. Upper south central room east door jamb detail.

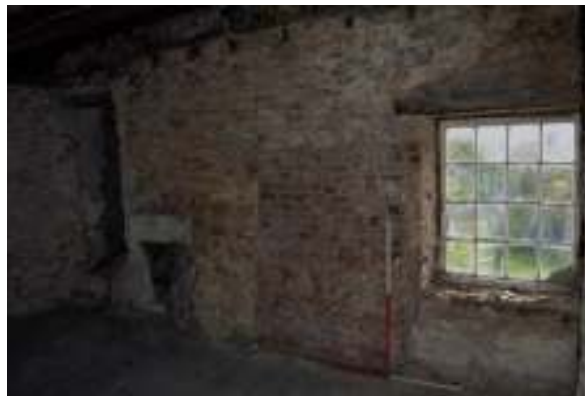
Figure 108. Upper south west room, west wall.

- 3.2.2.2.16. The east wall is the single skin brick wall previously described in the south eastern room, with a doorway at its northern end.
- 3.2.2.2.17. The room has three ceiling beams with ovolo chamfers and stops identical to those in the south eastern room. The middle beam of the three forms the tie beam of one of the roof trusses (see Fig. 97. above).
- 3.2.2.2.18. The south western room has a single window in the south elevation. The west wall is the western gable wall of the house and has a broad chimney breast with a blocked window on its south side and a large window on the north (Figure 108).

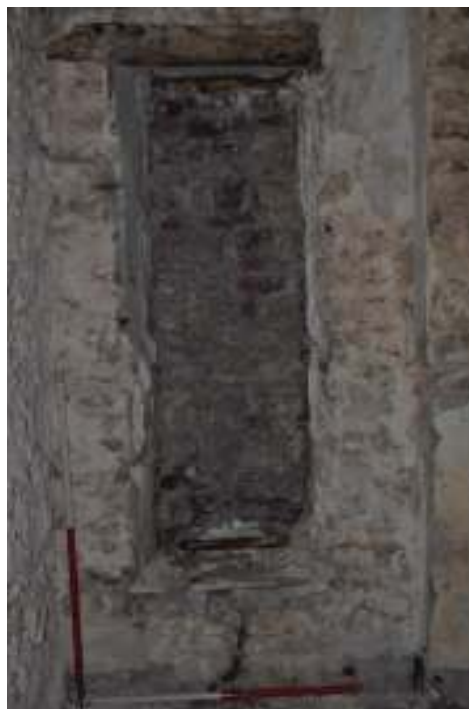
Figure 109. Upper south west room, blocked window in west wall.

- 3.2.2.2.19. The blocked window is in a deep splay. The position mirrors the blocked window in the room below but the splay is less pronounced (Figure 109).
