LOWER CLERK HILL, WHALLEY LANCS.

HISTORIC BUILDING RECORD

January 2018

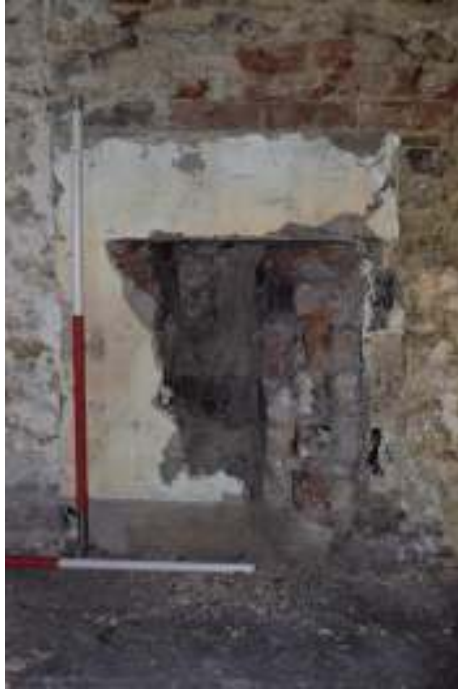
Figure 110. Upper south west room fireplace.

- 3.2.2.2.20. The chimney breast has the fireplace offset on the southern side, the firebox originally having had stone slab cheeks with a stone lintel. The firebox has been reduced in capacity with brick blocking on either side and in the final phase was blocked and plastered over (Figure 110).

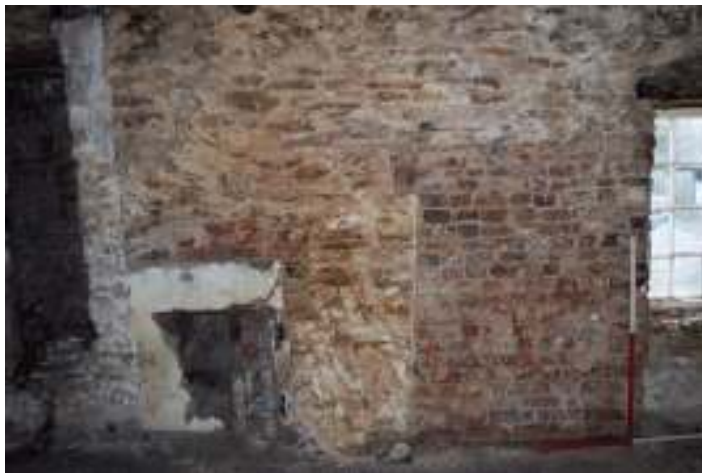
- 3.2.2.2.21. The northern part of the chimney breast is an area of brick with a straight joint with the stonework to the south. The upper three courses extend slightly further to the south, suggesting there was an opening with a timber lintel, all blocked and replaced with brickwork (Figure 111). The outer face of the wall does not show an obvious trace of a former opening at this point.

Figure 111. Upper south west room, chimney breast.

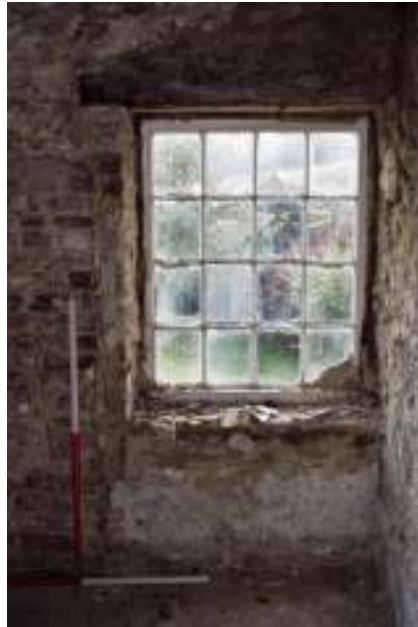
Figure 112. Upper south west room west wall window.

- 3.2.2.2.22. At the north end of the elevation is a window with fixed panes in a 4 x 4 arrangement. The southern jamb is finished with brick, the northern is cleanly against the north wall which may indicate the window was originally narrower, perhaps matching the size of the blocked opening to the south, and has been altered to make it larger. Prior to the removal of internal walls this window was not within the south western room but lit the upper landing of the now removed staircase.

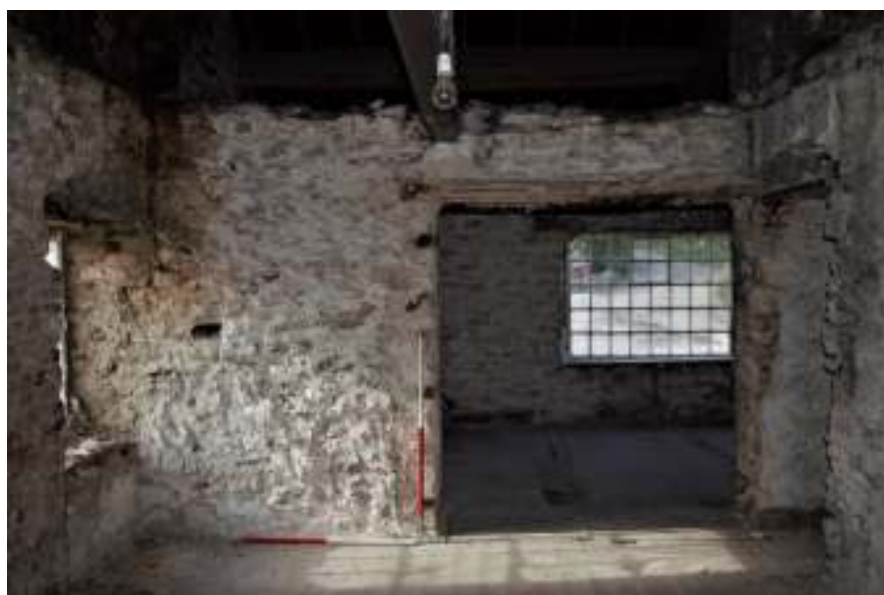
Figure 113 Upper south west room, north wall.

- 3.2.2.2.23. The north wall has a wide opening under a timber lintel, which allowed access into the two western rooms of the northern range from the stair landing (Figure 113).

3.2.2.2.36. The north wall has the wide opening under a timber lintel that allowed access to the doors of the two rooms created by partition in this space (see Fig. 113).

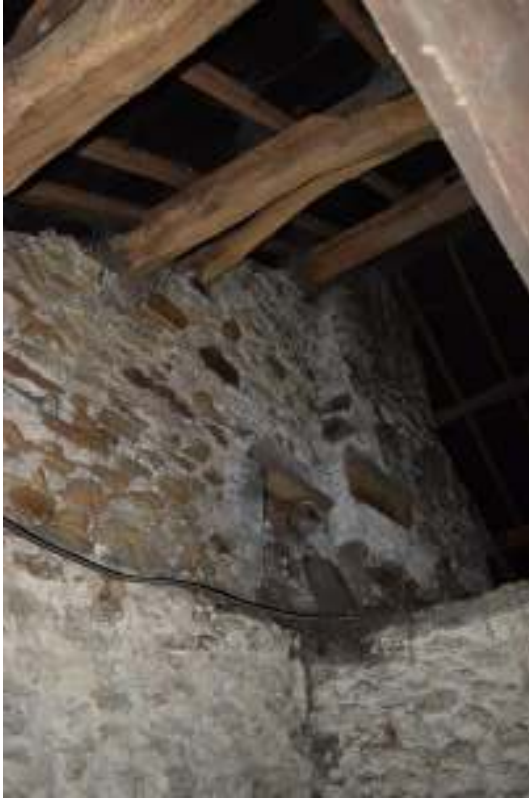
Figure 114. Upper south west room gable former window.

- 3.2.2.2.24. Above the level of the ceiling, indicated by the remains of the plaster and ceiling beams, on the gable wall, is a small former opening under a stone lintel. This is likely to have been a window lighting loft space above the upper floor ceiling (Figure 114).

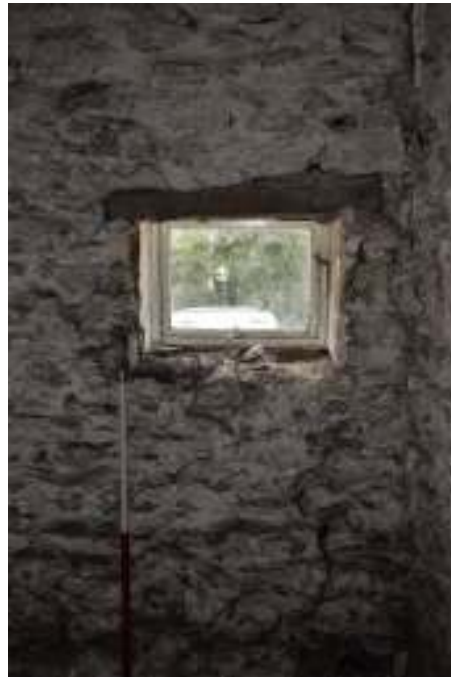
Figure 115. Upper north east room, east window.

- 3.2.2.2.25. The north east room was subdivided into three (a bedroom, bathroom and the upper part of the stairwell) prior to the strip out of partitions. The north wall has three windows, the east window being a small rectangular window with a single light, pivot hung in a wooden frame and under a timber lintel (Figure 115).

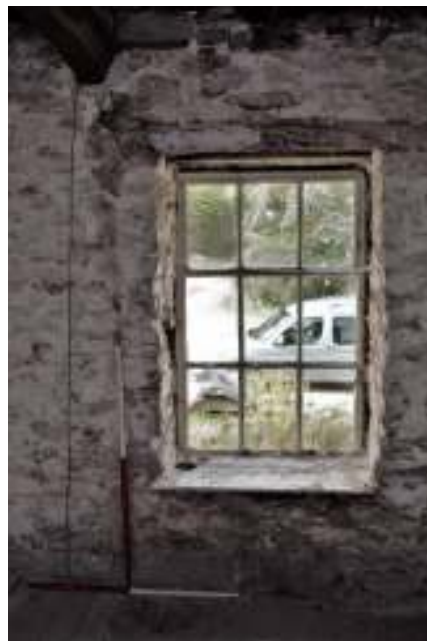
Figure 116. Upper north east room central window.

- 3.2.2.2.26. The central window is a rectangular nine paned window with a 3 x 3 arrangement of panes, the upper row of panes being hopper hung (Figure 116).

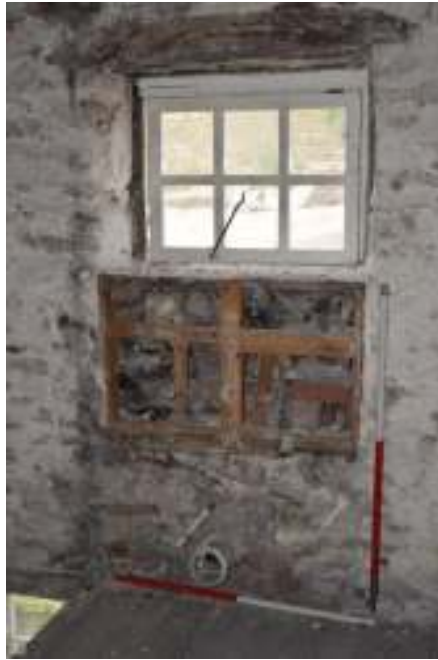
Figure 117. Upper east room, western window.

- 3.2.2.2.27. The western window is a small rectangle with six panes in a 2 x 3 configuration, contained in a canopy hung frame. The original opening was deeper but the lower part has been part blocked. This part of the room was

partitioned off as a bathroom and the blocking provided privacy for the bath (Figure 117).

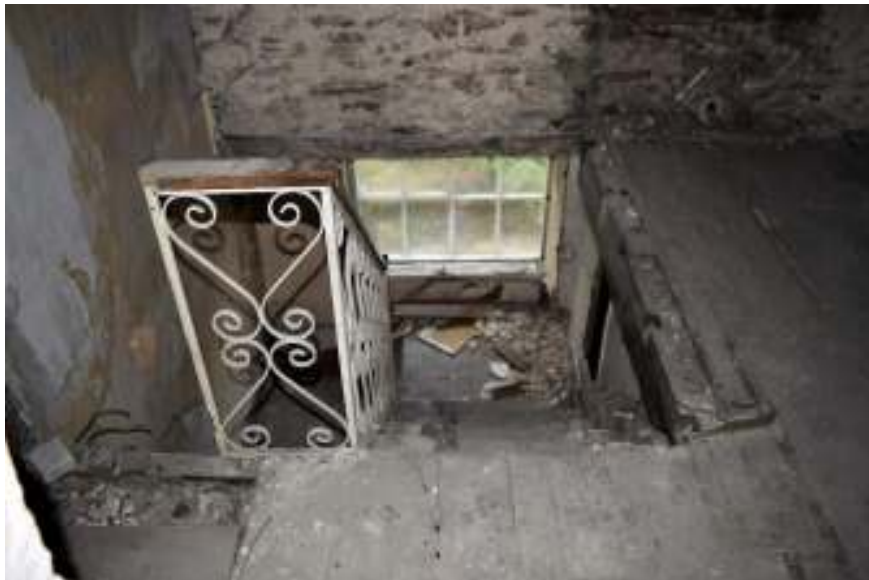
Figure 118. Upper north east room stairwell.

3.2.2.2.28. At the eastern end of the room is the stairwell for the later, inserted staircase. The cogging on the floor joist on the eastern side of the stairwell indicates where floor boards and joists have been cut and removed (Figure 118).

- 4.8. The present staircase is an insertion, shown by the empty cogging in the access through the first floor where floor joists have been removed to create the opening for the stairs. The current banisters are recent (lightweight wrought mild steel, probably later 20th C) although they may replace an earlier set. This may have been an additional staircase to that against the west gable if the house was subdivided or an insertion relating to the reorganisation of the interior space, again perhaps associated with the changes to the fireplaces and the front windows being carried out.

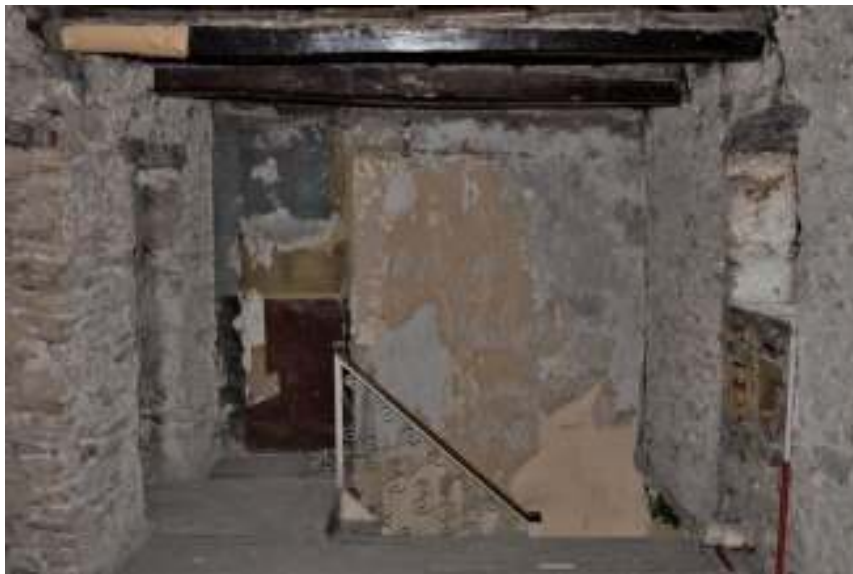
Figure 119. Upper north east room west elevation.

- 3.2.2.2.29. The west wall is a single skin brick insertion, plastered on this face but with the structure visible in the south western room (Figure 119 and see below, Fig.3.2.2.2.35).

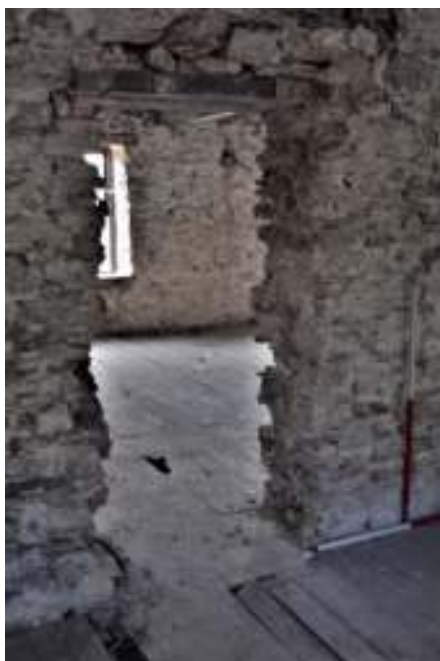
- 3.2.2.2.30. The north wall has two doorways, the eastern of which opened into the former bedroom from a corridor which ran along the southern side of the central spine wall and the western which allowed access to the corridor from the staircase. As described above (para. 3.2.2.2.15) the eastern doorway appears to have been cut through the spine wall (Figure 120) while the western doorway has a finer finish to the jambs that suggests it is part of the original build (Figure 121).

Figure 120 Doorway cut through spine wall to enable access between rooms partitioned from original spaces.
For the use of PWA Planning and Mrs and Mrs McHugh.

3.2.2.2.15. The eastern doorway has much rougher jambs, indicating that it has probably been cut through the wall to create a new doorway when the interior of the house was reorganised at some point (Figure 107). Both doorways have timber lintels above which ceiling beams enter the wall, this has resulted in structural cracking over both doorways.

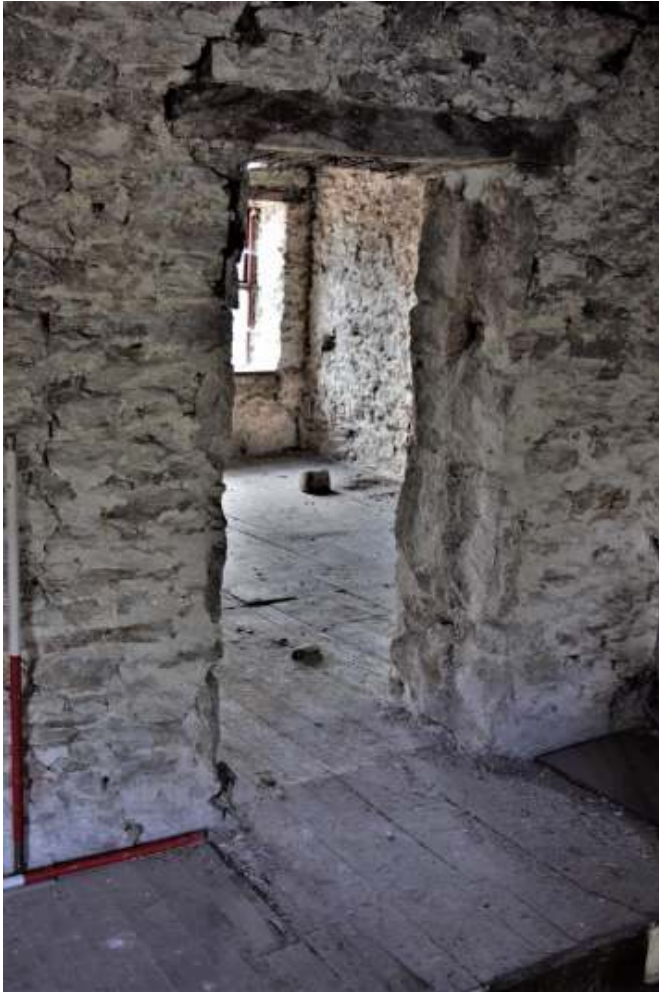
Figure 121 Original doorway between north east rooms in north and south ranges.

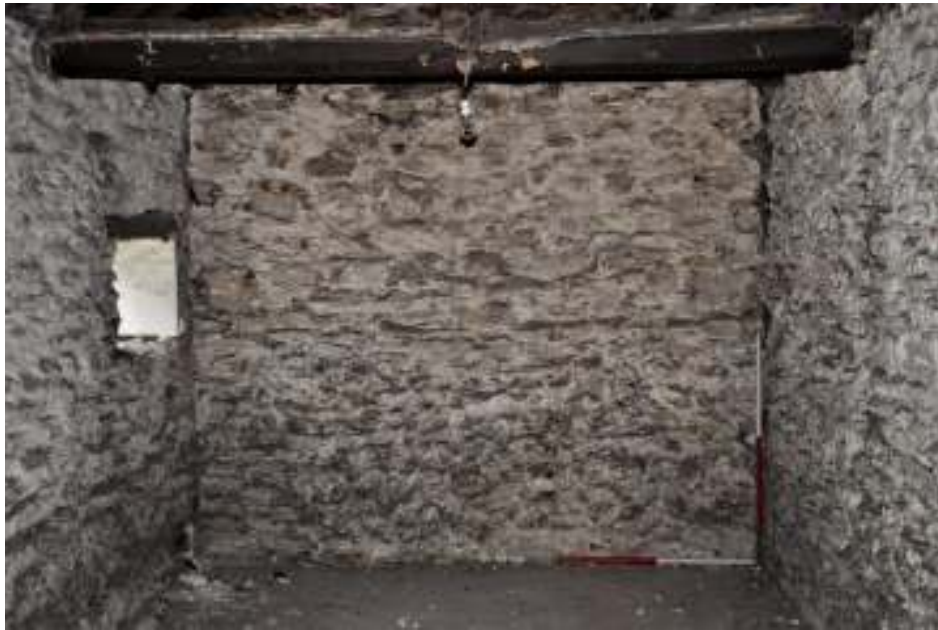
Figure 122 Upper north east room, east elevation.

3.2.2.2.31. The east wall is the gable wall of the house and is relatively featureless (Figure 122).

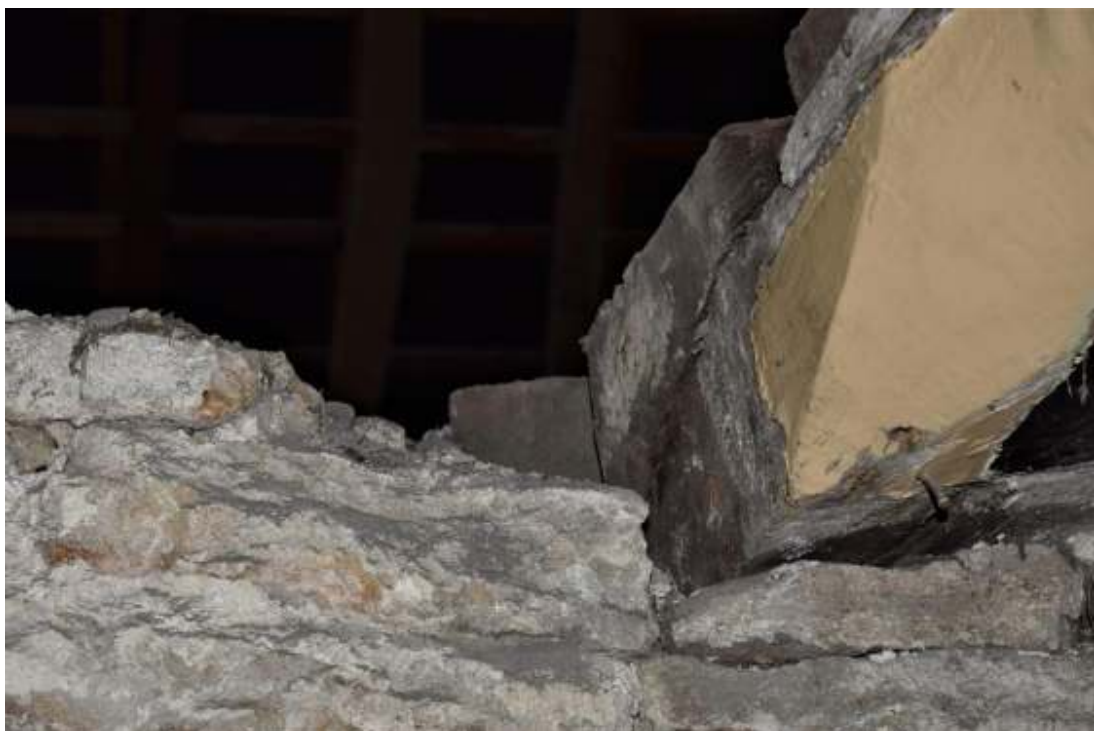
3.2.2.2.32. The ceiling beams are rather irregular timbers and have simple chamfers with no stops. The upper arrisses are cogged for ceiling joists. (Figure 123). While the roof truss ties appear to run across the width of the building, the ceiling beams are shorter lengths which span the rooms between the outer walls and the spine wall, the butted ends being supported on top of the spine wall (Figure 124).

Figure 123 Upper north east room ceiling beams.

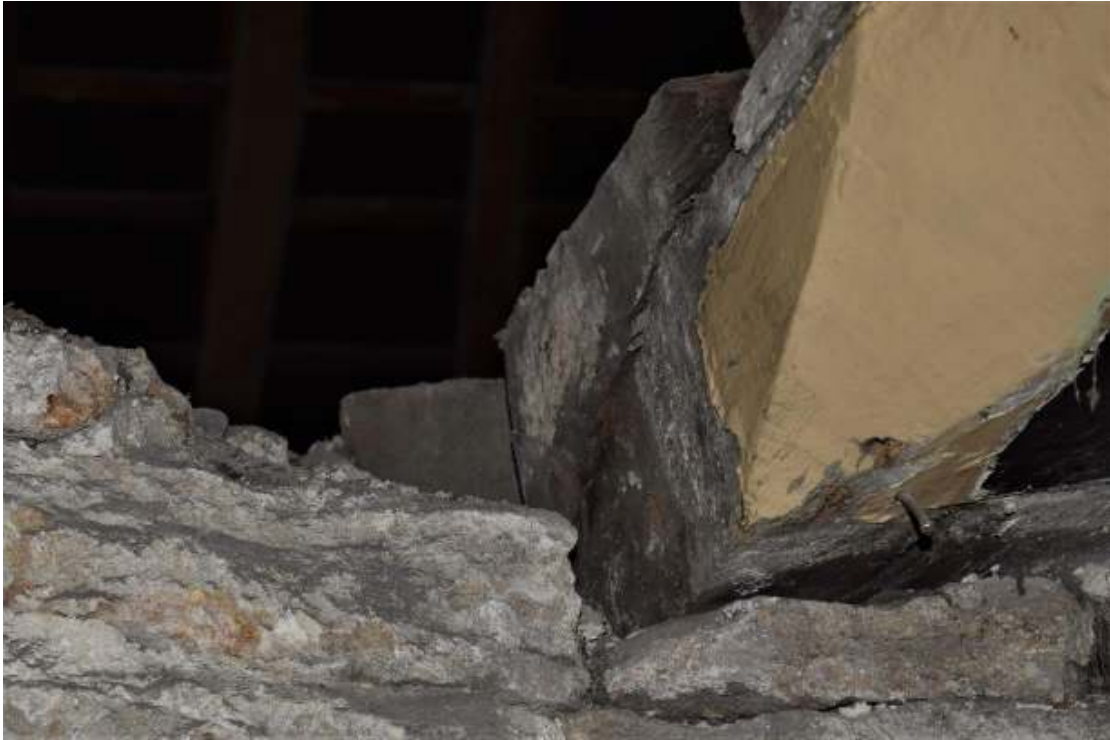
Figure 124. Upper north east room, butted ends of ceiling beams.

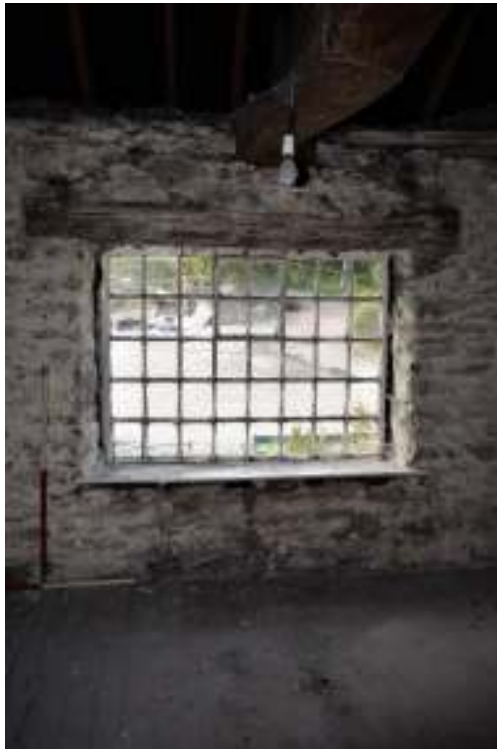
Figure 125. Upper north west room, north wall, east window.

3.2.2.2.33. The upper north west room was subdivided into two rooms by a partition prior to the building being stripped out. The north wall has two windows. The east window is large with forty small panes in an 8 x 5 arrangement. The centre pair of panes in the top two rows are in a pivot hung opening light in a 2x 2 frame pivoted horizontally. The window opening has a substantial timber lintel, supporting the northern end of the west roof truss above it (Fig 125).

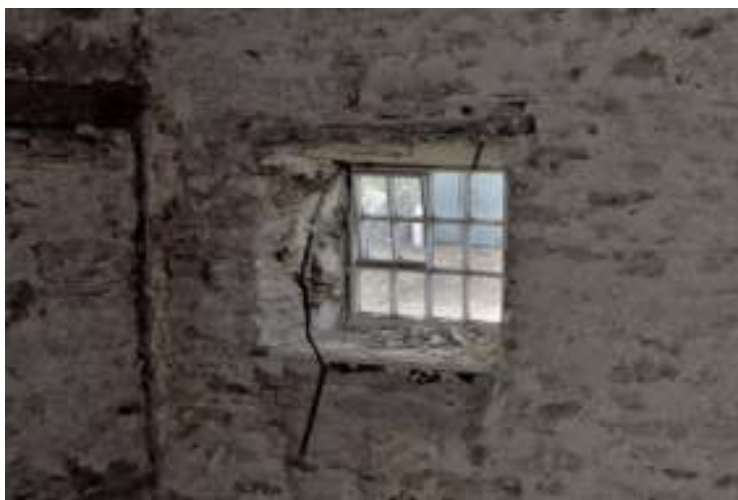
Figure 126. Upper north west room, north wall, west window.

- 3.2.2.2.34. The west window has 12 panes in a 4 x 3 arrangement. The western pair of the top two rows are in a pivot hung opening light in a 2 x 2 frame, pivoted horizontally (Figure 126).

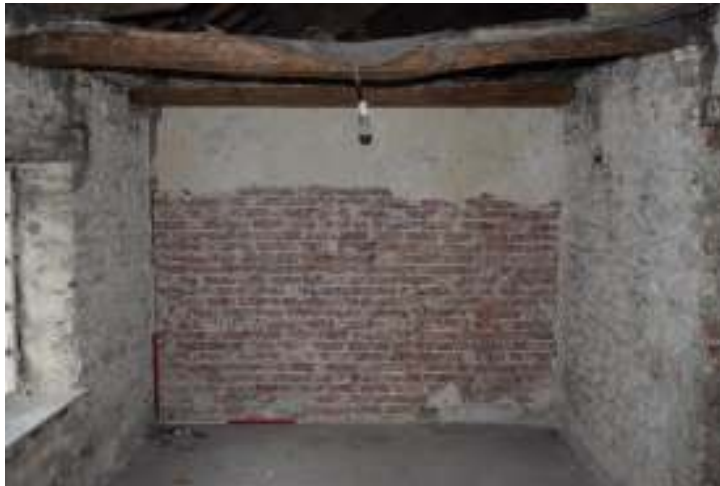
Figure 127. Upper north west room, inserted single skin brick east wall.

- 3.2.2.2.35. The east wall is an inserted single skin brick partition standing just to the east of a ceiling beam (Figure 127).

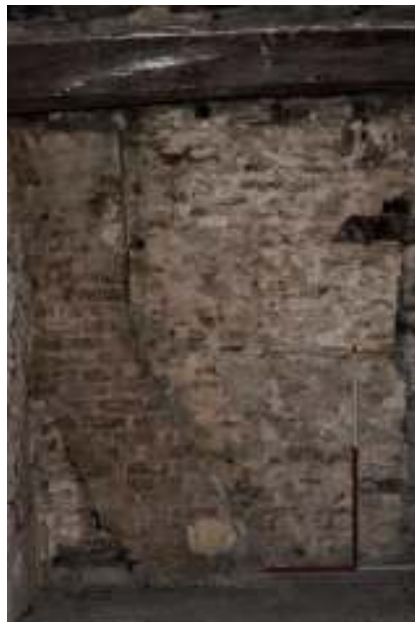
Figure 128. Upper north west room, flue built from ground floor fireplace.

3.2.2.2.37. The west wall is the west gable of the house. A brick flue has been built into the southern side of the wall, sloping from just south of the centre line to meet the spine wall c. 0.75 m above the floor then running vertically to the chimney stack. This is likely to have been inserted when the fireplace in the ground floor room below was built, or during one of the alterations to that fireplace and has been partly cut into the inner face of the wall (Figure 128).

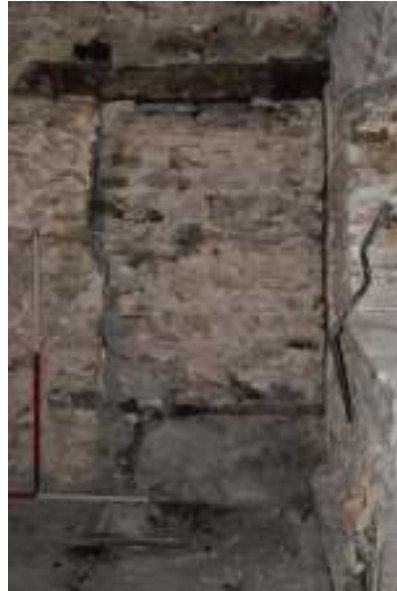
Figure 129. Upper north west room, west wall blocked window.

- 3.2.2.2.38. At the northern end of the wall is a recess with a timber lintel supporting the inner face of the wall above. This is likely to be the position of a blocked window, mirroring that on the west wall of the south western room although the slobbered rubble finish of the outer face of the gable end makes this hard to distinguish on the outside (Figure 129).

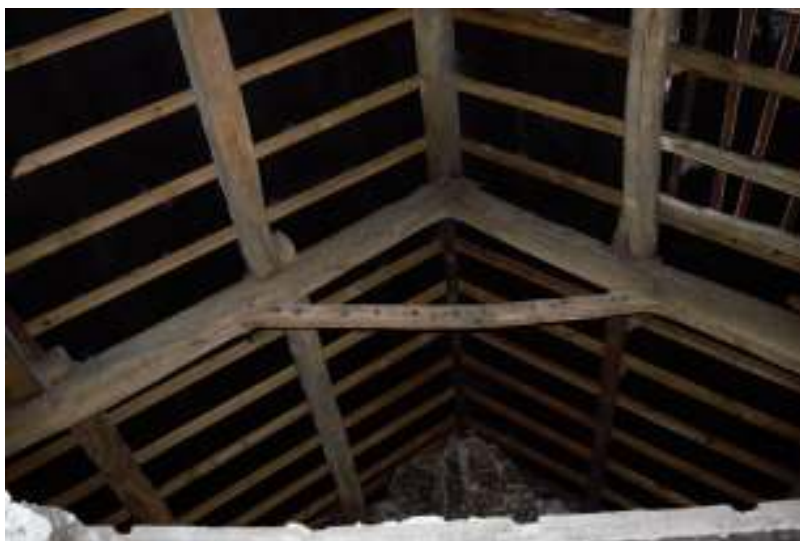
Figure 130 Eastern roof truss from west.

- 3.2.2.2.40. The two full trusses are triangular each with a collar towards the apex and raking struts towards the outer ends (Figure 130).

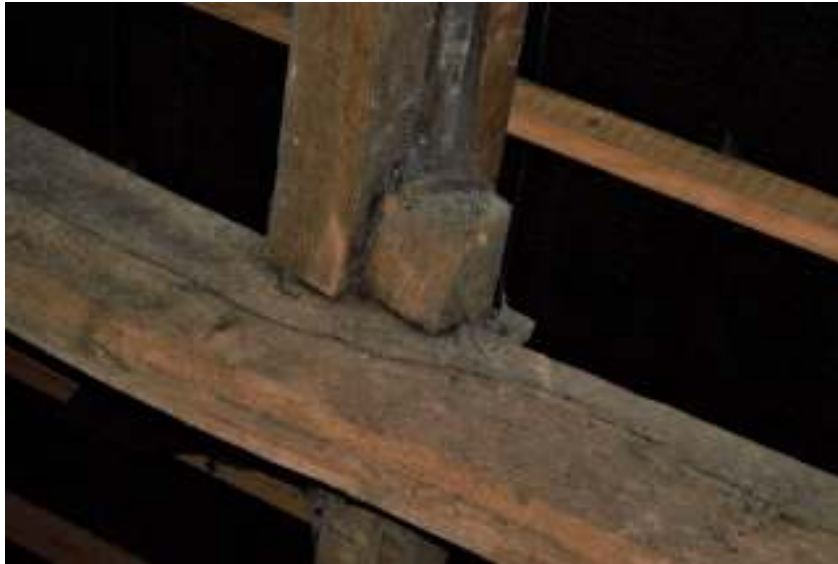
- 3.2.2.2.41. The apex ends of the principal rafters are connected with half lap joints with the ridge piece set diamond orientation. There are two purlins on each side, trenched over, and overlapping at the principle rafters, a peg blow the purlins helping to hold them in position (Figure 131).

Figure 131. Purlin overlap at truss with retaining peg below.

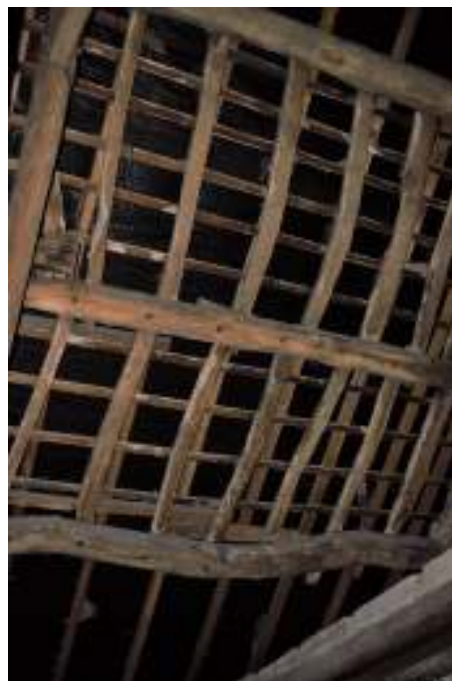
- 3.2.2.2.42. The surviving original common rafters are segmented, short lengths running between the purlins and the ridge piece. Many of the common rafters are cut from irregularly shaped small wood. There is also evidence of “recycling” of timbers from earlier structures with several of the purlins and one of the collars having lines of holes for the sails of wattle walls ((Figure 132).

Figure 132 Roof structure with surviving common rafters and re-used timbers as purlins.

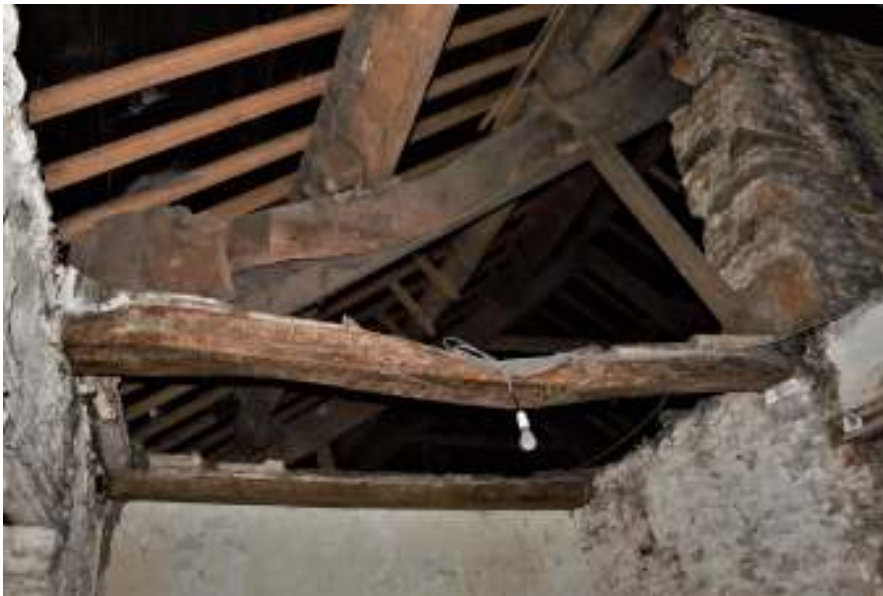
- 3.2.2.2.43. The half truss appears to have originally been simply two rather irregular timbers, pegged at the outer end and built into the north side of the substantial wall that divides the south range of rooms (Figure 133). It appears to have either suffered structural failure or at least have created a cause for concern over its structural integrity as it has had a reinforcing member, comprising a length of sawn softwood plank, bolted to the east face of the principal and a raking strut added between the south end of the tie beam where it meets the wall and the principal, the lower end of the strut being held in a birdmouth on a block of timber attached to the top of the tie beam (Figure 134).

Figure 133 Upper floor, north west room, roof half truss.

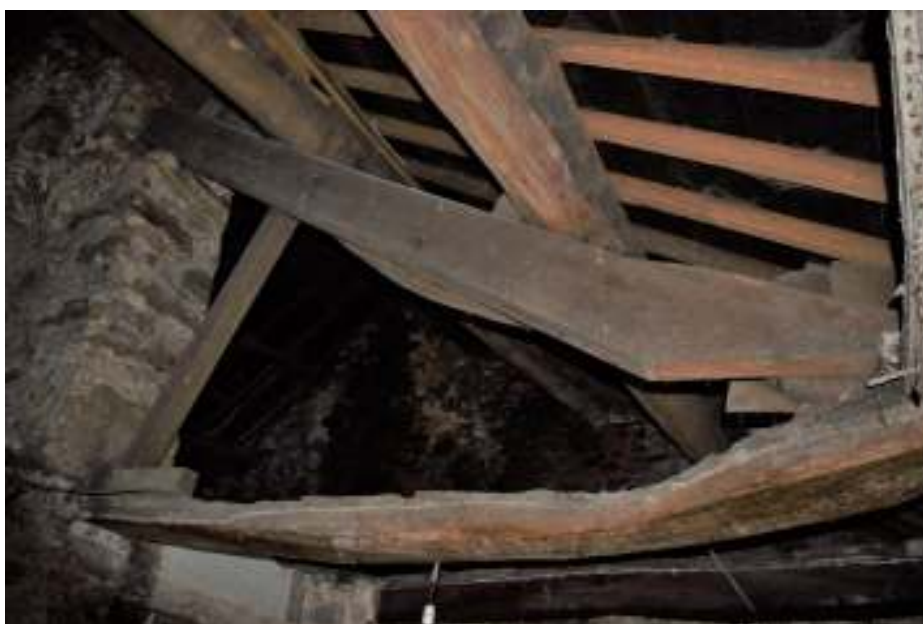
Figure 134 West half truss with reinforcing members.

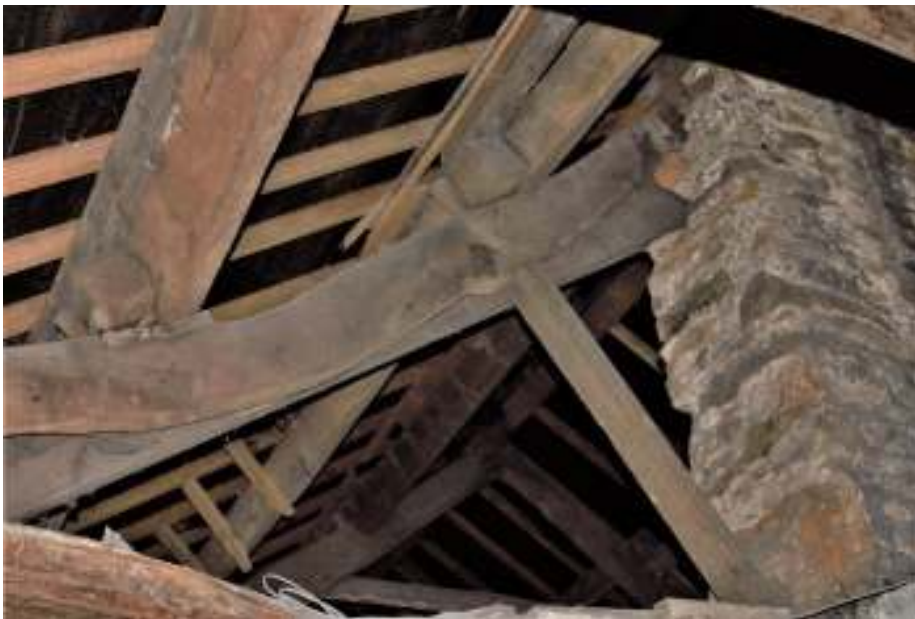
- 3.2.2.2.44. The modern common rafters do not, in several places, sit neatly on the irregular timbers of the purlins and there are a number of packing pieces and support struts visible (Figure 135).

Figure 135 Packing pieces and support struts for modern rafters visible behind truss timbers.

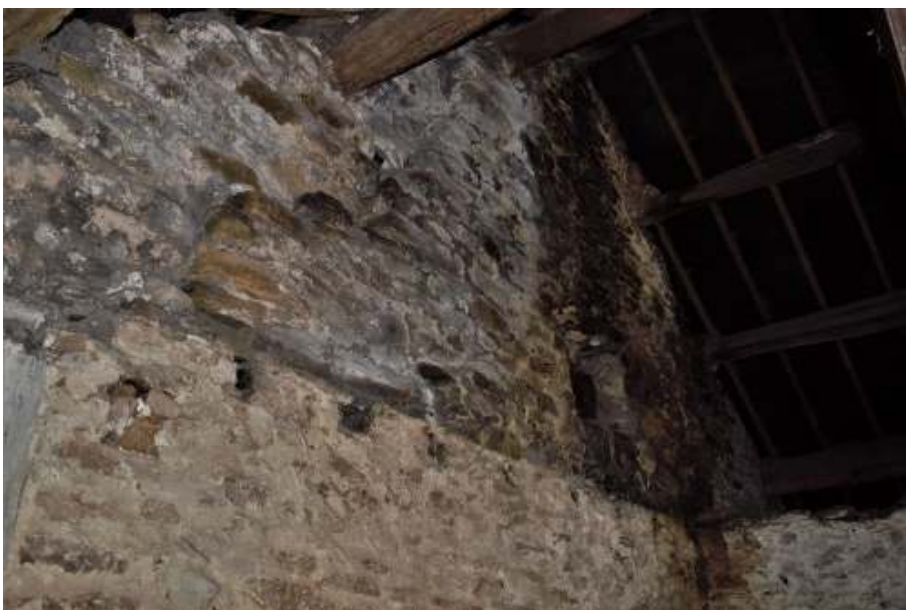
- 3.2.2.2.45. The roof space appears to have been lit by small windows, now blocked, in the end gables, the space most likely used for storage although servants sometimes slept in “attic” rooms although there does not appear to be any traces on the timbers of partitions to create rooms. According to the building contractor who carried out the stripping out of the interior of the house, the roof space latterly had a thick layer of hay lying on the ceilings, most probably having been placed in the roof space to act as insulation.

Figure 136 West gable wall with possible sweeping hole.

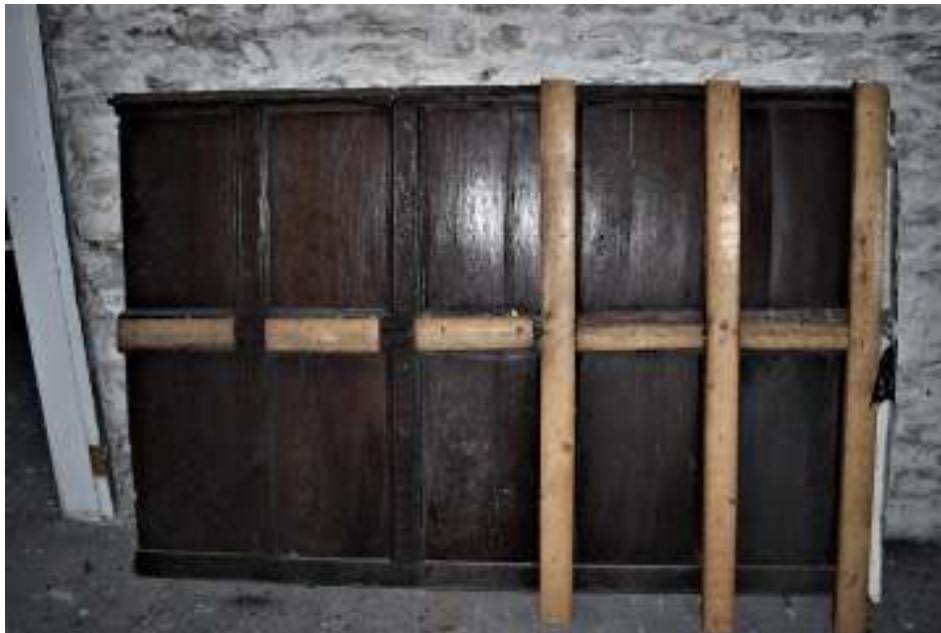
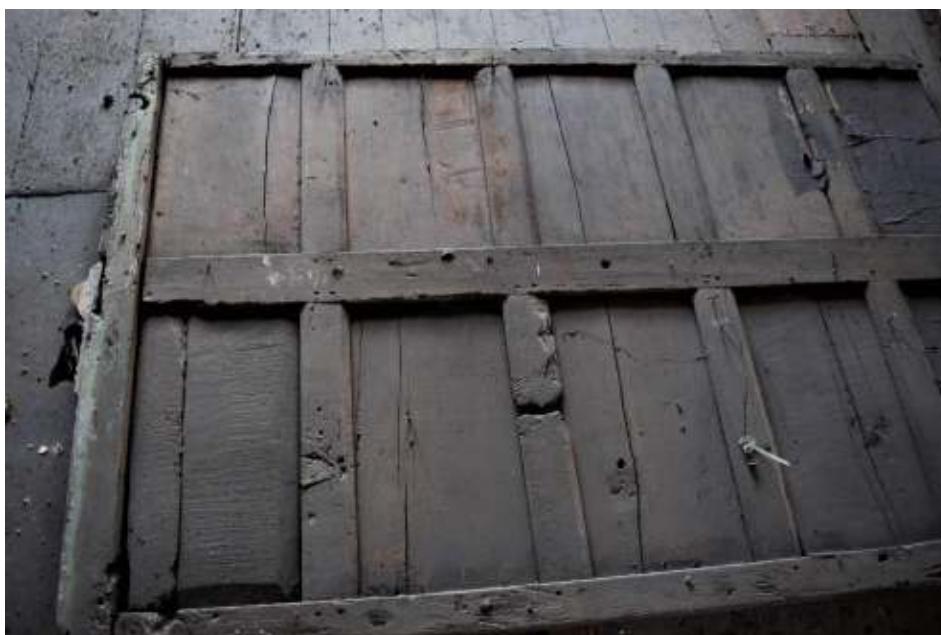
- 3.2.2.2.46.1. There is a section of detached panelling which appears to have been reused in a partition, having had battens nailed to the “front face” to support a different covering. Its original location is unknown and it may have been part of decorative wall panelling in one of the rooms, or formed part of a lightweight room partition in an earlier iteration of the house plan (Figures 137 and 138)

Figure 137 Section of re-used panelling, original front face.

Figure 138 Section of panelling, rear face.

- 4.9. The stripping out of the interior removed almost all the evidence for the internal finishes and structural details of the partitions, leaving only one section of panelling to provide possible evidence for some of the decorative finishes and their reuse in partitions. One the other hand, a record of the house prior to the strip out would have recorded a much less complex story of the development and alteration of the buildings’ interior and fenestration.

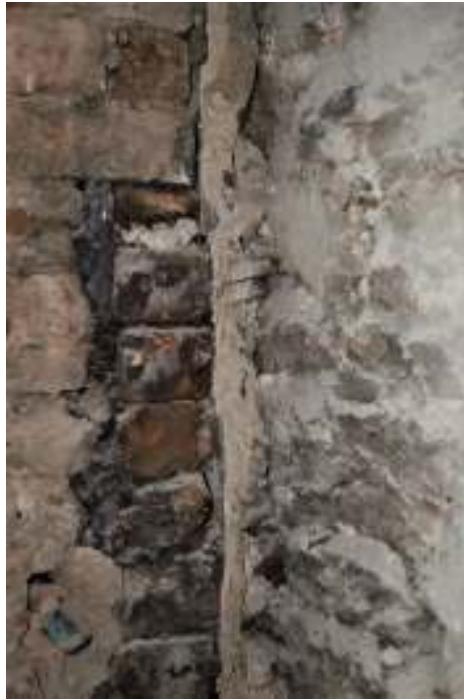
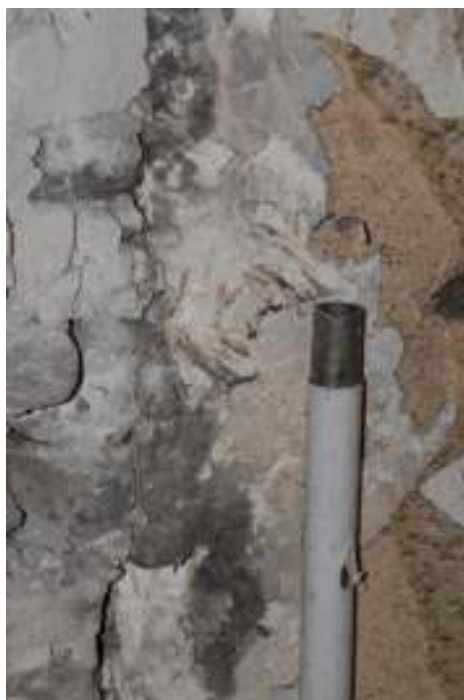
- 3.2.2.2.46.2. Areas of surviving original plasterwork behind the chimney breasts that have been added to several rooms indicate that some, although apparently not all, the original lime plaster was tempered with chopped straw or chaff. Hair temper is well known as an addition to lime plasters (e.g. Historic Scotland 2003), straw/chaff is less frequently cited as a binder in the UK (Figures 139 and 140).

Figure 139 Wall plaster behind chimney breast.

Figure 140 Straw binder in wall plaster.

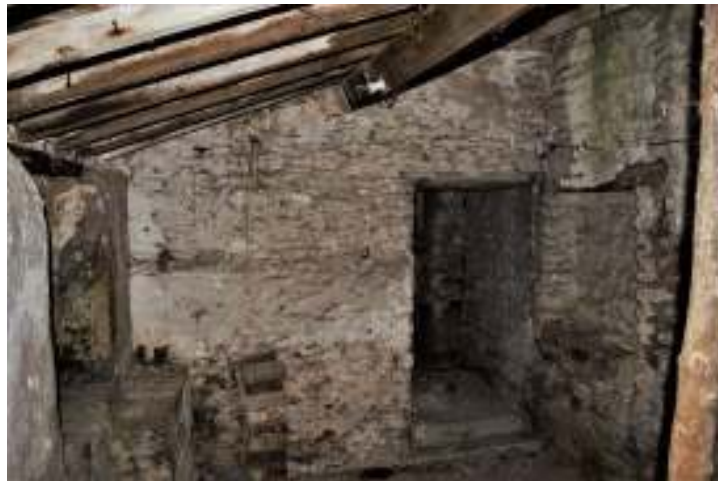
Figure 141 Lean to central dividing wall from south.

3.2.2.2.47.1. The lower story of the west gable of the house is covered by a single story lean-to, constructed of random rubble with a stone slab roof (see Fig. 23). The lean-to is internally divided by a stone wall which acts as a roof support (Figure 141). A timber truss helps support the northern section of the roof (Figure 142), the southern section has only the common rafters as support. The original function of the lean-to is uncertain although stalls against the southern wall indicate the most recent use of the southern part as a stable (Figure 143).

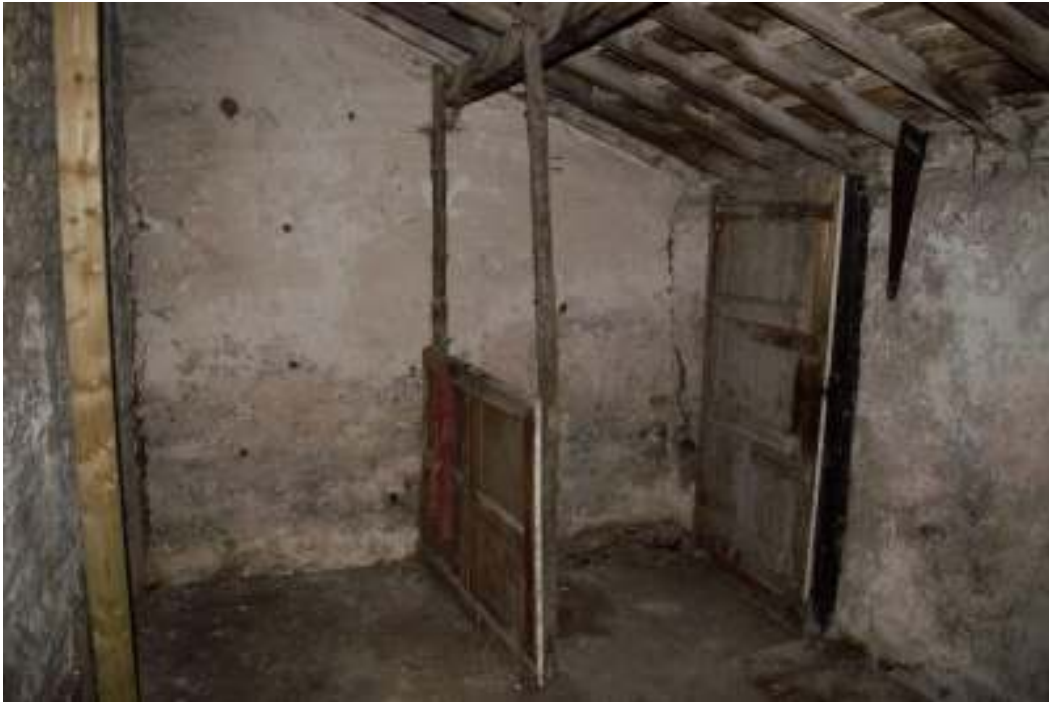
Figure 143 Stalls against south gable of lean-to.
