CHIPPING HOMES

Church Raike, Chipping

Geo-Environmental Assessment Report

AJH/C2179/3577

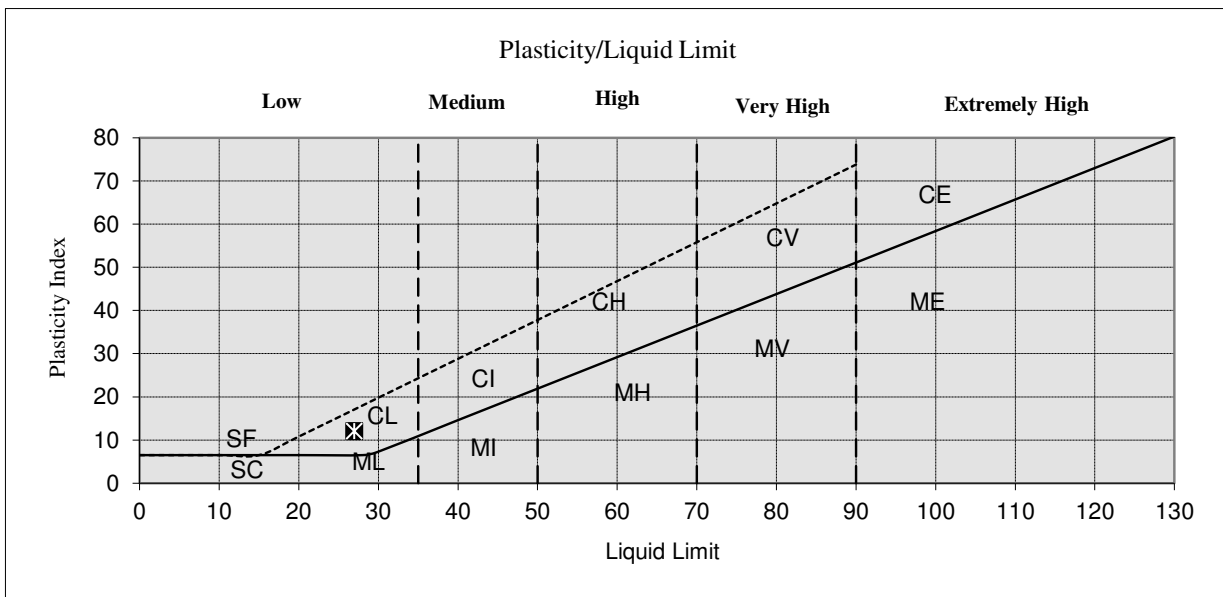
Site:	Church Raike, Chipping	Job No.:	-
Client:	Brownfield Solutions Ltd	Lab Ref No.:	SA13268/01
	Wychwood House	Sample Ref.:	WS1 @ 1.50m
	1 Queen Street	Date Received:	20/02/2013
	Northwich CW9 5JL	Date Tested:	27/02/2013
Originator:	Anthony Hewitt	Date Reported:	27/02/2013

Sampling Certificate	No
Sampled By	Client
Sample Type	Disturbed
Sample Preparation Method	Washed
MATERIAL	Brown Gravelly Clay
Retained 425 micron (%)	30
Natural Moisture Content (%)	13
Liquid Limit (single point)(%)	27
Plastic Limit (%)	15
Plasticity Index	12

- 4.2.1 Water soluble sulphate testing was undertaken on six of the natural strata. The results revealed soluble sulphate (SO₄) contents of <0.01 g/l to 0.13g/l. Associated pH values were obtained which ranged between 5.2 and 8.2 and indicating slightly acid to slightly alkaline conditions.
- 4.2.2 Plasticity index results which ranged between 10% and 22%, moisture contents were in the range 11% to 30%.
- 4.2.3 After modification of particle size in accordance with NHBC Chapter 4.2 the modified plasticity indices are in the range 7.5% to 16.5% indicating the soils to be of low volume change potential.

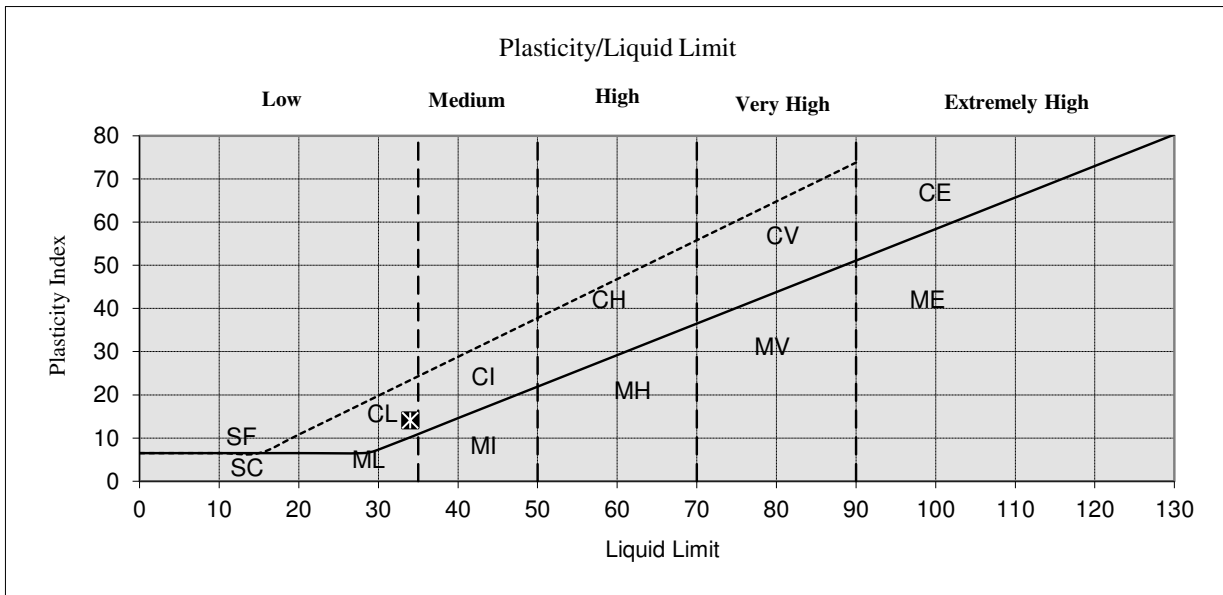
Site:	Church Raike, Chipping	Job No.:	-
Client:	Brownfield Solutions Ltd Wychwood House 1 Queen Street Northwich CW9 5JL	Lab Ref No.:	SA13268/05
Originator:	Anthony Hewitt	Sample Ref.:	WS5 @ 1.60m
		Date Received:	20/02/2013
		Date Tested:	27/02/2013
		Date Reported:	27/02/2013

Sampling Certificate	No
Sampled By	Client
Sample Type	Disturbed
Sample Preparation Method	Washed
MATERIAL	Brown Gravelly Clay
Retained 425 micron (%)	25
Natural Moisture Content (%)	15
Liquid Limit (single point)(%)	34
Plastic Limit (%)	20
Plasticity Index	14

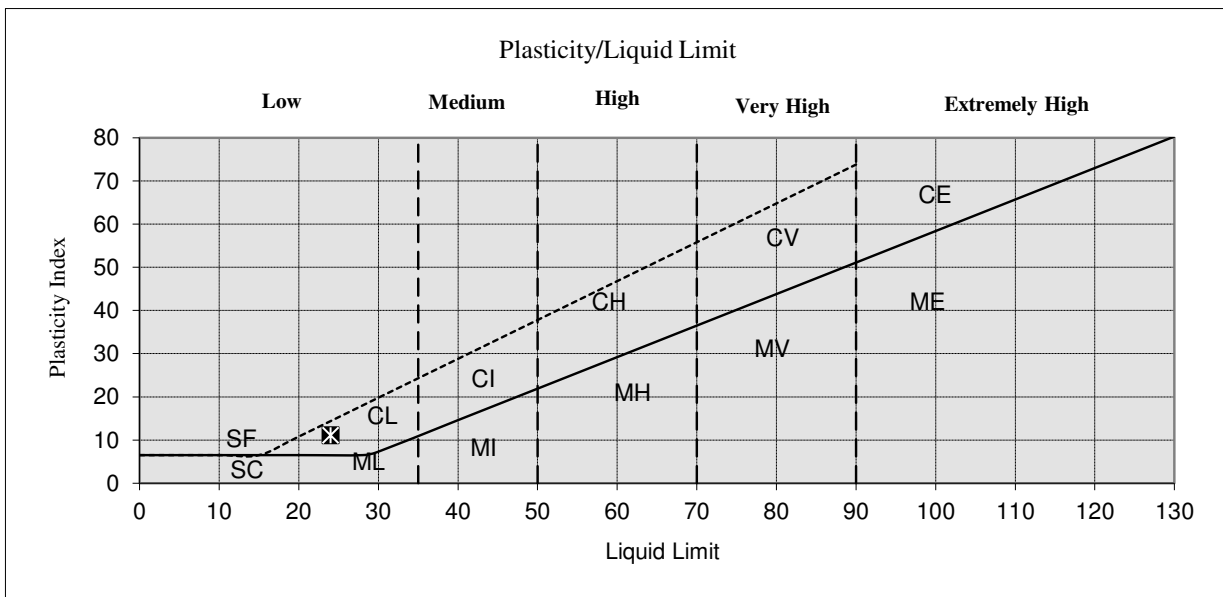
Site:	Church Raike, Chipping	Job No.:	-
Client:	Brownfield Solutions Ltd	Lab Ref No.:	SA13268/04
	Wychwood House	Sample Ref.:	WS4 @ 1.80m
	1 Queen Street	Date Received:	20/02/2013
	Northwich CW9 5JL	Date Tested:	27/02/2013
Originator:	Anthony Hewitt	Date Reported:	27/02/2013

Sampling Certificate	No
Sampled By	Client
Sample Type	Disturbed
Sample Preparation Method	Washed
MATERIAL	Brown Gravelly Clay
Retained 425 micron (%)	25
Natural Moisture Content (%)	11
Liquid Limit (single point)(%)	24
Plastic Limit (%)	13
Plasticity Index	11

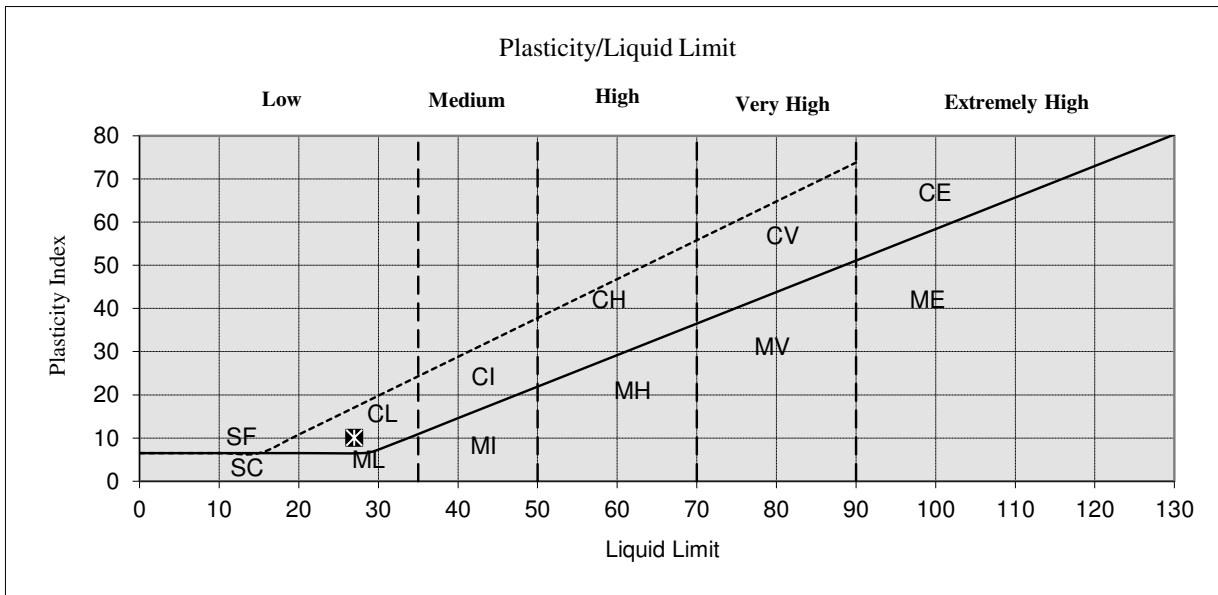
Site:	Church Raike, Chipping	Job No.:	-
Client:	Brownfield Solutions Ltd	Lab Ref No.:	SA13268/03
	Wychwood House	Sample Ref.:	WS3 @ 1.20m
	1 Queen Street	Date Received:	20/02/2013
	Northwich CW9 5JL	Date Tested:	27/02/2013
Originator:	Anthony Hewitt	Date Reported:	27/02/2013

Sampling Certificate	No
Sampled By	Client
Sample Type	Disturbed
Sample Preparation Method	Washed
MATERIAL	Brown Gravelly Clay
Retained 425 micron (%)	25
Natural Moisture Content (%)	13
Liquid Limit (single point)(%)	27
Plastic Limit (%)	17
Plasticity Index	10

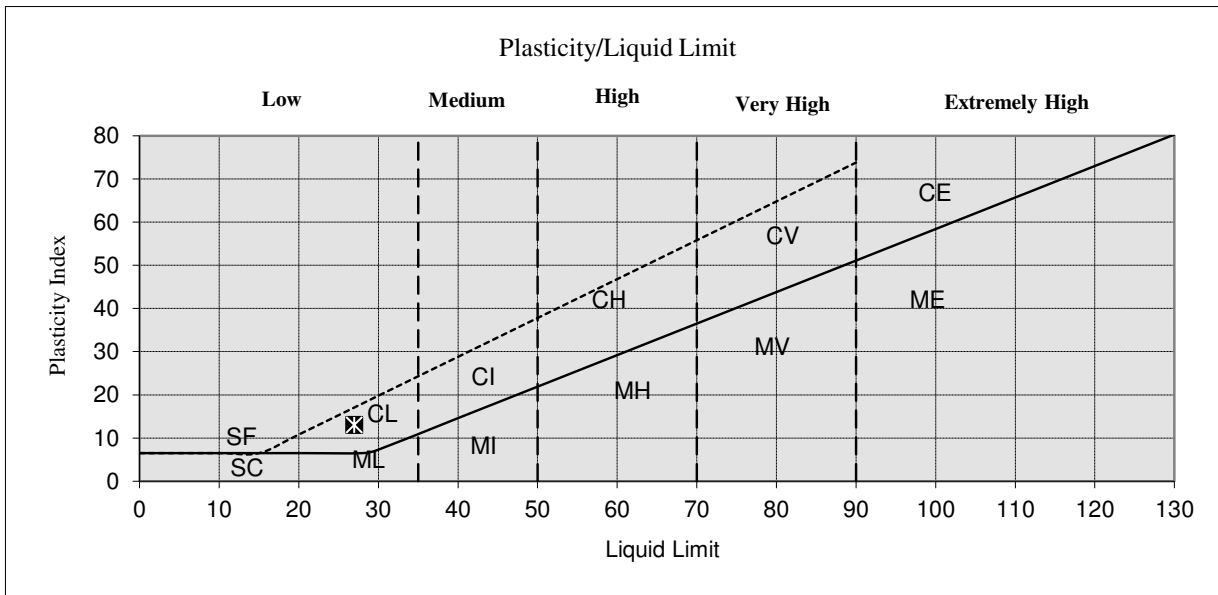
Site:	Church Raike, Chipping	Job No.:	-
Client:	Brownfield Solutions Ltd	Lab Ref No.:	SA13268/02
	Wychwood House	Sample Ref.:	WS2 @ 1.50m
	1 Queen Street	Date Received:	20/02/2013
	Northwich CW9 5JL	Date Tested:	27/02/2013
Originator:	Anthony Hewitt	Date Reported:	27/02/2013

Sampling Certificate	No
Sampled By	Client
Sample Type	Disturbed
Sample Preparation Method	Washed
MATERIAL	Brown Gravelly Clay
Retained 425 micron (%)	30
Natural Moisture Content (%)	12
Liquid Limit (single point)(%)	27
Plastic Limit (%)	14
Plasticity Index	13

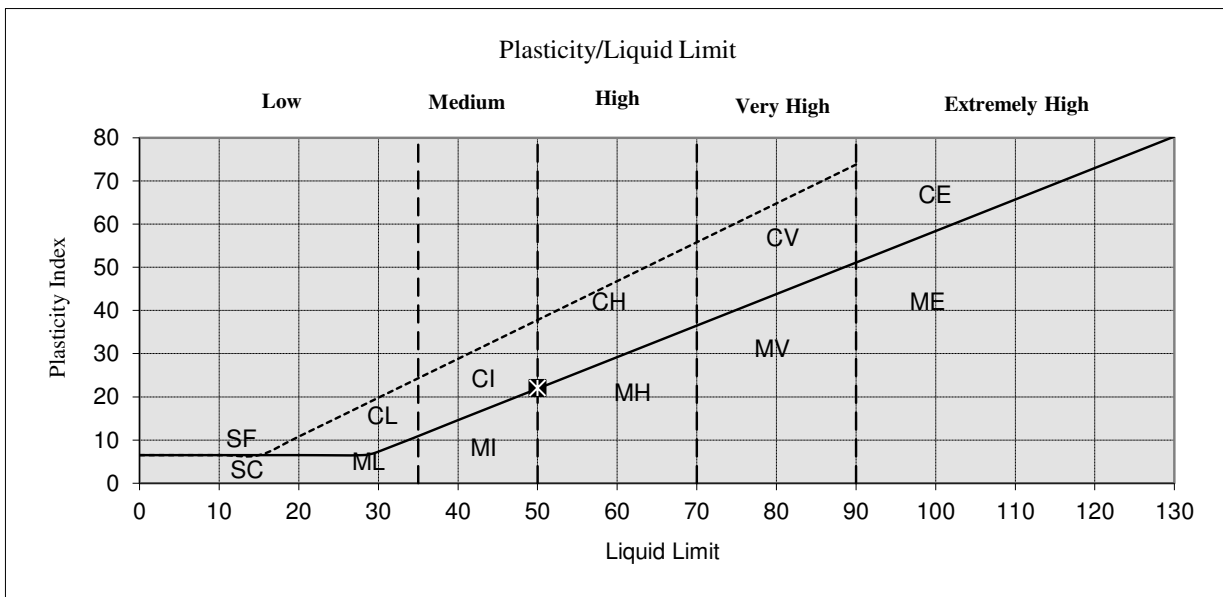
Site:	Church Raike, Chipping	Job No.:	-
Client:	Brownfield Solutions Ltd Wychwood House 1 Queen Street Northwich CW9 5JL	Lab Ref No.:	SA13268/06
Originator:	Anthony Hewitt	Sample Ref.:	WS7 @ 0.50m
		Date Received:	20/02/2013
		Date Tested:	27/02/2013
		Date Reported:	27/02/2013

Sampling Certificate	No
Sampled By	Client
Sample Type	Disturbed
Sample Preparation Method	Washed
MATERIAL	Brown Sandy Clay
Retained 425 micron (%)	25
Natural Moisture Content (%)	30
Liquid Limit (single point)(%)	50
Plastic Limit (%)	28
Plasticity Index	22
