**BAT SURVEY AT -
ABBAYFIELD HOUSE CAREHOME
UNION STREET
LOWMOOR
CLITHEROE**

**DATE AND TIME OF VISIT
16th Jan 2018 11.30 am**

REFERENCE NO. 5493

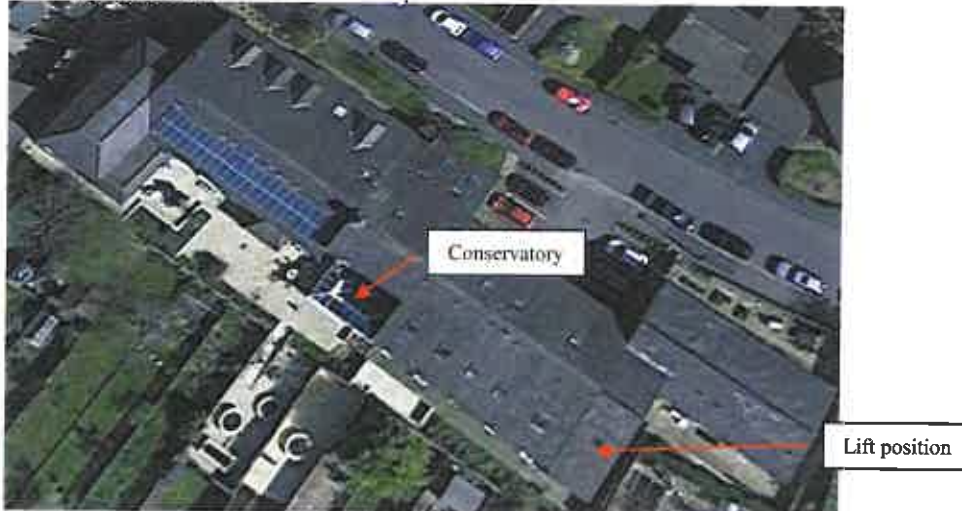
Potential removal of habitat and disruption of a roof.

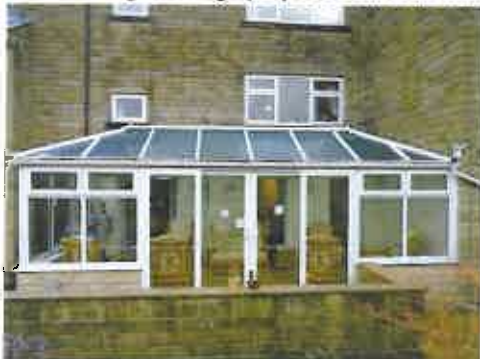
Conservatory

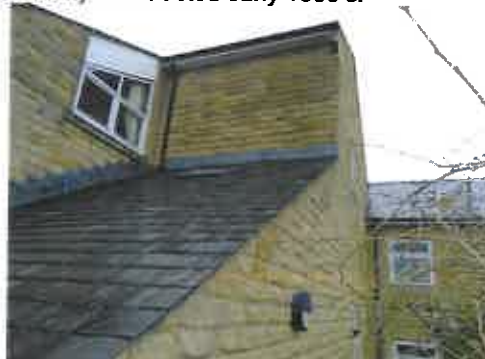
section of roof affected by construction of the lift

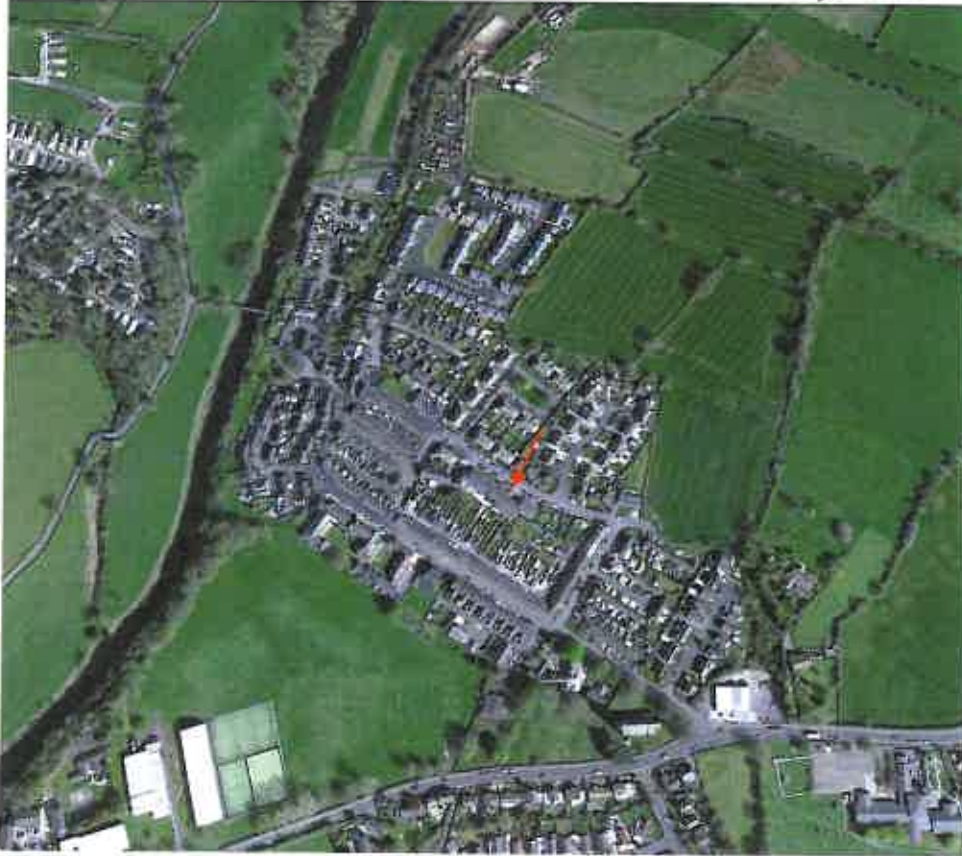
LOCATION SD: 730417 65m elevation.

The building is located in the middle of the Lowmoor area of Clitheroe directly on Union street.

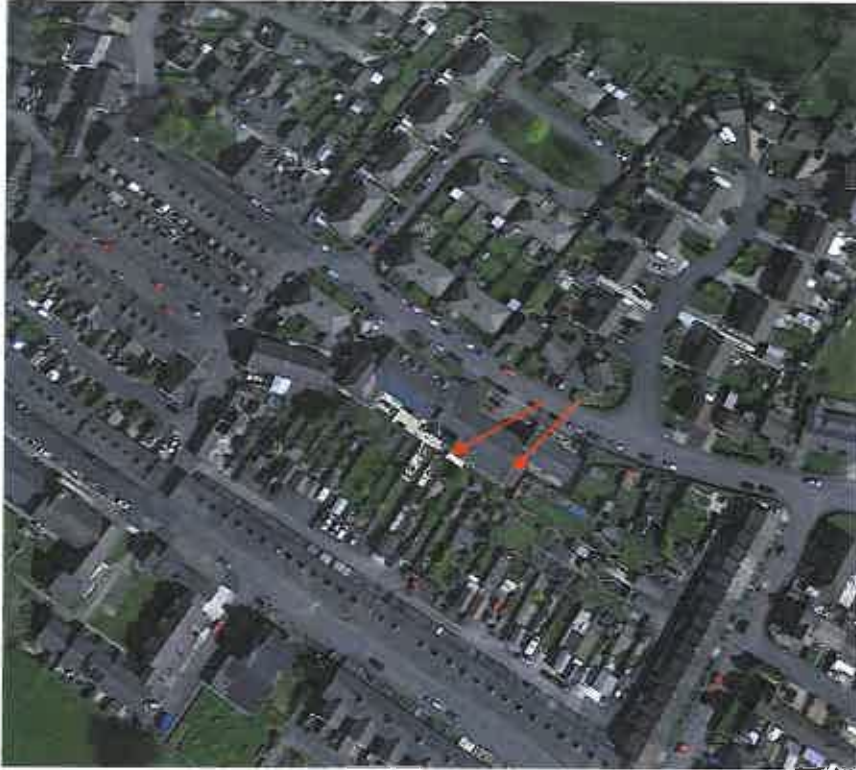
The building is located on Union road and is surrounded by residential properties comprising housing estates and period cottages whose gardens are adjacent to the rear and side of Abbeyfields. The greater locality has the tree lined river Ribble running to the west approx 250m from the site however there are no significant trees within 150 m of the site. The immediate locality provides a sub optimal level of foraging potential with no connectivity to the greater area.

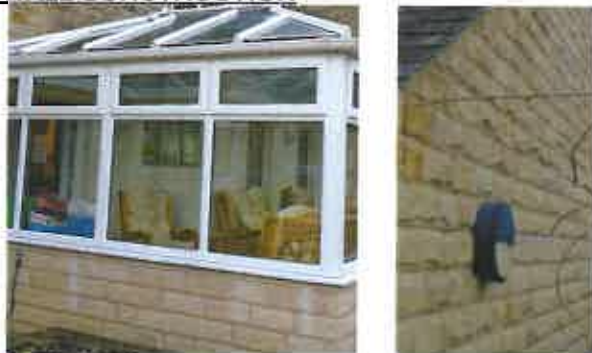
The conservatory appears to be a later addition to the original building, its base walls are coursed natural stone with glazed frames above.
The main building walls are dressed coursed stone cavity construction.

The walls are in perfect condition no cracks crevices or access points.

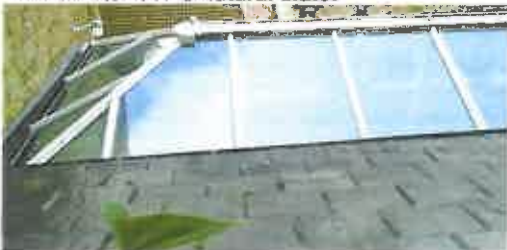
The conservatory roof is a glazed hipped structure, a Upvc frame, moulded gutters and valley gutters at abutment with the walls and adjacent lean to roof.

The lean to roof is natural slate.

Conservatory and adjacent lean to roof.

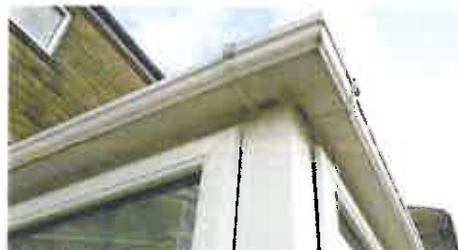
Moulded gutters on conservatory

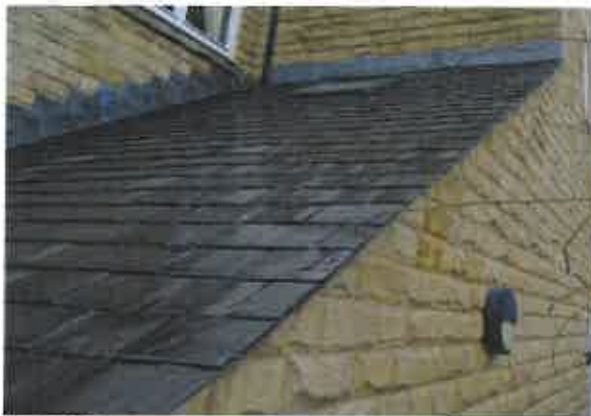
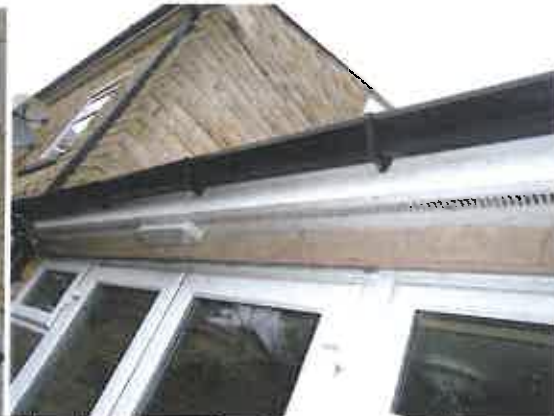
Lean to roof with slate finish, lead flashing at abutment with walls and upvc fascia with vented soffit.

The conservatory roof has no gaps or crevices, bats cannot enter any part of the roof. The both lean to slate roofs are in perfect condition as is the flashing and the fascia/ soffit, all is tight fitting with no gaps or crevices. Bats cannot access these roofs.

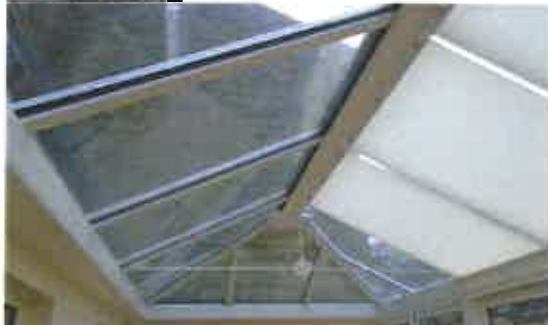
under side of conservatory roof

The lean to adjacent to the conservatory had a ceiling but there was no access to the void. The main lean -to did not have a roof void, the rafters were lined out to the underside forming a small room.
